# Service Bulletin

Bulletin No.: 19-NA-206

**Subject:** Intermittent Shift to Park Message Displayed While Vehicle in Park

**This bulletin replaces 18-NA-297. Please discard 18-NA-297.**

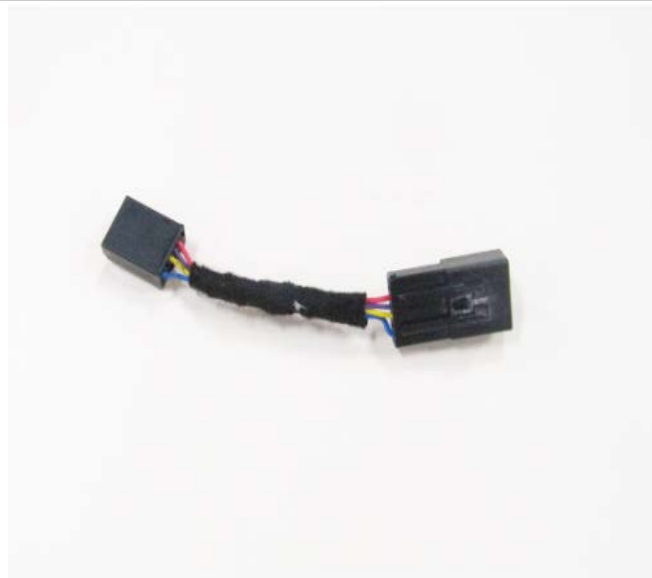
5386336

<b>Involved Region or Country</b>	United States, Canada, Mexico, Europe, Russia, Middle East, Israel, South America, Japan, South Korea, China, Thailand, Australia, New Zealand, Africa
<b>Condition</b>	Some customers may comment on seeing an intermittent Shift to Park message when the vehicle has been shifted into Park, and the ignition has been turned to the Off position.
<b>Cause</b>	The cause of the condition may be that the park switch in the transmission control (shifter) assembly is not pulling the BCM signal low to electronically show that the vehicle is in the Park position.

Verify the condition and following the steps in the Service Procedure below, install an In-line Shifter Wire Harness Jumper between the shifter base connector and the console harness connector.
