# Service Bulletin

Bulletin No.: 19-NA-228

**Subject: Malfunction Indicator Lamp (MIL) Illuminated, Shift to Park Message on Drivers Information Center (DIC), Unable to Turn Off Ignition and/or Discharged Battery - Multiple DTCs Set**

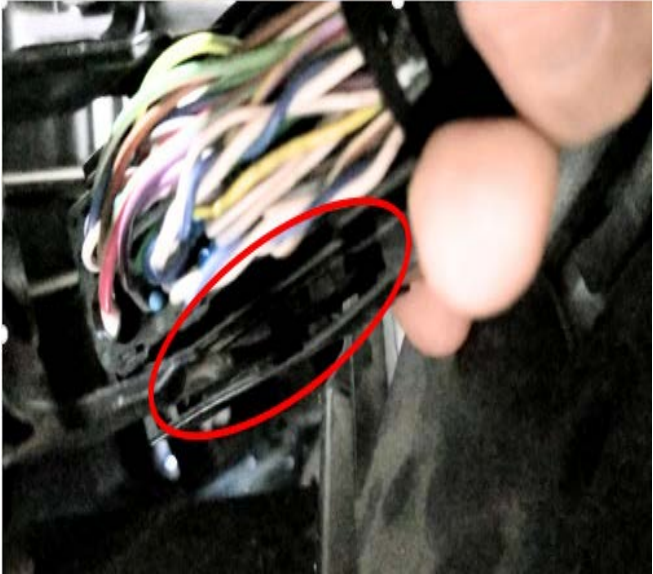
<p>Inspect the TCM (K71) connector for being properly seated.</p> <p>5415523</p>

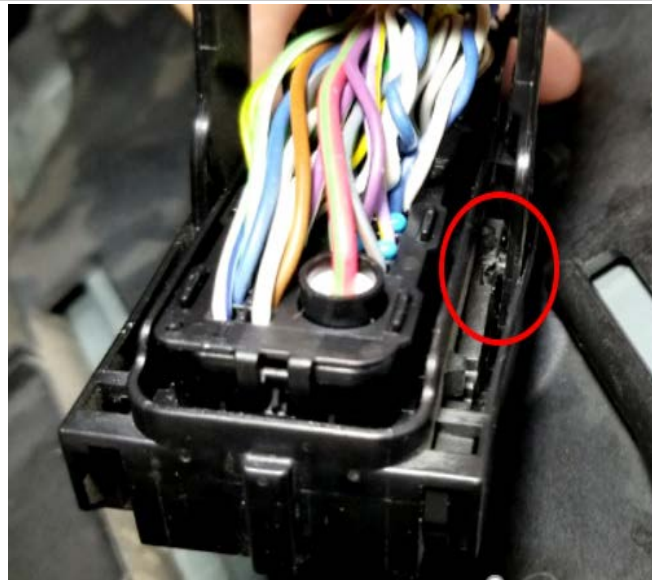
5415528

Inspection of the TCM (K71) connector may show that one of the lever lugs is coming out of position on the horizontal sliding lock bar, causing the drive lug to slide along the outside of the locking bar. Operating the lock lever may reveal that the lock is not moving properly.
