Mercedes-Benz

Campaign No. 2019100006, October 2019

SUBJECT: **Model 907 (Sprinter), Model Year 2019
Screw Connection Hood Catch**

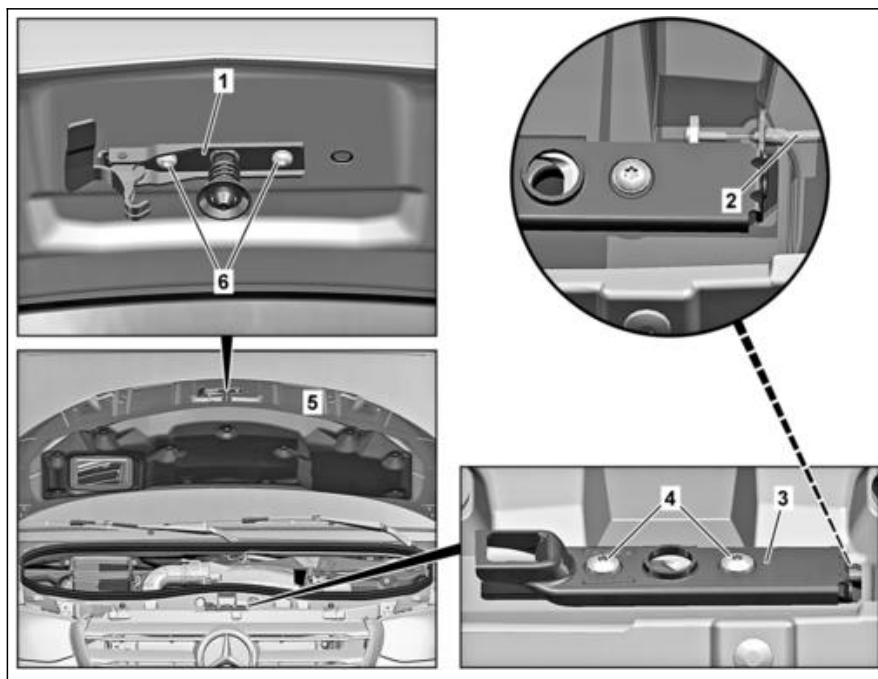
D88.40-1130-06

Daimler AG (“DAG”), the manufacturer of Mercedes-Benz and Freightliner Sprinter vans, has determined that, the screw connection on the upper hood catch of certain Mercedes-Benz and Freightliner Sprinter vehicles (VS30; Platforms 907) may not have been carried out according to specification. Depending on vehicle speed, wind resistance, aerodynamic drag and factors such as vehicle loading and road conditions, the hood could open while the vehicle is being operated. If the hood were to open while driving, it could impact the driver's field of vision, thereby increasing the risk of a crash. An authorized Mercedes-Benz or Freightliner Sprinter dealer will check and if necessary tighten the torque of the screw connection. Any missing screws will be replaced if necessary.

- 1 Hood catch upper section
- 6 Bolts

2	Check whether the screws (6) are present.	If a screw (6) are not present, ↓ screw in missing screw (6) subsequently by hand.	
Retighten Screws			
3	Retighten screws (6).	Bolt, upper section of hood catch to hood	BA88.40-N-1003-01TS

Number	Designation	Model 907
BA88.40-N-1003-01TS	Bolt, upper section of hood catch	8Nm
