TECHNICAL SERVICE BULLETIN

Technical Service Bulletin: 15-1110

15-1110 - CARDINAL SKYLIGHT – REMEDY INSTRUCTIONS

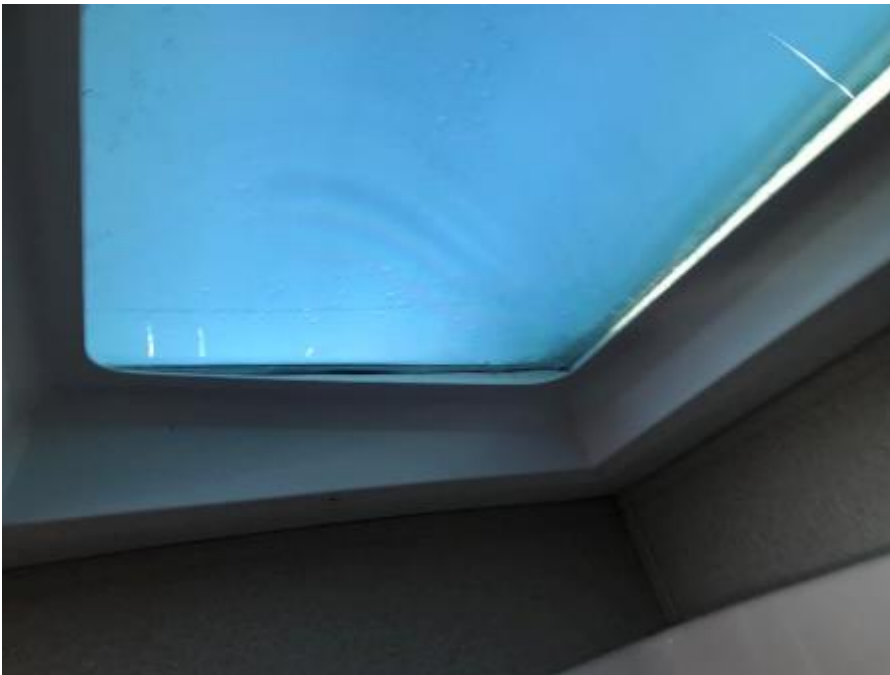
A limited number of outer dome skylights have displayed cracks soon after installation. Cracks may originate at the flange of the skylight and extend outward. The cracks may lead to water infiltration of the vehicle if left unchecked.

SAMPLE OF CRACKED SKYLIGHT

STEP 1: FROM THE ROOF SIDE OF THE UNIT, REMOVE THE COMPLETE SKYLIGHT;

STEP 2: PREPARE THE REPLACEMENT 24" X 36" PART NUMBER 177079 POLYCARBONATE SKYLIGHT AS FOLLOWS;

- APPLY ¼ INCH BY ¾ INCH BUTYL TAPE TO THE BOTTOM OF THE SKYLIGHT SCREW FLANGE.

STEP 3: USE ALFA SEAL PART # N102106T ON IT AND NOT THE DÉCOR SEAL SO THAT IT DOES NOT CRACK AGAIN

STEP 4: POSITION THE REPLACEMENT SKYLIGHT AND INSTALL THE NEW SKYLIGHT TO THE UNIT USING 1 ¾ INCH SCREWS;

STEP 5: FINISH BY APPLYING SEALANT TO THE FLANGE OF THE REPLACEMENT SKYLIGHT OVERLAPPING ONTO ANY OF THE ORIGINAL SEALANT;
