15-19-04TT - Check Engine Light is ON After Camshaft Adjuster Repair or Long Block Replacement, DTC P0017 Stored

Release date: 11/22/2019

Applicable Vehicles					
Model(s)	Year	Eng. Code	Trans. Code	VIN Range From	VIN Range To
Jetta	2017- 2019	1.4L (DGXA, DJXA)	All	All	All

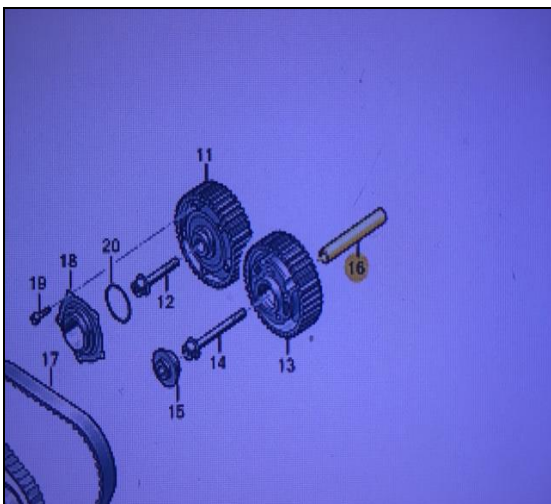
Figure 1

Failure to reinstall oil sleeves when servicing cam shafts and adjusters.

When removing the camshaft adjusters, note that both adjusters have an inner oil sleeve (figure 1). The sleeves must be reinstalled on both adjusters, whenever installing the adjusters on the camshafts (figure 2). Failure to install both sleeves will result in DTC P0017 to setting.
