# Service Action Code: 1903

**Subject** Coolant Bottle

**Release Date** November 8, 2019

**Problem Description** The coolant bottle may leak coolant into the electrical connector for the coolant level sensor.

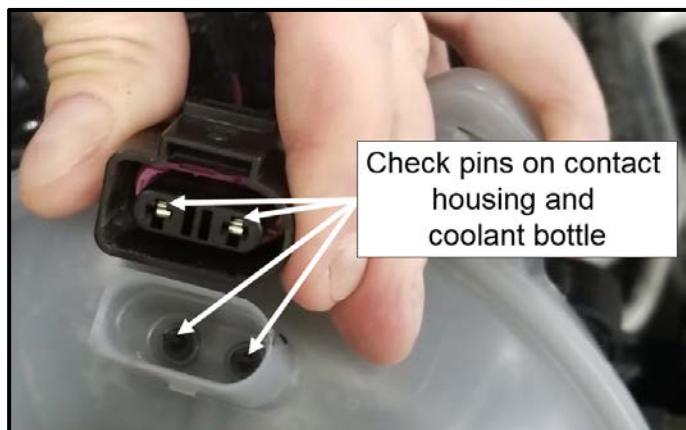
## Section B – Coolant Bottle Inspection

### Inspect coolant level sensor wiring connector and coolant bottle connector housing:

- If coolant or corrosion **IS FOUND** at the coolant level sensor wiring connector and coolant bottle connector housing:
  - Coolant bottle requires replacement.
  - Coolant bottle connector and connector pins require inspection.
  - -J519- requires inspection.
  - TIGUAN ONLY: Ambient temperature sensor requires inspection.
  - **Proceed to Section C.**
- If coolant or corrosion **IS NOT** found at the coolant level sensor wiring connector and coolant bottle connector housing:
  - Reconnect the coolant level sensor connector to the coolant bottle.
  - No further work is required.
  - **Proceed to Section E.**

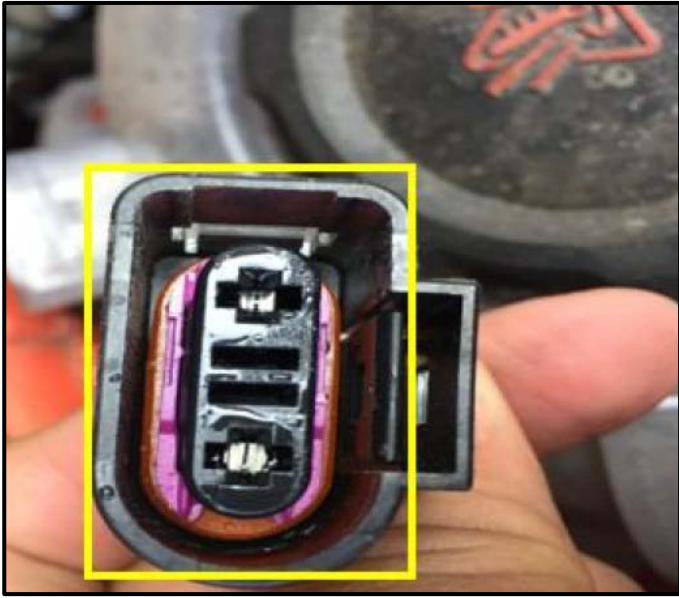
## Section D – Coolant Migration Inspection

### Inspect coolant bottle connector:

- If corrosion is found on the connector pins:
  - The connector pins must be replaced.
- If only liquid coolant is found at the connector pins:
  - The coolant bottle connector housing must be cleaned with a dry, lint free cloth.
  - The coolant bottle connector pins must be cleaned with compressed air.

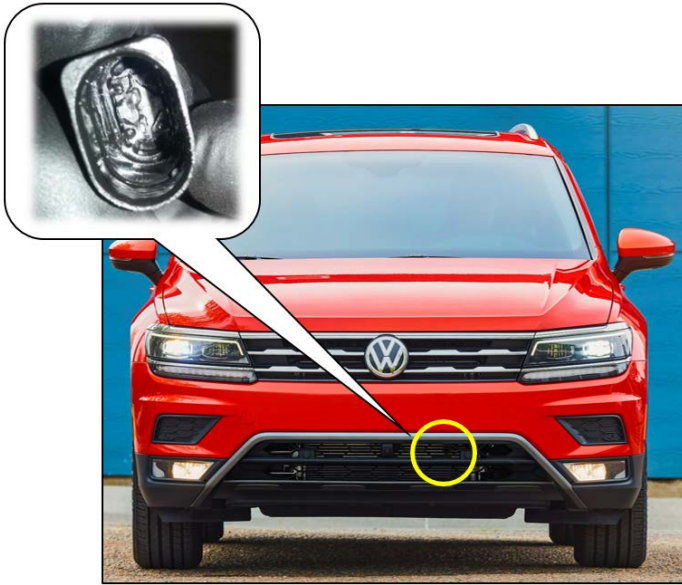
**TIGUAN ONLY - Inspect ambient temperature sensor for coolant migration:**

- Connector and sensor will be inspected.
- If NO liquid coolant or corrosion is found:
  - Reconnect connector to sensor.
- If corrosion is found on the connector or sensor pins:
  - Ambient temperature sensor must be replaced.
  - Corroded connector pins must be replaced.
- If only liquid coolant is found at the sensor, but there is NO corrosion:
  - Ambient temperature sensor connector and pins should be cleaned with a dry, lint free cloth.
  - Ambient temperature sensor connector and pins should also be cleaned with compressed air.

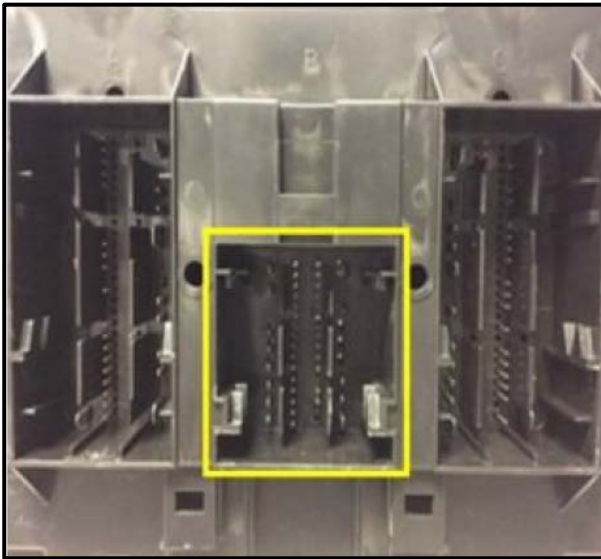
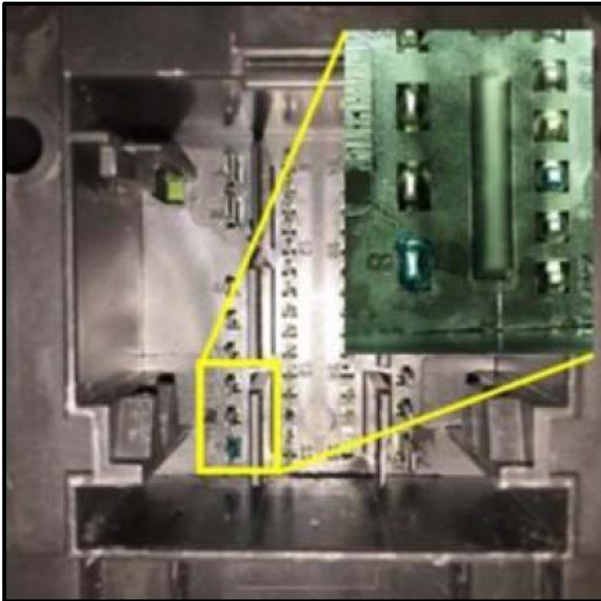
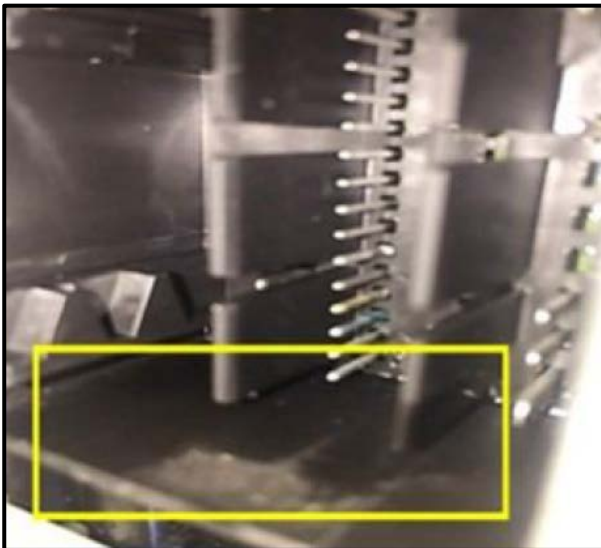
### Inspect -J519- for coolant migration:

- Connector T46b connector will be inspected.
- If NO liquid coolant or corrosion is found:
  - Reassemble vehicle in reverse order of removal.
  - Proceed to Section E.
- If corrosion is found on the -J519- pins:
  - -J519- must be replaced.
  - Corroded connector pins must be replaced.
- If only liquid coolant is found at the -J519-, but there is NO corrosion:
  - -J519- should be cleaned with a dry, lint free cloth.
  - The -J519- pins must be cleaned with compressed air.

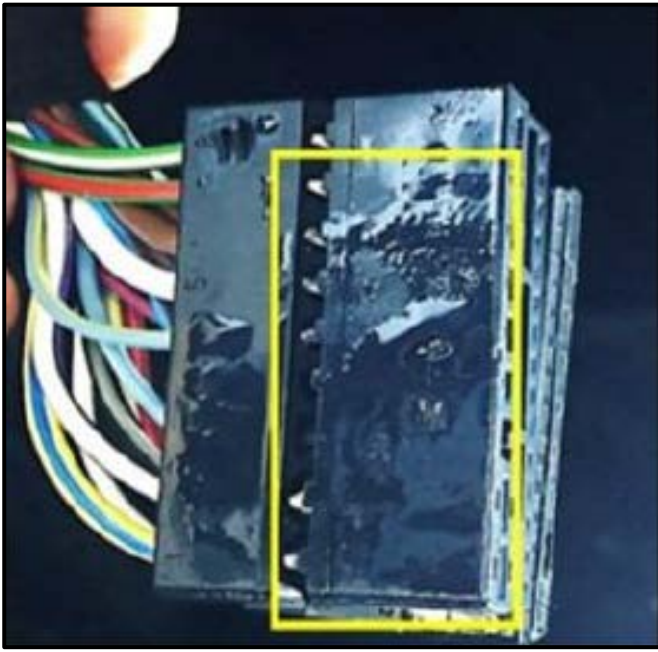
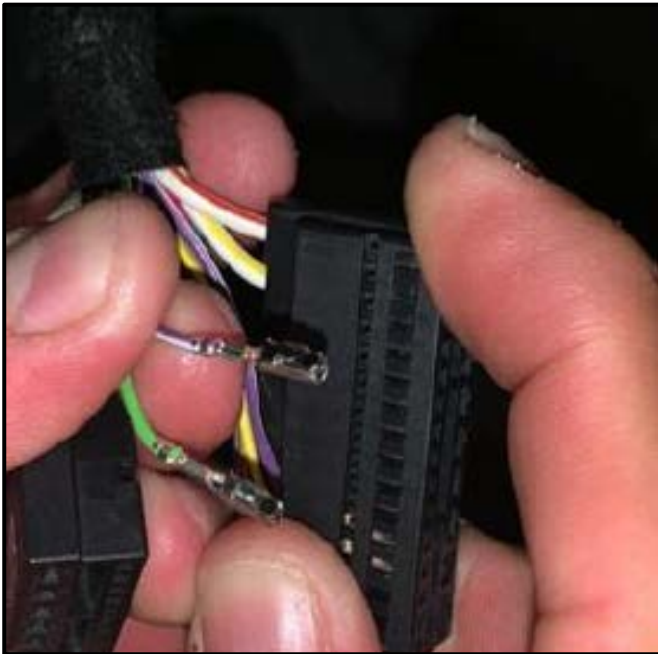
#### Check -J519- connector for coolant migration:

- Separate the individual terminal housings and inspect for coolant migration or corrosion.
  - See Appendix A for detailed disassembly instructions for separating the individual pin terminal housings from the -J519- connector housing.
- If NO liquid coolant or corrosion is found:
  - Reassemble vehicle in reverse order of removal.
  - Proceed to Section E.
- If corrosion is found on the -J519- connector pins:
  - Corroded connector pins must be replaced.
- If only liquid coolant is found on the -J519-, but there is NO corrosion:
  - -J519- connector housing must be cleaned with a dry, lint free cloth.
  - The connector pins must be cleaned with compressed air.
- Once all necessary -J519- repairs have been performed, **Proceed to Section E.**
