**96-19-01 - Access-Start Authorization (KESY) - Keyless Defective Message in Instrument Cluster**

Release date: 11/5/2019

Applicable Vehicles						
Model(s)	Year	Eng. Code	Trans. Code	VIN Range From	VIN Range To	PR Code
Passat	2018 - 2019	All	All	All	All	4F6

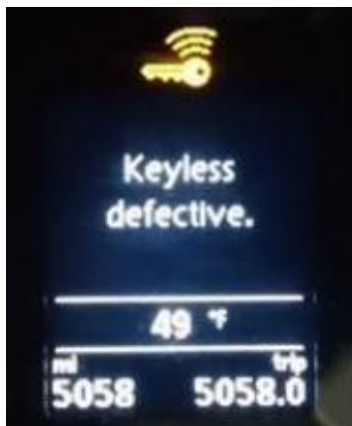
Figure 1.

The customer reports that the warning message "Keyless defective" has appeared in the instrument cluster after starting the engine (Figure 1).

A software-related deviation in the Access/Start Authorization Control Module **-J518-** allows false detection of an open circuit condition during engine cranking.

Using software version management (SVM), update the software of the Access/Start Authorization Control Module.
