NUMBER: 08-016-19 REV. D

GROUP: 08 - Electrical

DATE: October 2, 2019

UAS, UAQ, UCS and UCQ Radio Enhancements

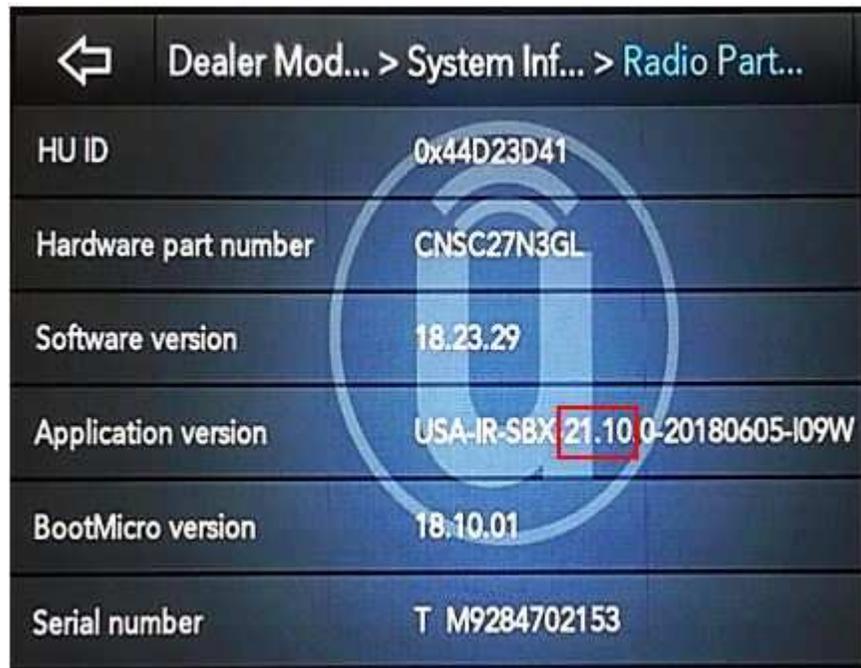
Fig. 1
Radio Software Level Screen

1. Verify the radio software version. Radio must be in Dealer Mode to verify by following these steps:
 - Push and hold the Front Defrost, Driver Temperature Up and Temperature Down buttons simultaneously until the Dealer Mode screen appears (approximately seven seconds). Release buttons.
 - Select "Radio Part Information". The software version will be listed next to "Application Version". (Fig. 1)
2. Is the current radio software level at or higher than?
 - 22.6 - DS, D2, DP, DD, DF and DJ vehicle with UAS **UCQ and UAQ** radio.
 - 22.5 - LA, LD and LX vehicle with UAS and UAQ.
 - 21.9 - All other vehicles and radios.
 - YES >>> The radio software is already up to date. This bulletin has been completed. Use inspect LOP (18-60-02-VK) to close the active RRT.
 - NO >>> The radio software needs to be updated. Back out of Dealer Mode and proceed to [Step 1](#) of the Repair Procedure.

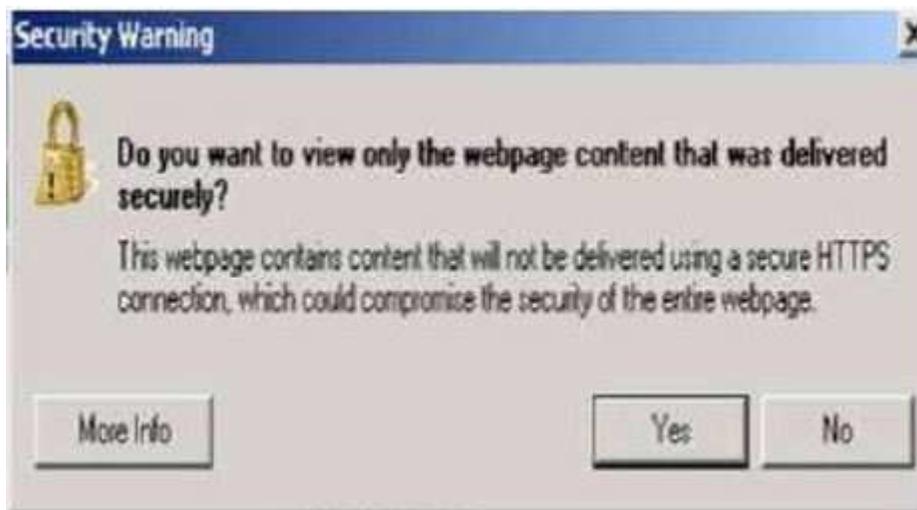
Fig. 2
Pop-Up Security Message

1. Has a **16GB** USB flash drive been created?
 - YES >>> Proceed to [Step 10](#).
 - NO >>> Proceed to [Step 2](#).
2. Go to DealerCONNECT>Service>Uconnect Command Center>Uconnect>More Information >Dealer software downloads to download the files.
3. If a security message appears “Do you want to view only the web page content that was delivered securely?” (Fig. 2) . Press “No” to continue.

NOTE: If the software cannot be downloaded, make sure you have proper security access. If not, have the Service Manager or Shop Foreman download the software update.

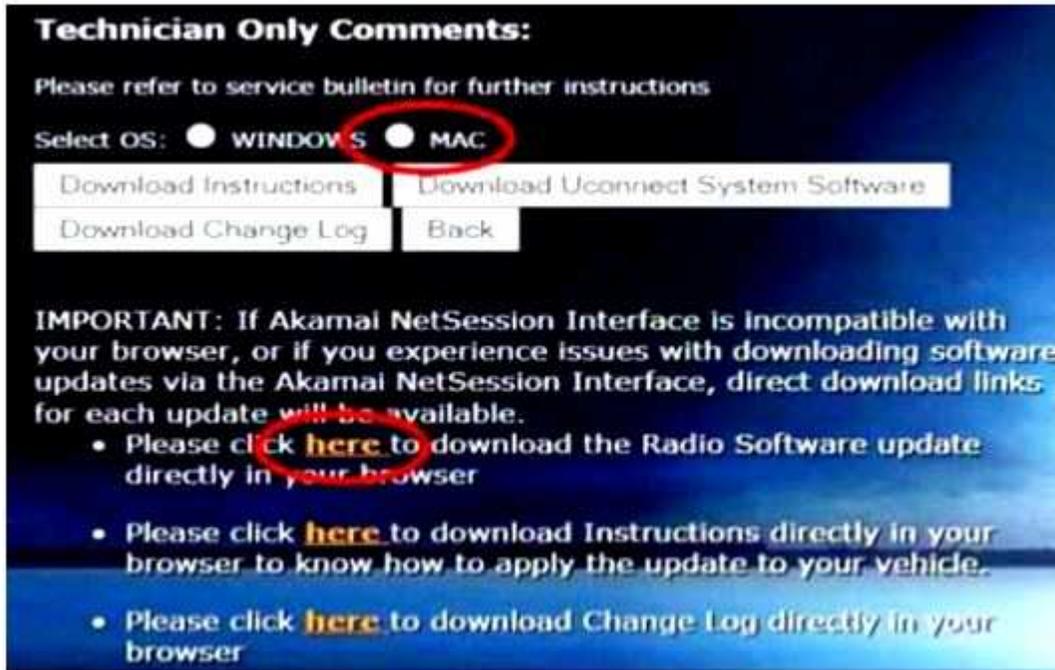
Fig. 3

4. Use a blank USB flash drive with at least 16GB of space. Follow the on-screen instructions to download the software files.
5. Download the software update file to your local PC's desktop. Make sure to select the "MAC" radial button for all downloads (Fig. 3) .

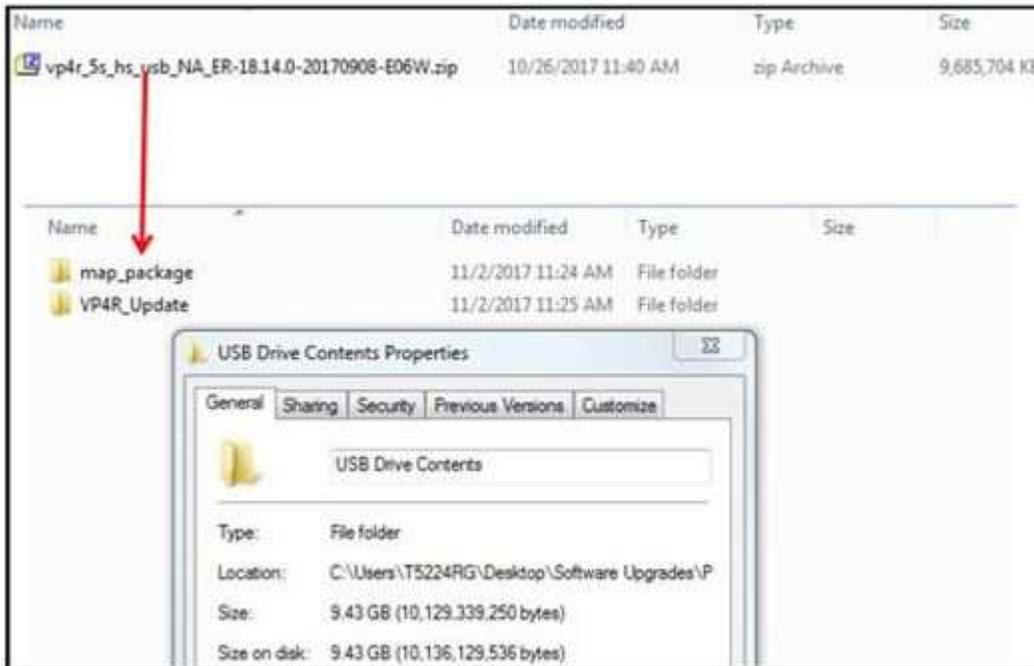
Fig. 4
Files/Folders In The USB Flash Drive

8. Unzip all the files to the root folder of USB flash drive. Files should not be within a zip folder. Your USB files should look like (Fig. 4) when you open it, displaying multiple files/folders.

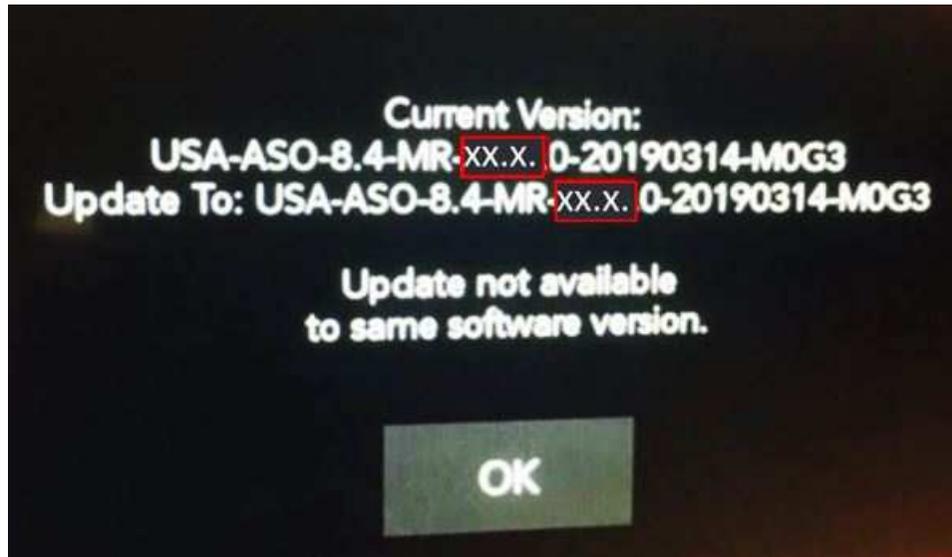
Fig. 5

11. If the radio software is up to date, the “Current Version” and “Update To” will be the same (Fig. 5) . Press “OK” and remove the USB flash drive.

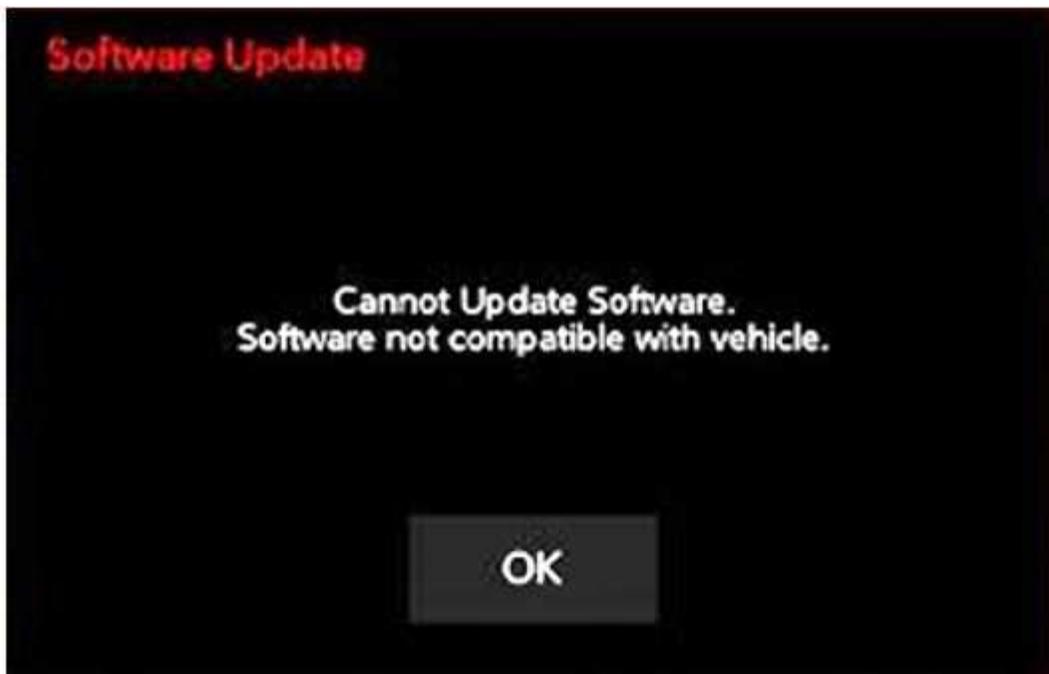
Fig. 6

12. If the screen in (Fig. 6) is displayed, the USB flash drive was not set up correctly. Use a top name brand USB like Kingston and create a new flash drive and start the update again.

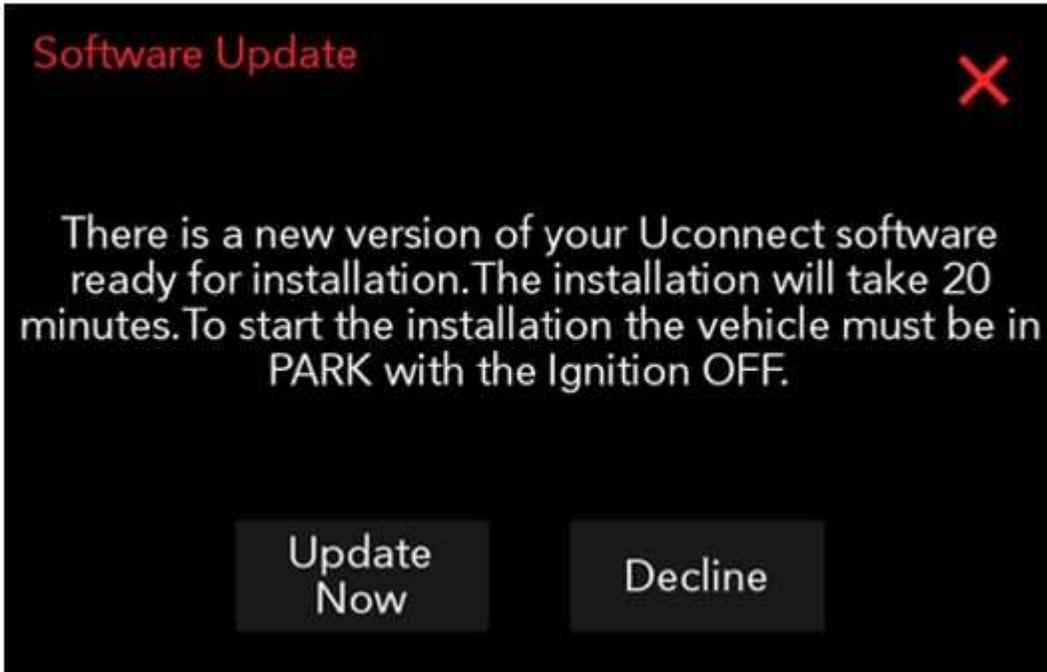
Fig. 7
Software Update Is Available

- NOTE: Do not turn off the ignition until the two minute timer has expired, as seen in (Fig. 8) .**
13. Once the system has verified there is an available update, touch the "Update Now" button. Make sure the vehicle is in park, **do NOT turn off the ignition at this point, (Fig. 7) .**

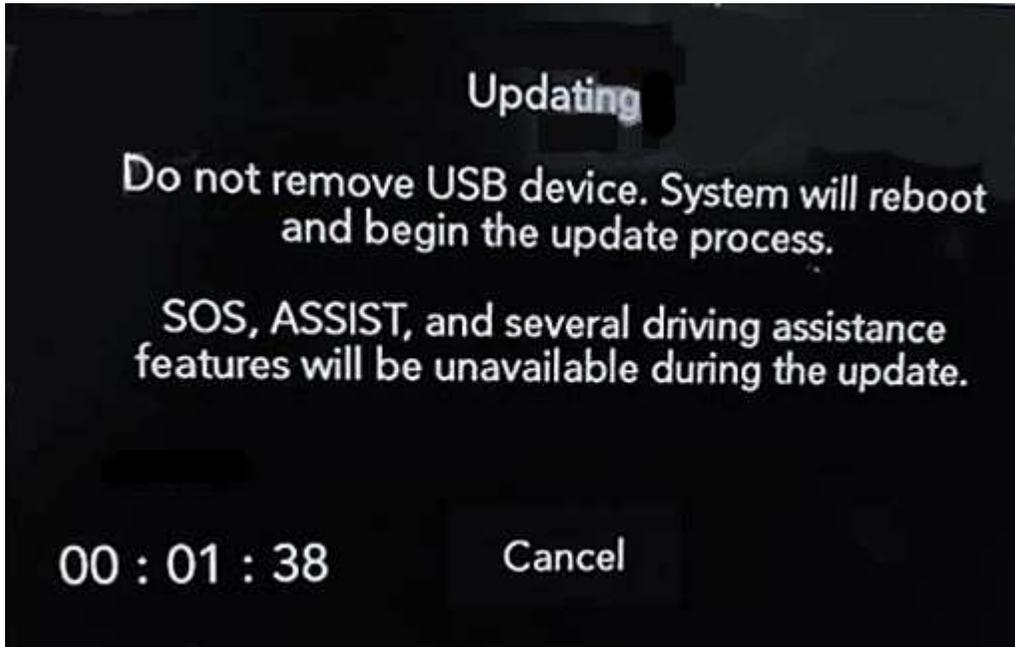
Fig. 8
Radio Update Process Begins

- 14. The ignition must be turned to the off position **after** the two minute timer has expired, or the update may be canceled, (Fig. 8) .

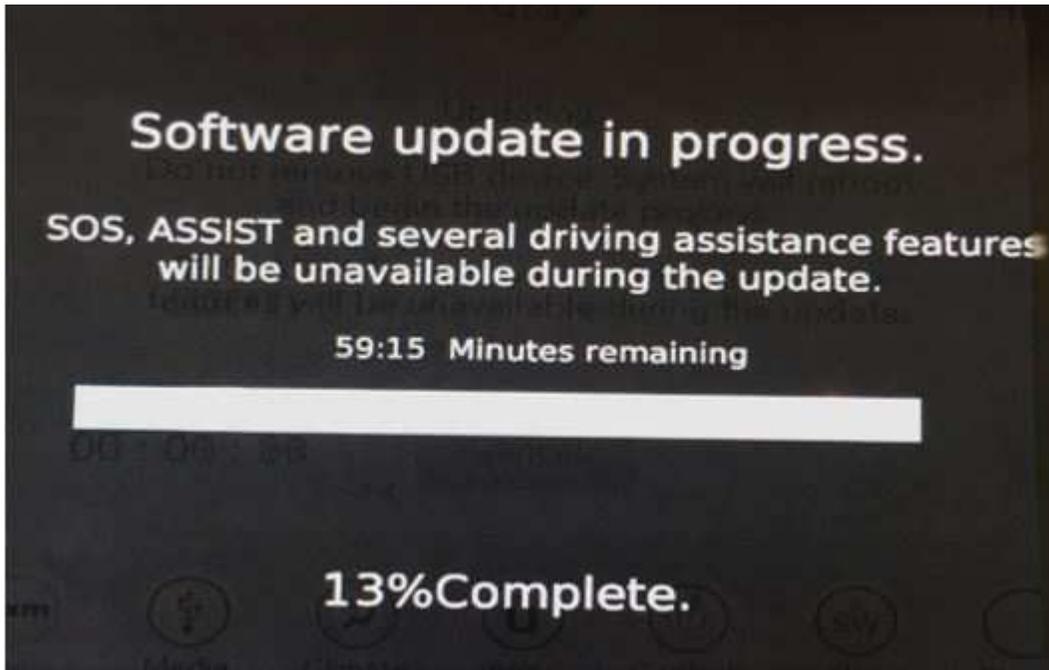
Fig. 9
Software Update In Progress

- 15. The radio will reboot and the update will begin. The update should only take 20 minutes, the timer on the screen may display the incorrect time remaining, (Fig. 9) .

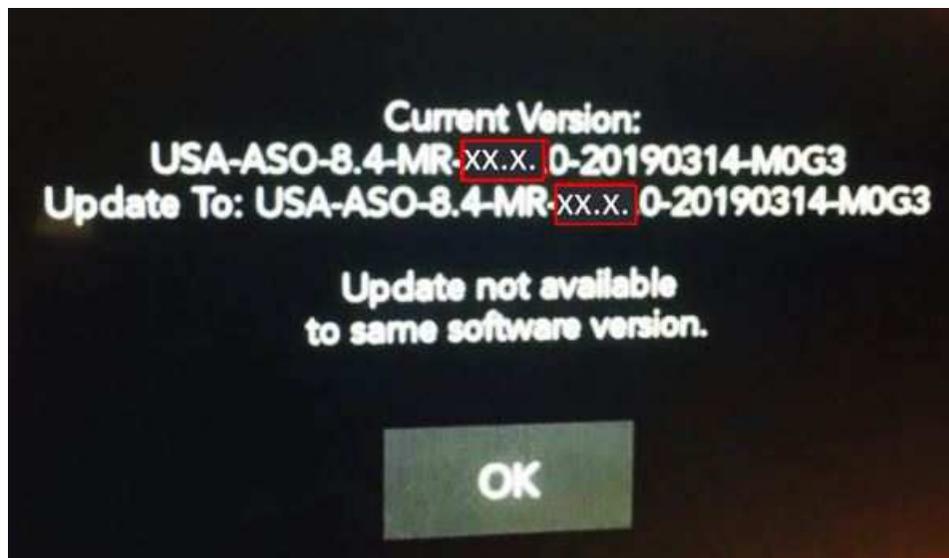
Fig. 10
Radio Software Level Location

16. After the update has completed, the radio will shut down. With the USB flash drive still inserted in the USB port, turn the ignition back to the run position. If the radio has been updated correctly, the screen in (Fig. 10) will be displayed, with the updated software levels. Press "OK" and remove the USB flash drive.
