NUMBER: 08-016-19 REV. E

GROUP: 08 - Electrical

SUBJECT:

UAS, UAQ, UCS and UCQ Radio Enhancements

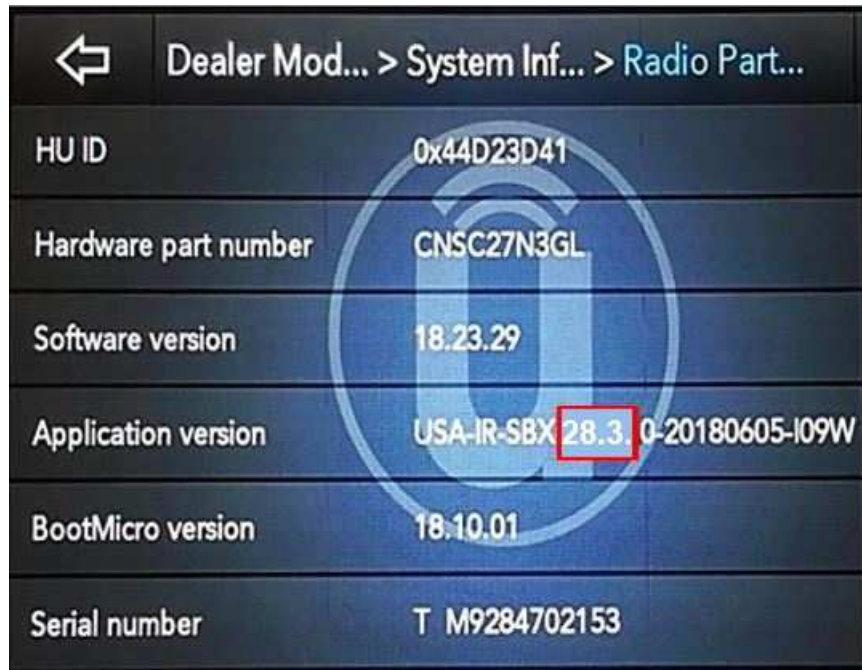
Fig. 1
Radio Software Level Screen

1. Verify the radio software version. Radio must be in Dealer Mode to verify by following these steps:
 - Push and hold the Front Defrost, Driver Temperature Up and Temperature Down buttons simultaneously until the Dealer Mode screen appears (approximately seven seconds). Release buttons.
 - Select "Radio Part Information". The software version will be listed next to "Application Version" (Fig. 1) .

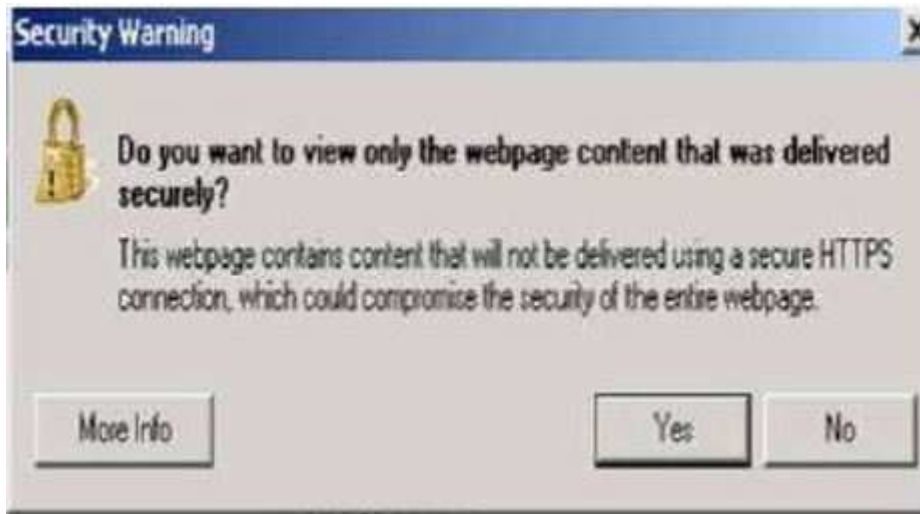
Fig. 2
Pop-Up Security Message

1. Has a **16GB** USB flash drive been created?
 - YES >>> Proceed to [Step 10](#).
 - NO >>> Proceed to [Step 2](#).
2. Go to DealerCONNECT>Service>Uconnect Command Center>Uconnect>More Information >Dealer software downloads to download the files.
3. If a security message appears "Do you want to view only the web page content that was delivered securely?" ([Fig. 2](#)) . Press "No" to continue.

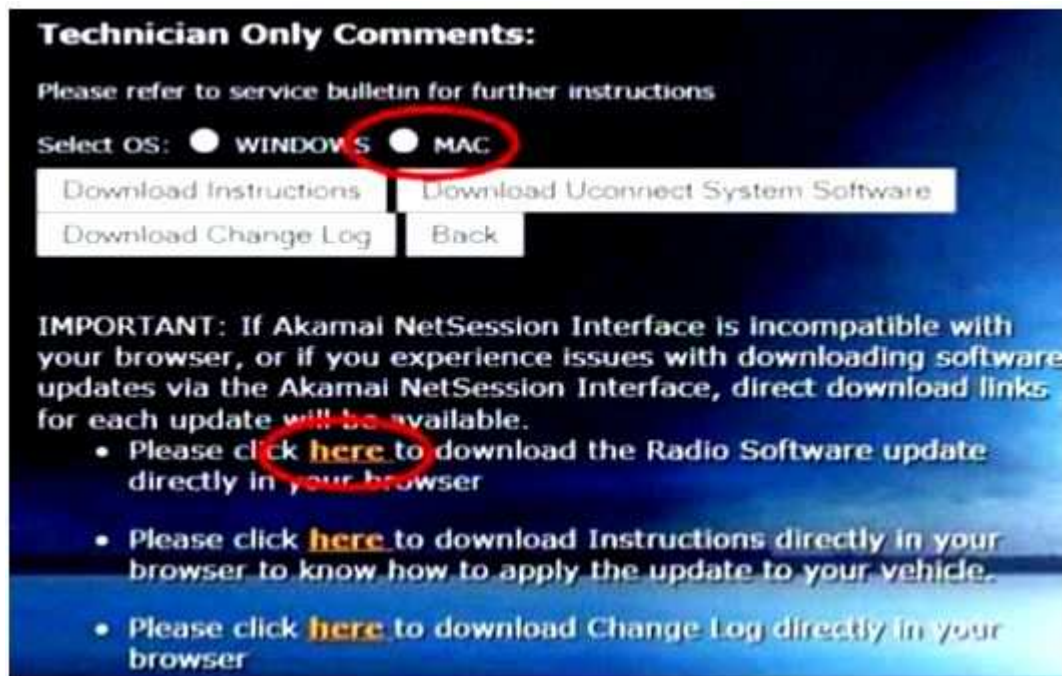
Fig. 3
MAC Download Steps

4. Use a blank USB flash drive with at least 16GB of space. Follow the on-screen instructions to download the software files.
5. Download the software update file to your local PC's desktop. Make sure to select the "MAC" radial button for all downloads (Fig. 3) .

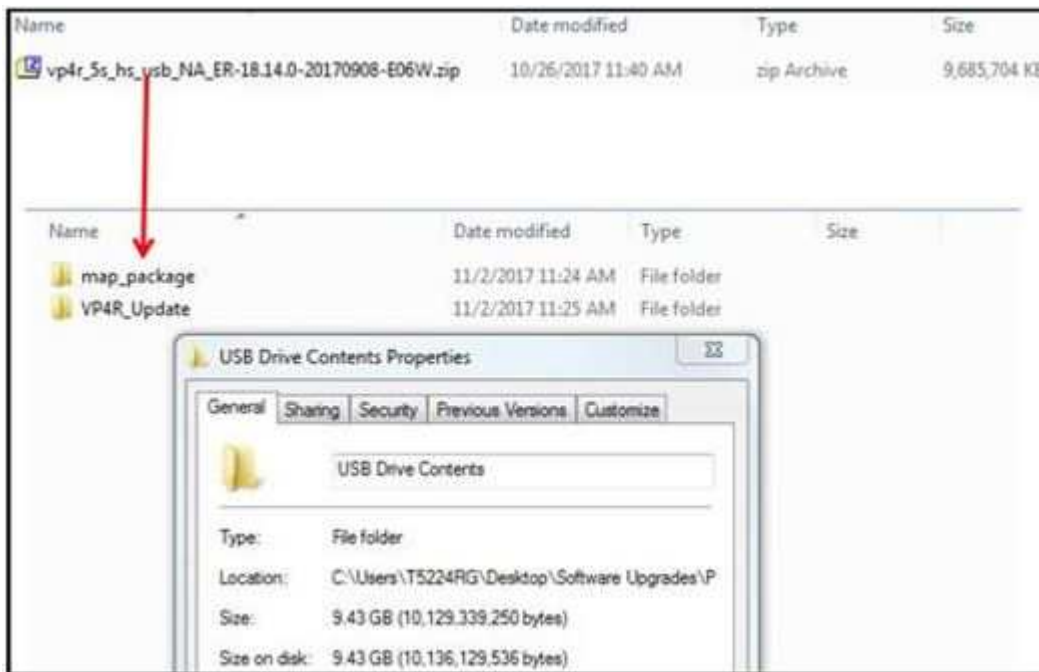
Fig. 4
Files/Folders In The USB Flash Drive

8. Unzip all the files to the root folder of USB flash drive. Files should not be within a zip folder. Your USB files should look like (Fig. 4) when you open it, displaying multiple files/folders.

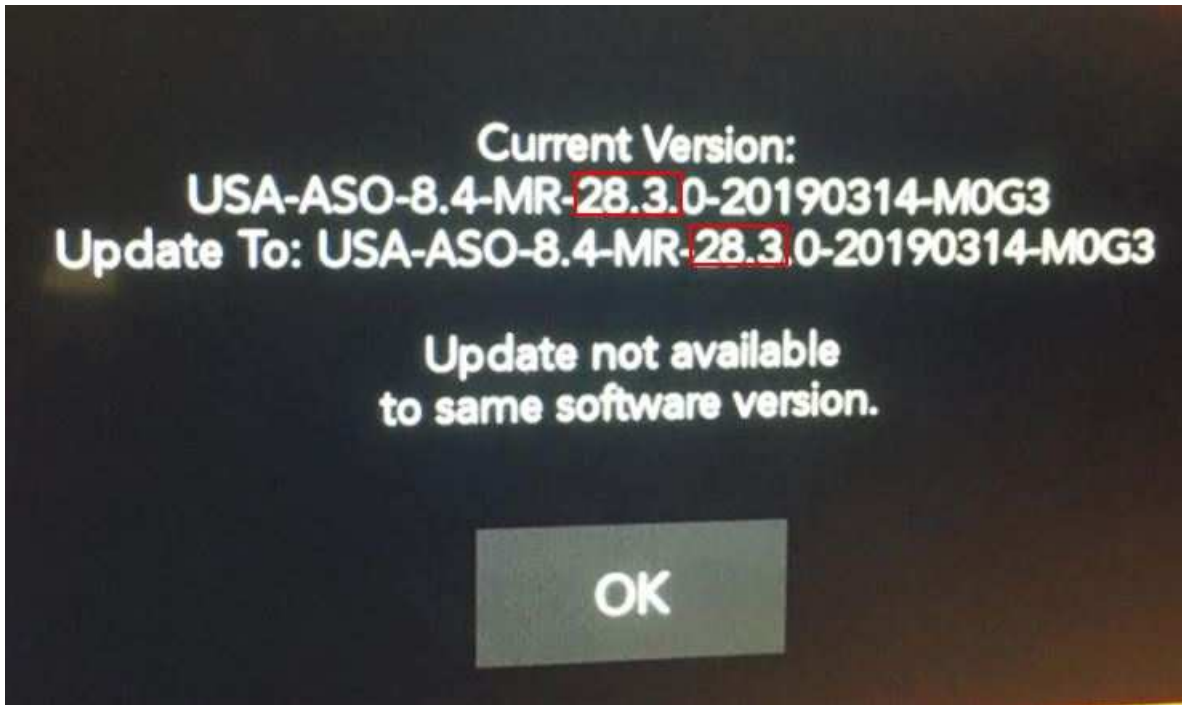
Fig. 5
Screen Displayed When Radio Software Is Up To Date

11. If the radio software is up to date, the “Current Version” and “Update To” will be the same (Fig. 5) . Press “OK” and remove the USB flash drive.

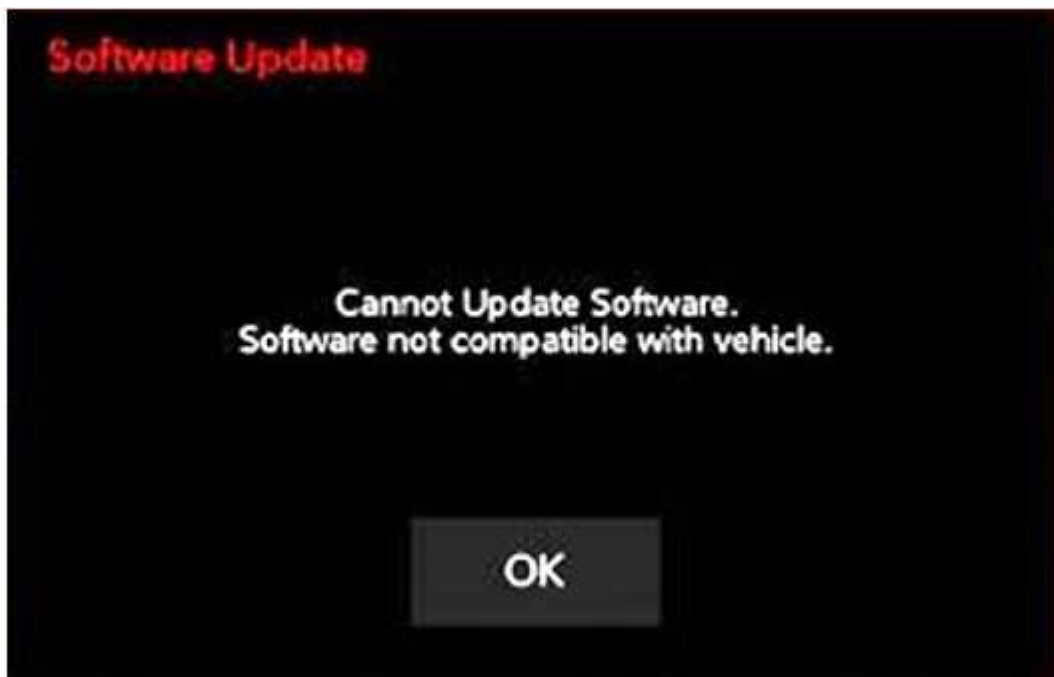
Fig. 6
Software Not Compatible

12. If the screen in (Fig. 6) is displayed, the USB flash drive was not set up correctly. Use a top name brand USB and create a new flash drive and start the update again.

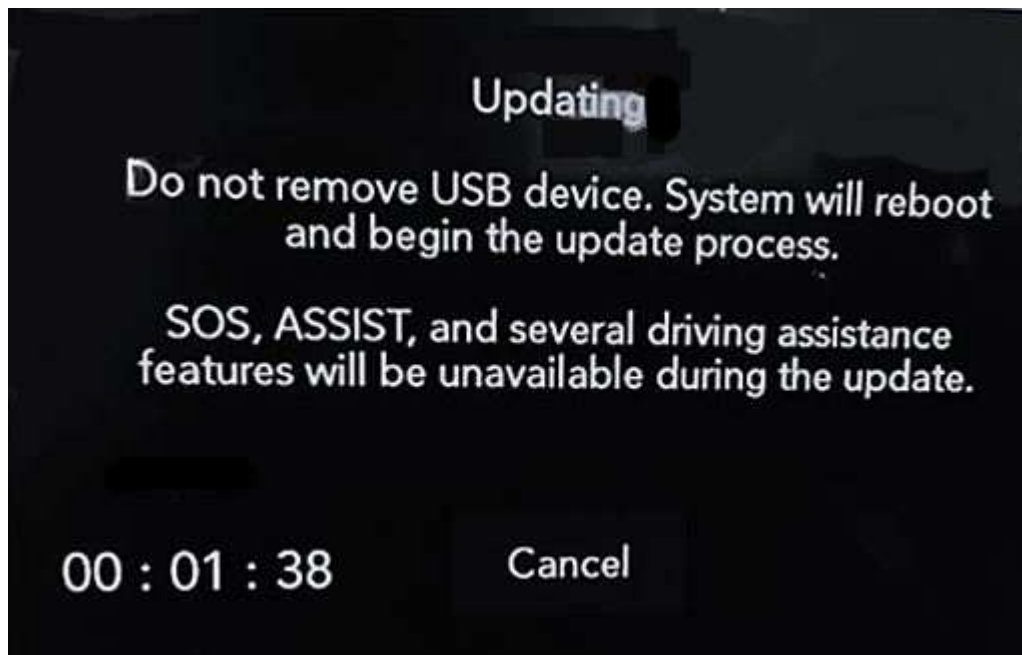
Fig. 8
Radio Update Process Begins

NOTE: Do not turn off the ignition until the two minute timer has expired, as seen in (Fig. 8) .

14. The ignition must be turned to the off position **before** the two minute timer has expired, or the update may be canceled, (Fig. 8) .

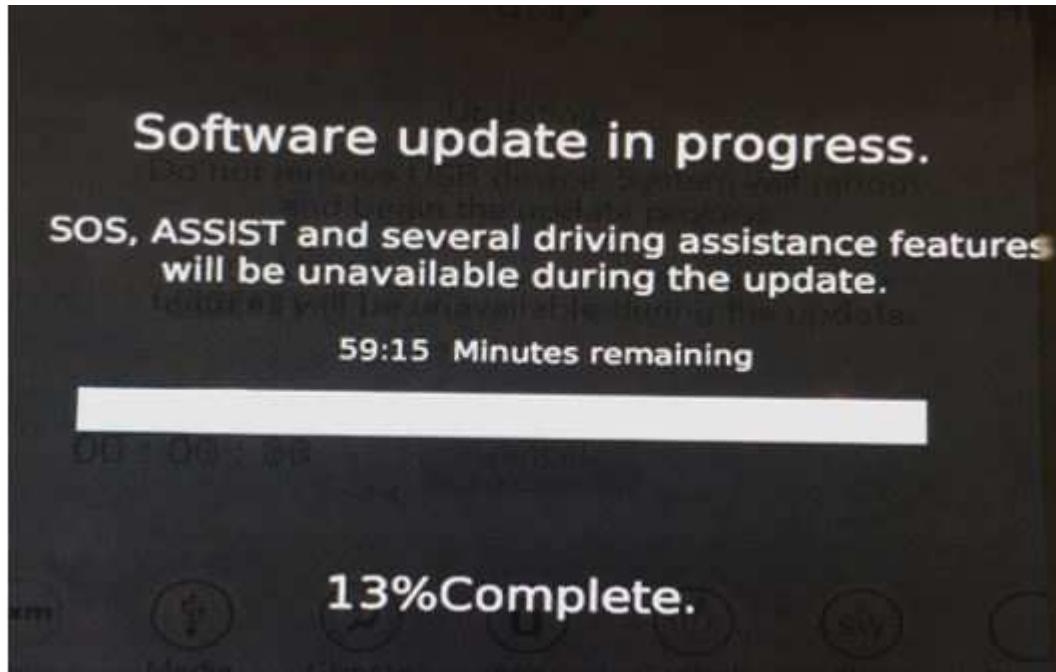
Fig. 9
Software Update In Progress

15. The radio will reboot and the update will begin. The update should only take 20 minutes, the timer on the screen may display the incorrect time remaining, (Fig. 9) .

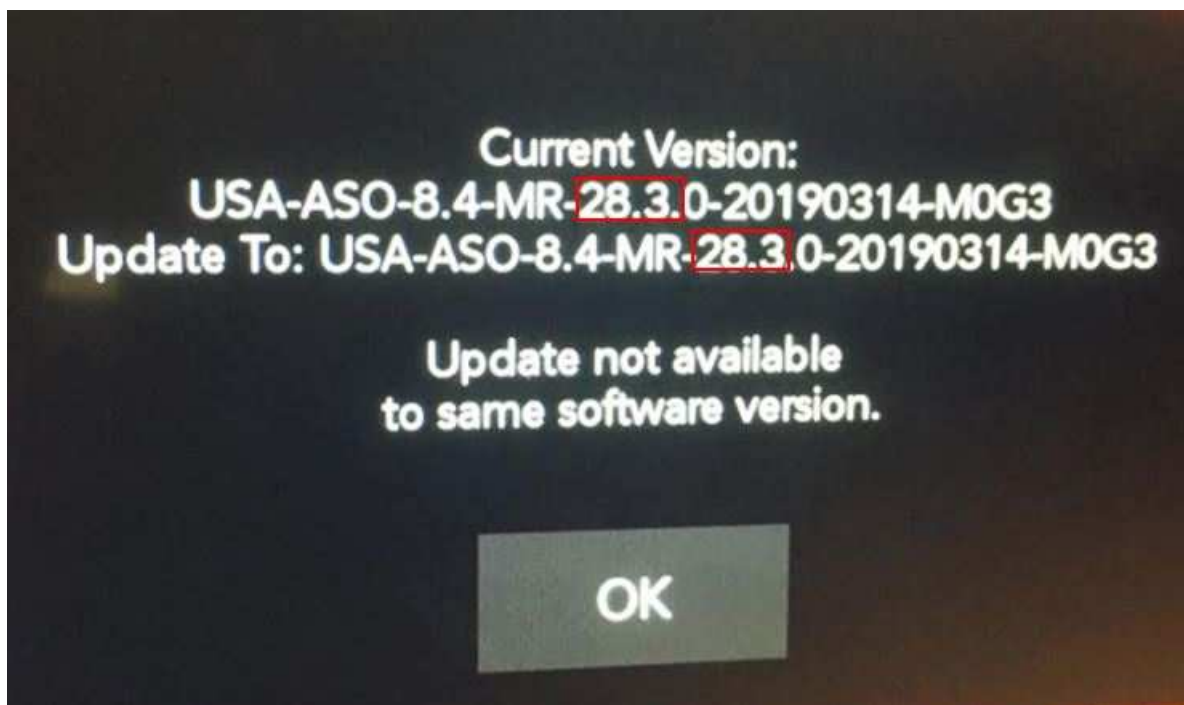
Fig. 10
Radio Software Has Been Updated

16. After the update has completed, the radio will shut down. With the USB flash drive still inserted in the USB port, turn the ignition back to the run position. If the radio has been updated correctly, the screen in (Fig. 10) will be displayed. Press "OK" and remove the USB flash drive.
