NUMBER: 08-095-19

DATE: October 8, 2019

Video Routing Module (VRM) Enhancements For Rear Seat Entertainment System

2018 (RU) Chrysler Pacifica

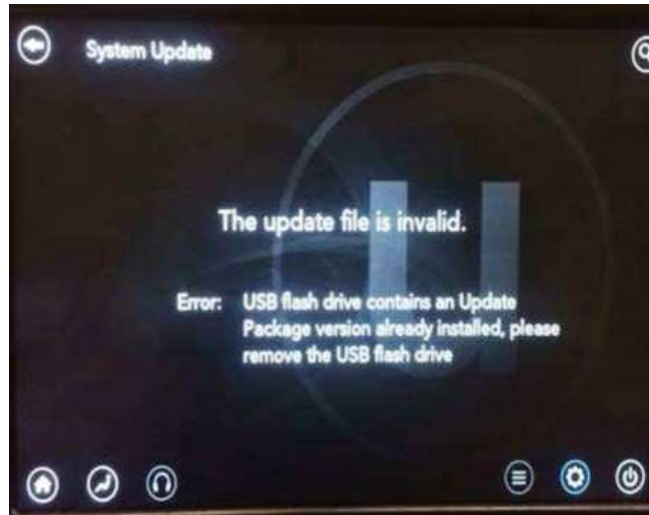
Fig. 3

NOTE: If the USB flash drive is left in the port after system reboot, there will be a pop-up on the rear seat back video screen that states "The update file is invalid" (Fig. 3) . This is not a concern as the system is already up to date.

Rear Seatback Video Screen Error
