NUMBER: 08-002-19 REV. A

UCQ Radio Enhancements

This bulletin involves inspecting and if required, updating the radio software level to ****28.3.****

2018 (JL) Jeep Wrangler

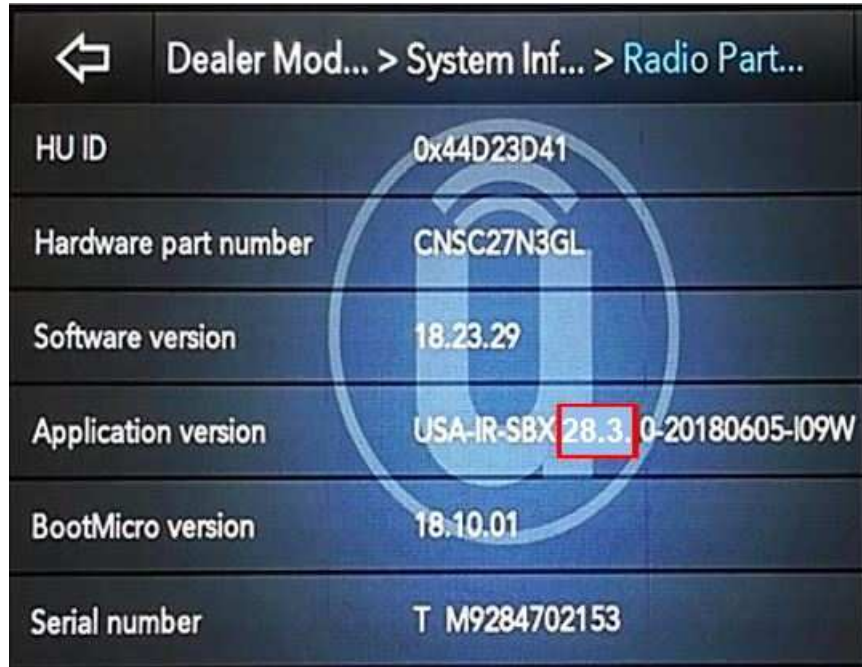
Fig. 1

1. Verify the radio software version. Radio must be in Dealer Mode to verify by following these steps:
 - a. Push and hold the front defrost, driver temperature up and temperature down buttons simultaneously until the 'Dealer Mode' screen appears (approximately seven seconds). Release buttons.
 - b. Select "Radio Part Information". The software version will be listed next to "Application Version" (Fig. 1) .

Radio Software Level Screen

2. Is the radio software level (Application Version) at or higher than **28.3**?
 - YES >>> The radio software is already up to date. Normal diagnostic should be performed.
 - NO >>> Proceed to [Step 1](#) of the Repair Procedure.

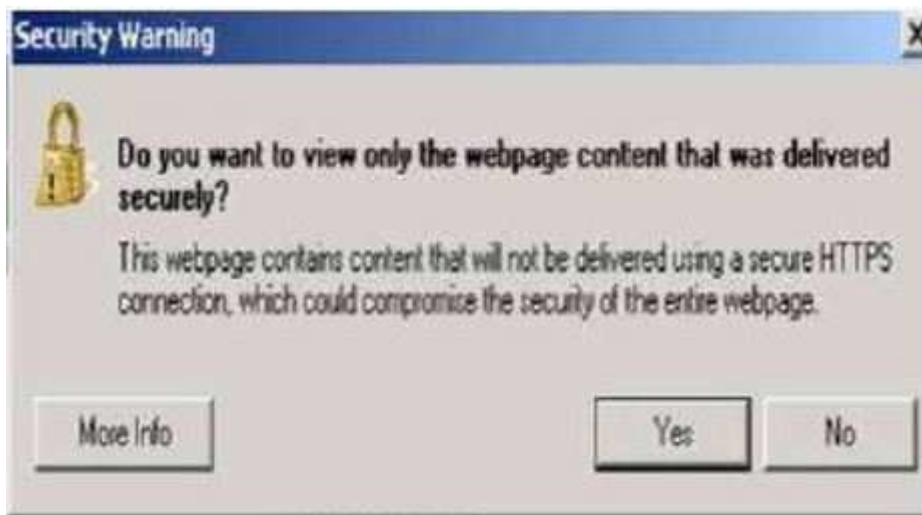
Fig. 2
Pop-Up Security Message

2. Go to DealerCONNECT>Service>Uconnect Command Center>Uconnect>More Information >Dealer software downloads to download the files.
3. If a security message appears “Do you want to view only the webpage content that was delivered securely?” ([Fig. 2](#)) . Press “No” to continue.

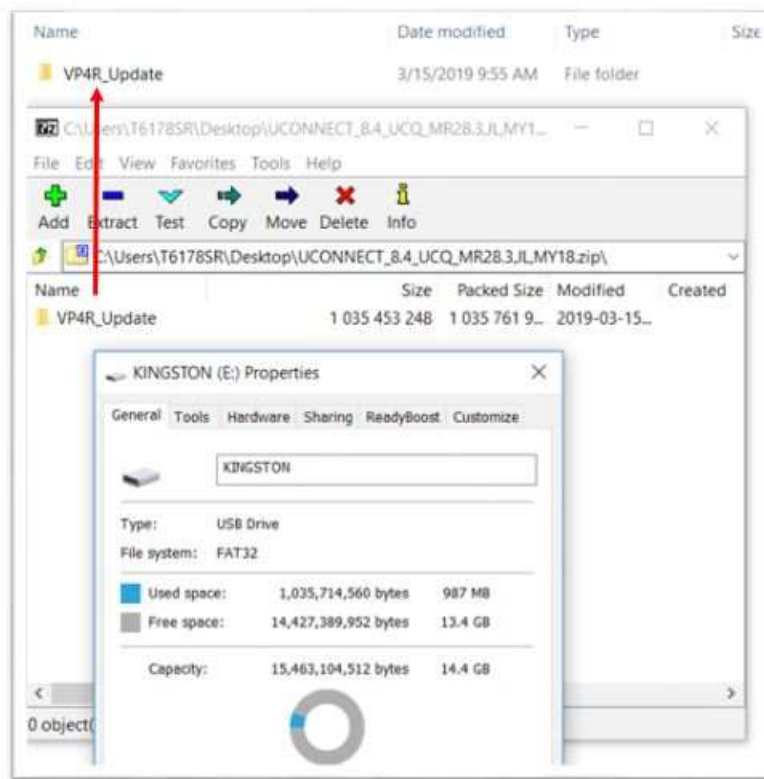
Fig. 4
File/Folder In The USB Flash Drive

- Unzip all the files to the root folder of USB flash drive. Files should not be within a zip folder. Your USB files should look like (Fig. 4) when you open it.

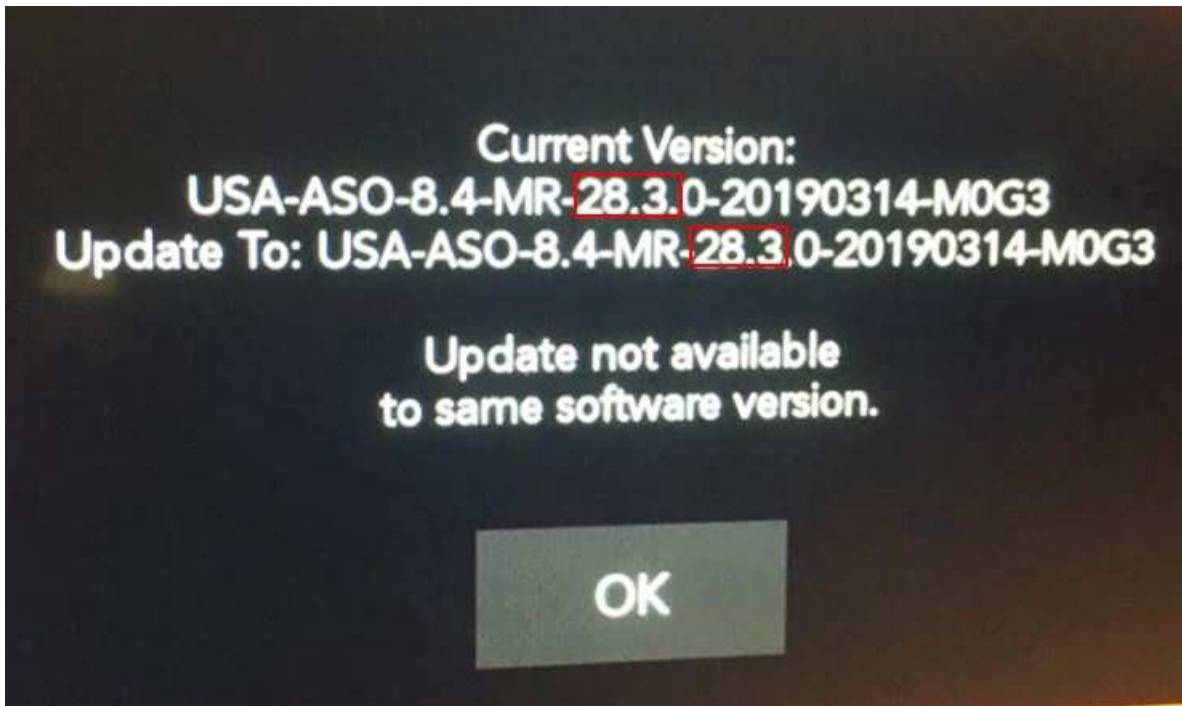
Fig. 6
Screen Displayed When Radio Software Level Is Up To Date

11. If the radio software is up to date, the screen in (Fig. 6) will be displayed. Press "OK" and remove the USB flash drive.

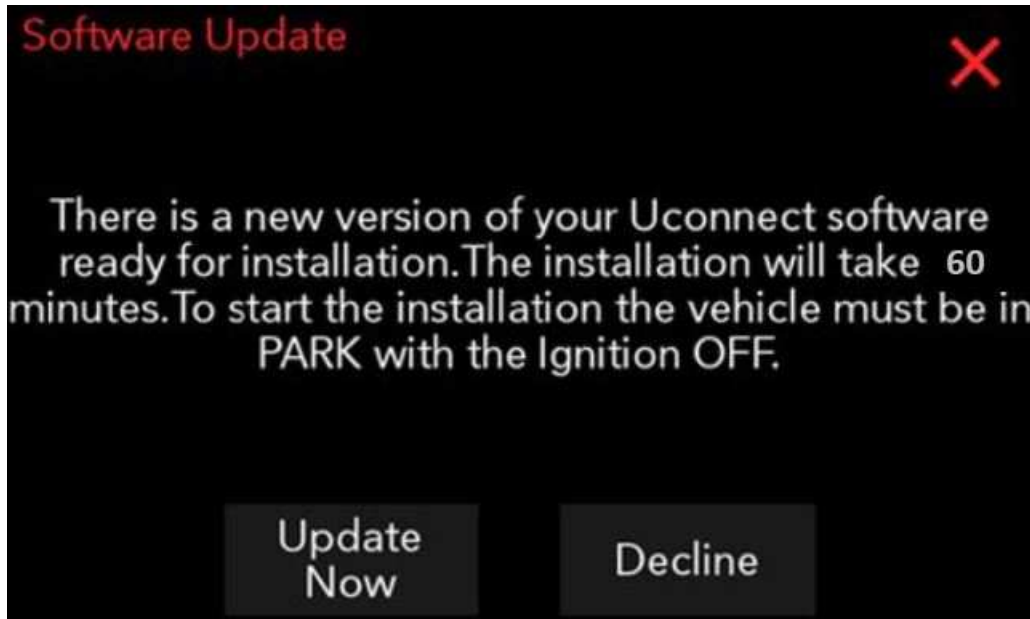
Fig. 7
Software Update Is Available

12. Once the system has verified there is an available update, press the “Update Now” button. Make sure the vehicle is in park. **Turn off the ignition at this point, (Fig. 7) .**

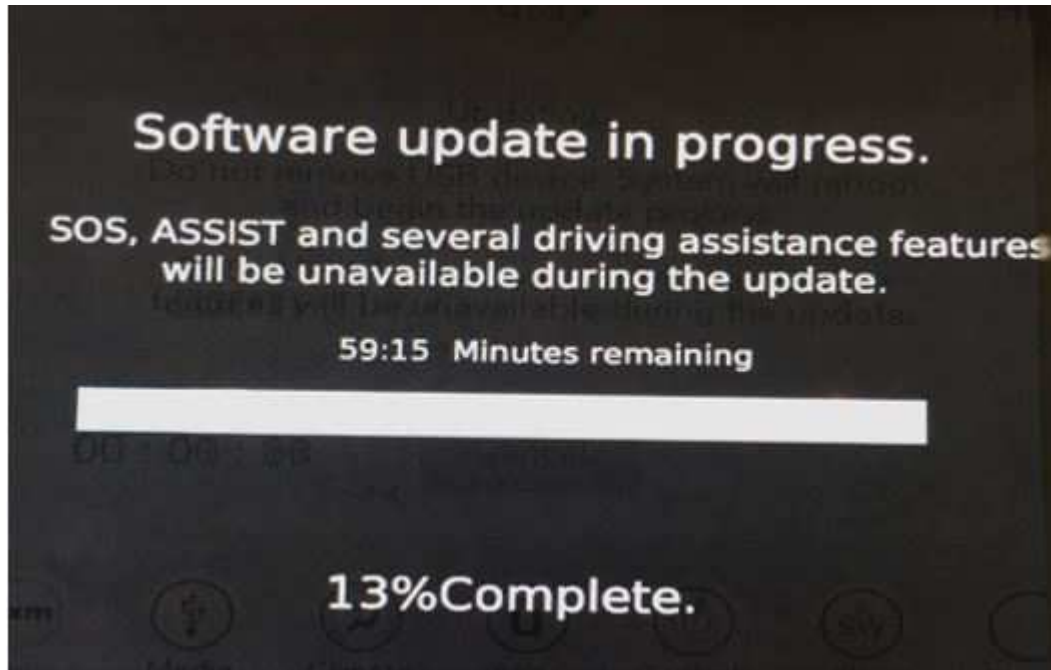
Fig. 9

Software Update In Progress

14. The radio will reboot and the update will begin. The update should only take 25 minutes, the timer on the screen may display the incorrect time remaining, (Fig. 9) .

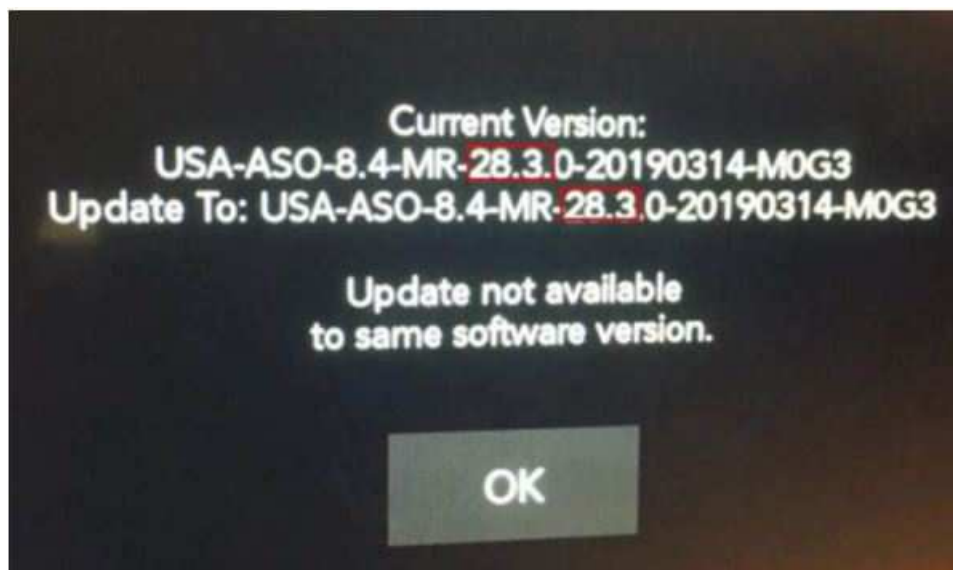
Fig. 10

Screen Displayed When Radio Software Level Is Up To Date

15. After the update has completed, the radio will shut down. With the USB flash drive still inserted in the USB port, turn the ignition back to the run position. If the radio has been updated correctly, the screen in (Fig. 10) will be displayed. Press "OK" and remove the USB flash drive.
