NUMBER: 08-096-19

Video Routing Module (VRM) Enhancements For Rear Seat Entertainment System

This bulletin involves updating the VRM software level to ****19.12.10.****

2017 (RU) Chrysler Pacifica

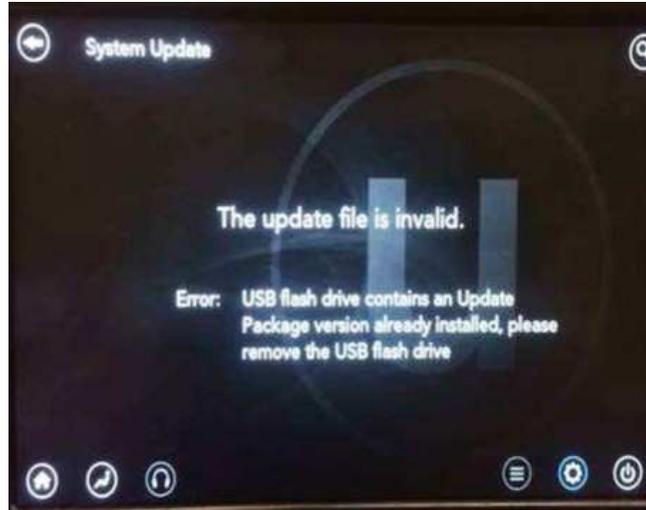
Fig. 3

NOTE: If the USB flash drive is left in the port after system reboot, there will be a pop-up on the rear seat back video screen that states "The update file is invalid" (Fig. 3) . This is not a concern as the system is already up to date.

Rear Seatback Video Screen Error
