NUMBER: 23-029-19

Rear Windows Squeaks or Binds When Closing

2019 (DT) RAM 1500 Pickup

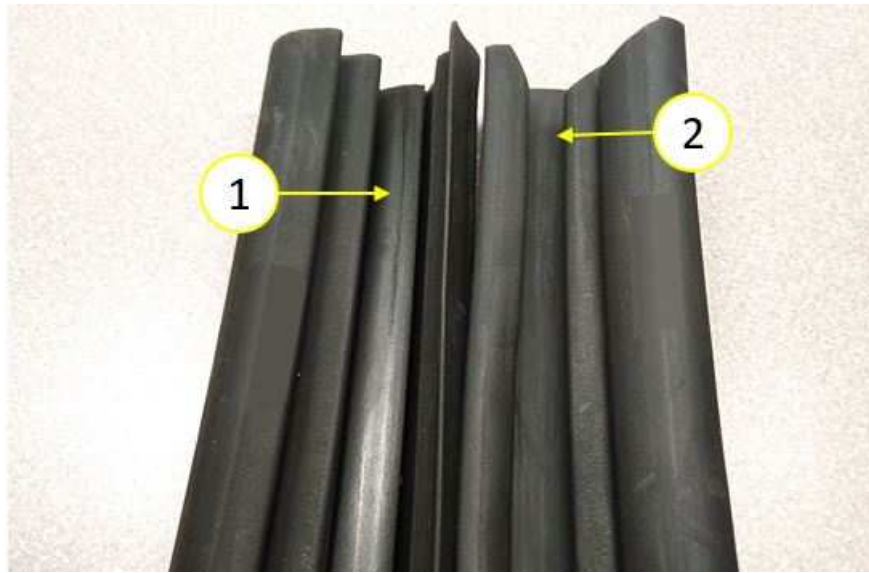
Fig. 1
Good and Bad Run Channel Seals

NOTE: Inspect for slip coat layer on rear driver and passenger door seals, check for slippery texture on the inside of the rear part of the door seal. This condition only happens to the rear channel of the rear window seal. (Fig. 1) .

- 1 - Hard slippery surface, Good.
2 - Soft non slippery surface, Bad.
-

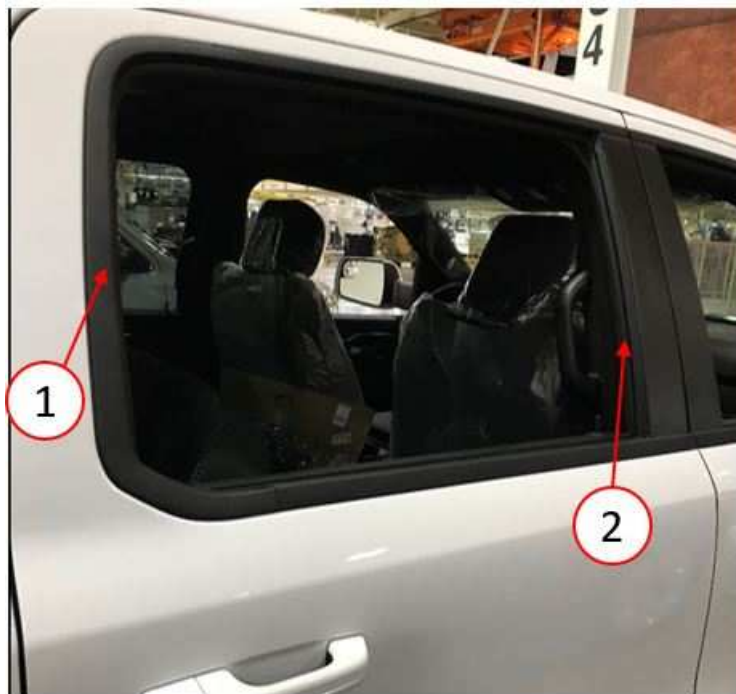
Fig. 2
Location Of Inspection Area

1. Open (lower) both rear door windows and inspect the rear channel of the rear seal. Compare the rear channel to the known good front channel seal, (Fig. 2) .

- 1 - Inspect this area for none slippery surface.
2 - Compare the known good side of the seal with the rear.
-

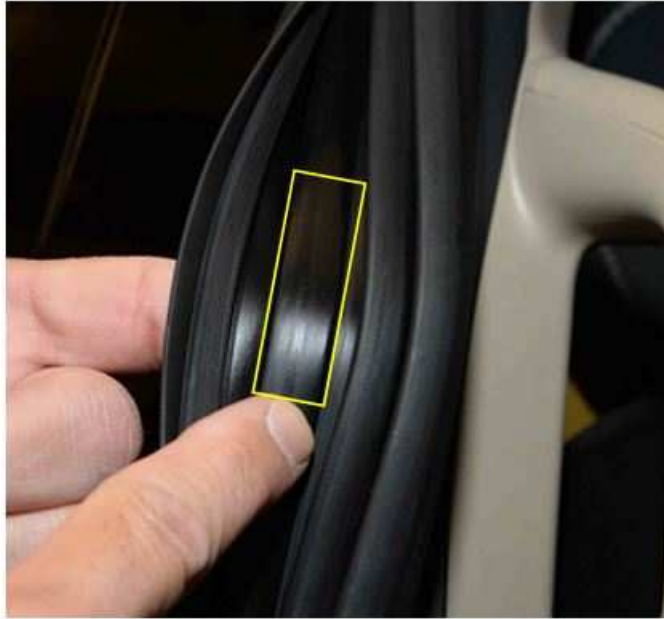
Fig. 3
Inspection Area

2. Pull a small section of the seal out of the run channel, (Fig. 3) .

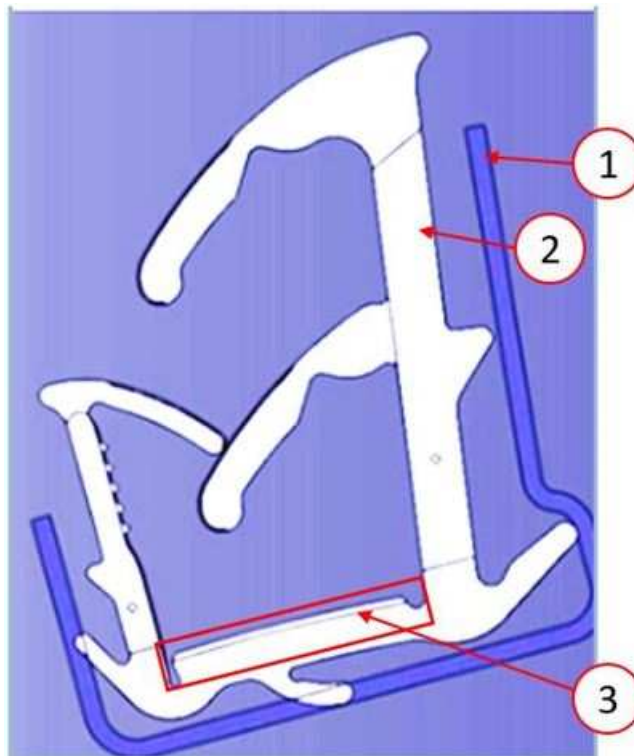
Fig. 4
Run Channel and Seal

3. Rub the bottom of the run channel seal, both rear doors, (Fig. 4) .

- 1 - Door run channel.
 - 2 - Run channel seal.
 - 3 - Inspection area for slippery surface.
-

4. Was the (both doors) run channel seal hard and slippery ?
- YES>>> This bulletin has been completed, use inspect LOP (23-33-20-9Q) to close the active RRT.
 - NO>>> Replace the run channel seal(s) on the side with the non-slippery seal(s). Proceed to [Step 5](#).
5. Pull the run channel seal(s) out of the window frame run channel, ([Fig. 5](#)) .
