NUMBER: 08-099-19

Splash Screen Displays Incorrect Logo In The Electronic Vehicle Information Center (EVIC)

2020 (DT) RAM 1500 Pickup

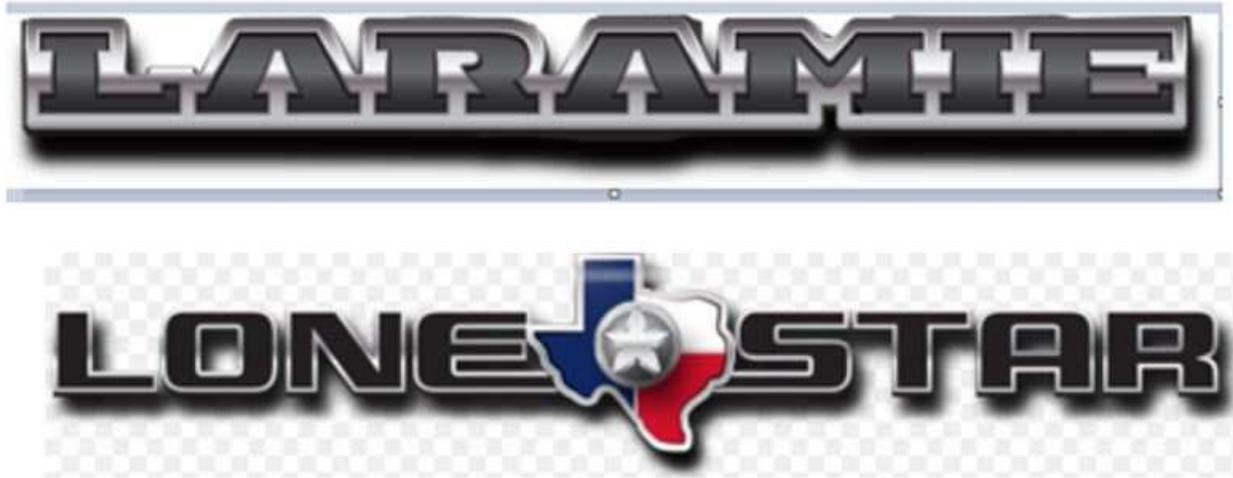
Fig. 1
Cluster Splash Screen Logos

- When the vehicle is first started, Laramie is displayed in the cluster, when Lone Star should be displayed. (Fig. 1) .

1. Start the vehicle and see which logo is displayed in the center of the cluster.
2. Was the Lone Star logo displayed (Fig. 1) ?
 - YES>>> This bulletin has been completed, use inspect LOP (18-19-02-EN) to close the active RRT.
 - NO>>> Proceed to [Step 3](#).
3. Using wiTECH, reconfigure the vehicle. This routine is available under the 'Guided Diagnostic' tab found on the home, 'Vehicle View', page of wiTECH.
4. Using wiTECH clear any DTCs which may have been set during the reconfiguration.
5. Disconnect the scan tool, turn off the ignition, open and close the drivers door. Let all modules go to sleep, this may take a minute. Start the vehicle and see if the proper logo is displayed.
