**NUMBER:** 08-016-19 REV. F

**GROUP:** 08 - Electrical

**DATE:** October 19, 2019

UAS, UAQ, UCS and UCQ Radio Enhancements

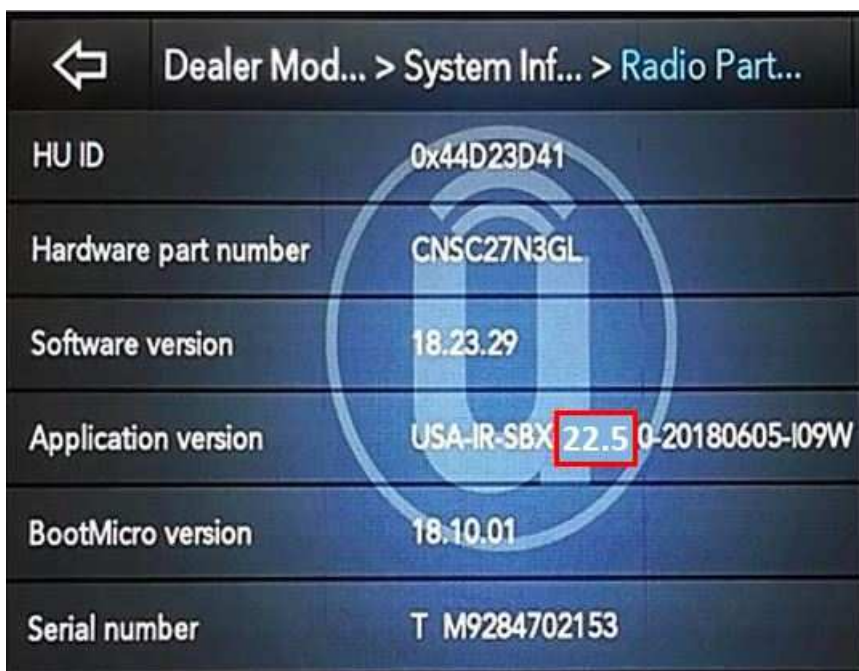
Fig. 1  
Radio Software Level Screen

1. Verify the radio software version. Radio must be in Dealer Mode to verify by following these steps:
  - Push and hold the Front Defrost, Driver Temperature Up and Temperature Down buttons simultaneously until the Dealer Mode screen appears (approximately seven seconds). Release buttons.
  - Select "Radio Part Information". The software version will be listed next to "Application Version" (Fig. 1) .
2. Is the current radio software level at or higher than?
  - 22.6 - DS, D2, DP, DD, DF and DJ vehicle with UAS, UCQ and UAQ radio.
  - 22.5 - LA, LD and LX vehicle with UAS and UAQ.
  - 21.9 - All other vehicles and radios.
  - YES >>> The radio software is already up to date. This bulletin has been completed, use inspect LOP (18-60-02-VK) to close the active RRT.
  - NO >>> The radio software needs to be updated. Back out of Dealer Mode and proceed to [Step 1](#) of the Repair Procedure.

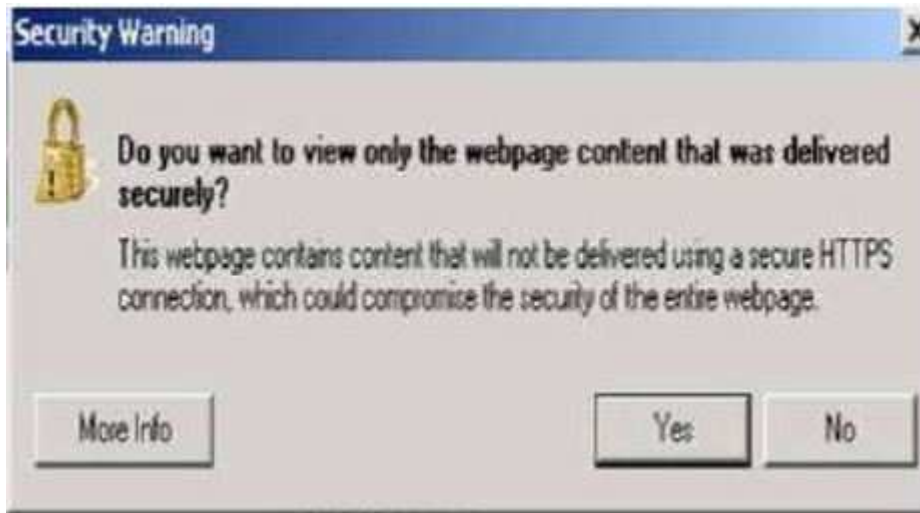
Fig. 2  
Pop-Up Security Message

3. If a security message appears “Do you want to view only the web page content that was delivered securely?” (Fig. 2) . Press “No” to continue.

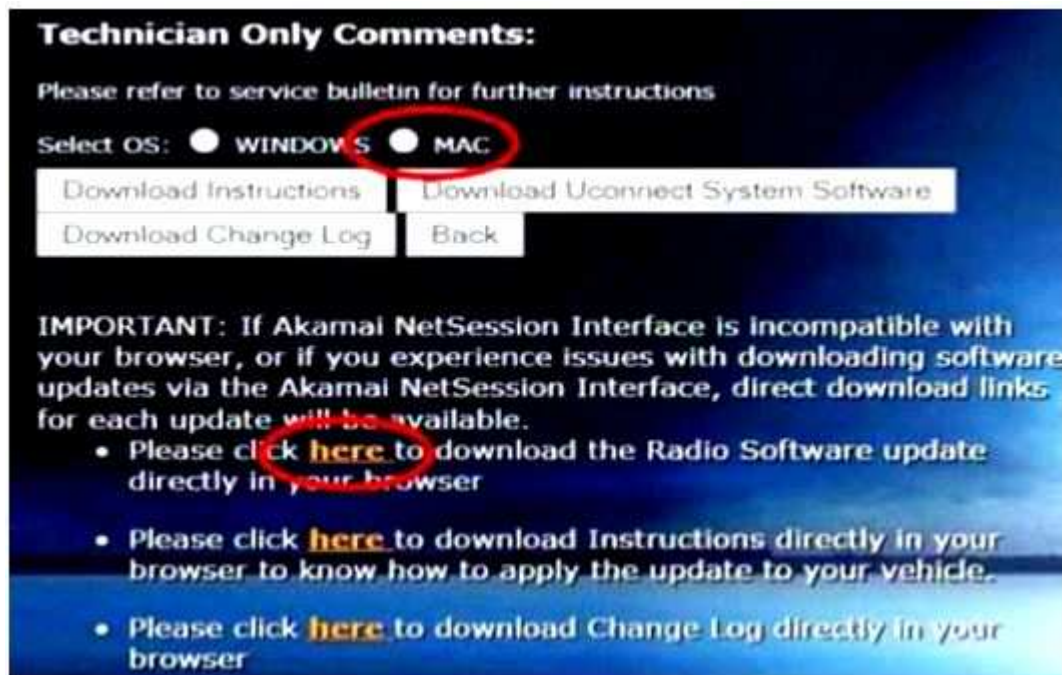
Fig. 3  
MAC Download Steps

4. Use a blank USB flash drive with at least 16GB of space. Follow the on-screen instructions to download the software files.
5. Download the software update file to your local PC’s desktop. Make sure to select the “MAC” radial button for all downloads (Fig. 3) .

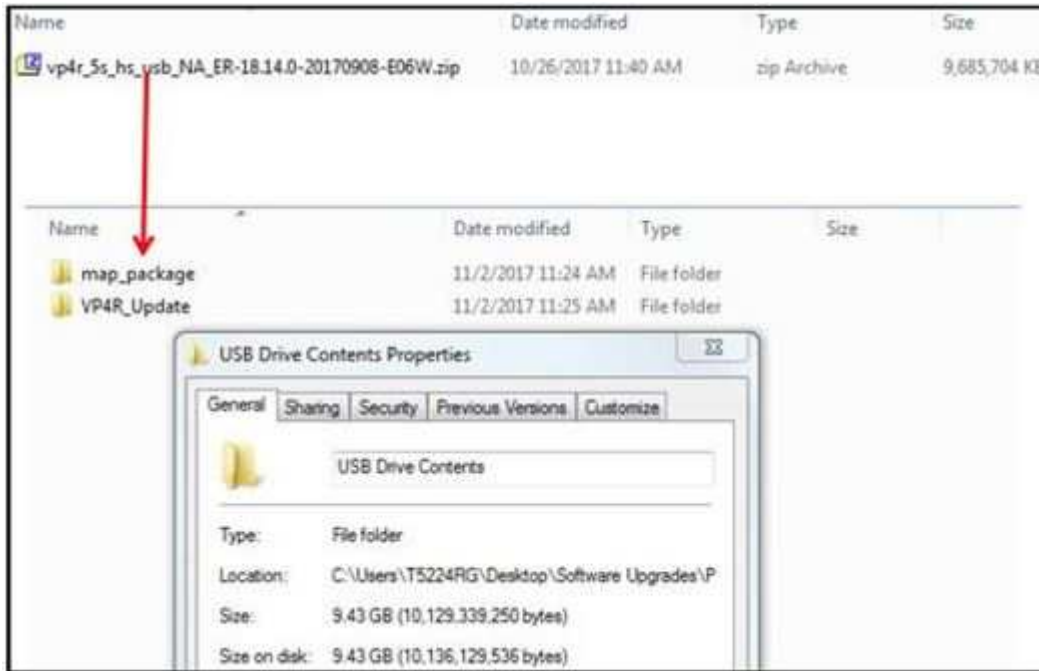
Fig. 4  
Files/Folders In The USB Flash Drive

7. A blank USB flash drive will be needed for each radio update, additional updates can not be on the same USB flash drive.
8. Unzip all the files to the root folder of USB flash drive. Files should not be within a zip folder. Your USB files should look like (Fig. 4) when you open it, displaying multiple files/folders.

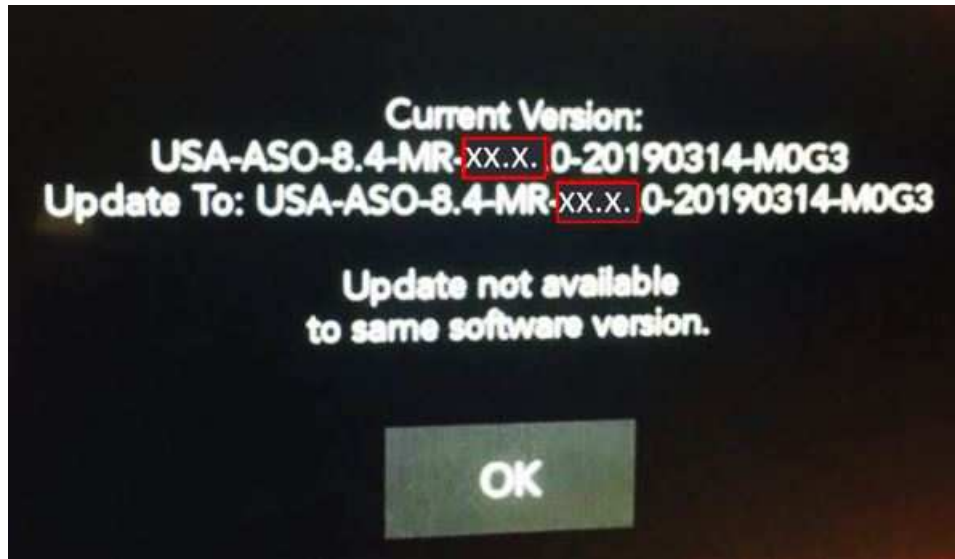
Fig. 5

11. If the radio software is up to date, the “Current Version” and “Update To” will be the same (Fig. 5) . Press “OK” and remove the USB flash drive.

Screen Displayed When Radio Software Is Up To Date

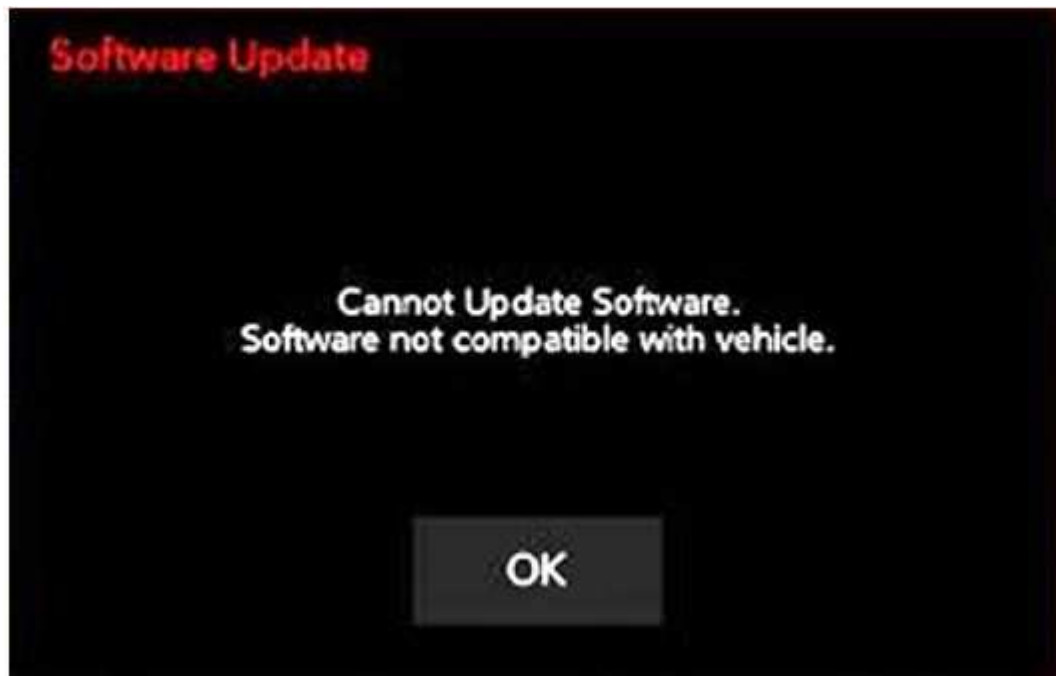
Fig. 6

12. If the screen in (Fig. 6) is displayed, the USB flash drive was not set up correctly. Use a top name brand USB and create a new flash drive and start the update again.

Software Not Compatible

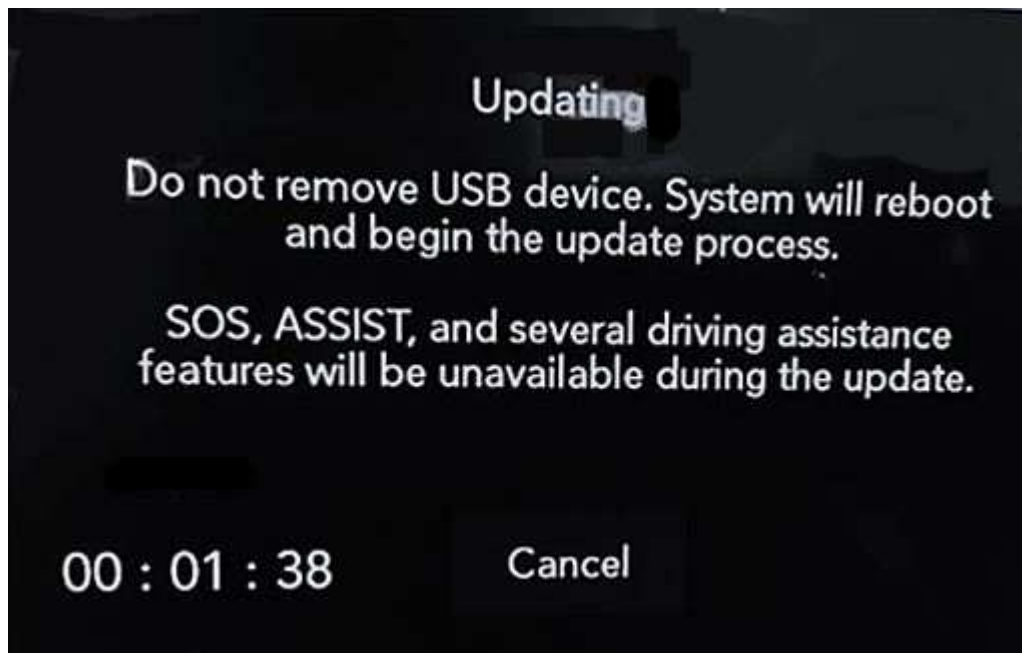
Fig. 8  
Radio Update Process Begins

**NOTE:** Do not turn off the ignition until the two minute timer has expired, as seen in (Fig. 8) .

14. The ignition must be turned to the off position **before** the two minute timer has expired, or the update may be canceled, (Fig. 8) .

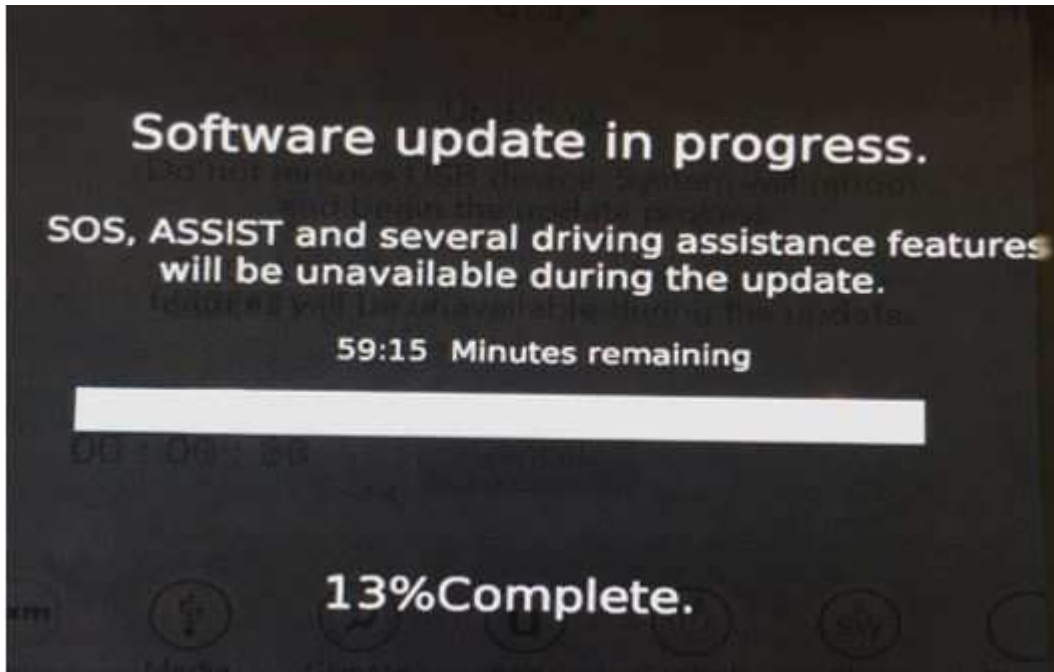
Fig. 9  
Software Update In Progress

15. The radio will reboot and the update will begin. The update should only take 20 minutes, the timer on the screen may display the incorrect time remaining, (Fig. 9) .

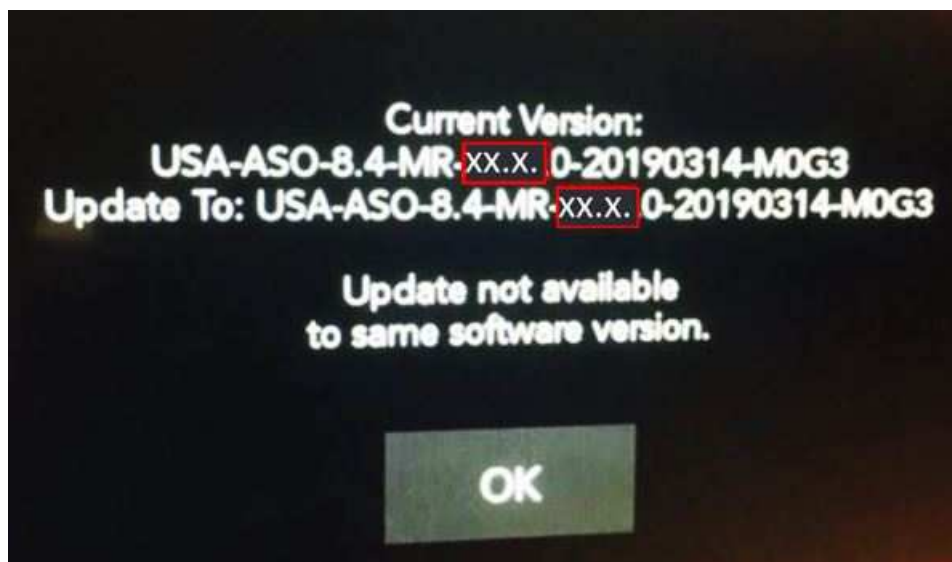
Fig. 10  
Radio Software Has Been Updated

16. After the update has completed, the radio will shut down. With the USB flash drive still inserted in the USB port, turn the ignition back to the run position. If the radio has been updated correctly, the screen in (Fig. 10) will be displayed. Press "OK" and remove the USB flash drive.
