**NUMBER:** 08-107-19

Positive Generator Battery Cable location Re-route

2019 (BV) Jeep Renegade

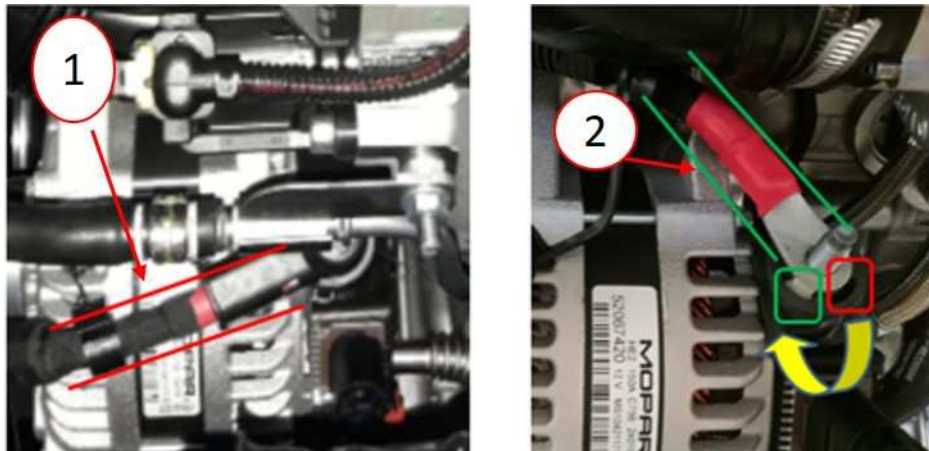
**Fig. 2**  
**Generator Cable Rerouting Position**

The generator positive battery cable may come into contact with the generator drive belt pulley.

- 1 - Before Re-routing.  
1 - After Re-routing.
-

3. Re-route the generator positive cable as shown (Fig. 2) .
