**NUMBER:** 08-106-19

UAQ and UCQ Radio Enhancements

This bulletin involves inspecting and if required, updating the radio software level to 28.3

2019 (JL) Jeep Wrangler

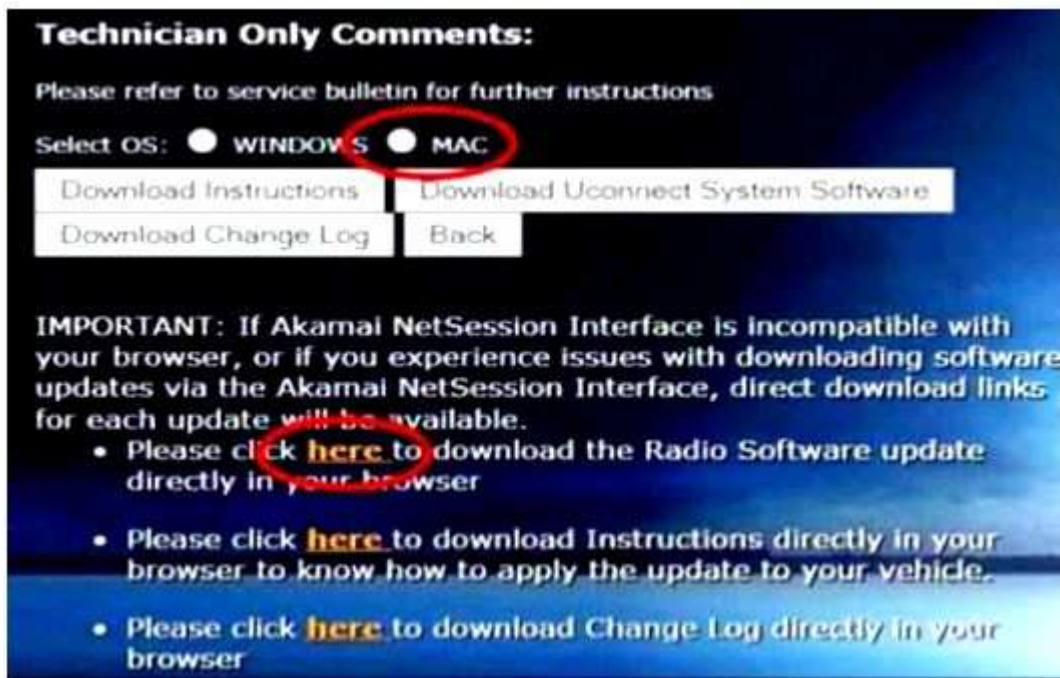
Fig. 3

**MAC Download Steps**

5. Download the software update file to your local PC's desktop. Make sure to select the "MAC" radial button for all downloads (Fig. 3) .

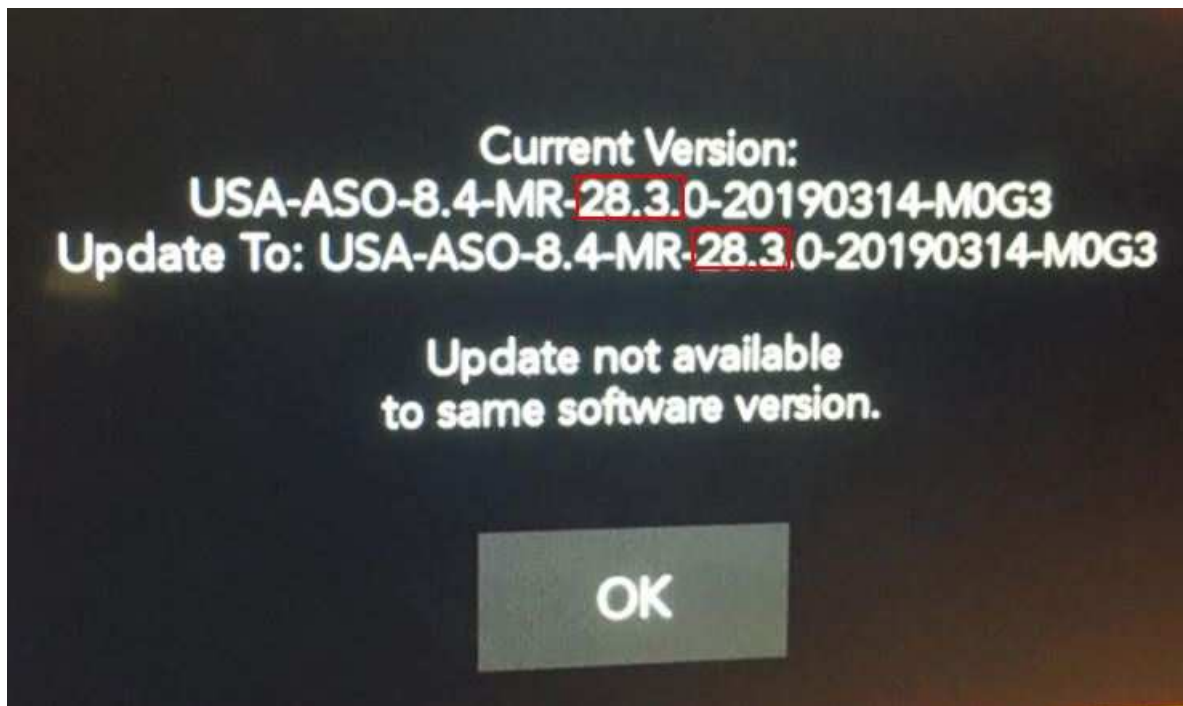
Fig. 6  
Screen Displayed When Radio Software Level Is Up To Date

11. If the radio software is up to date, the screen in (Fig. 6) will be displayed. Press "OK" and remove the USB flash drive.

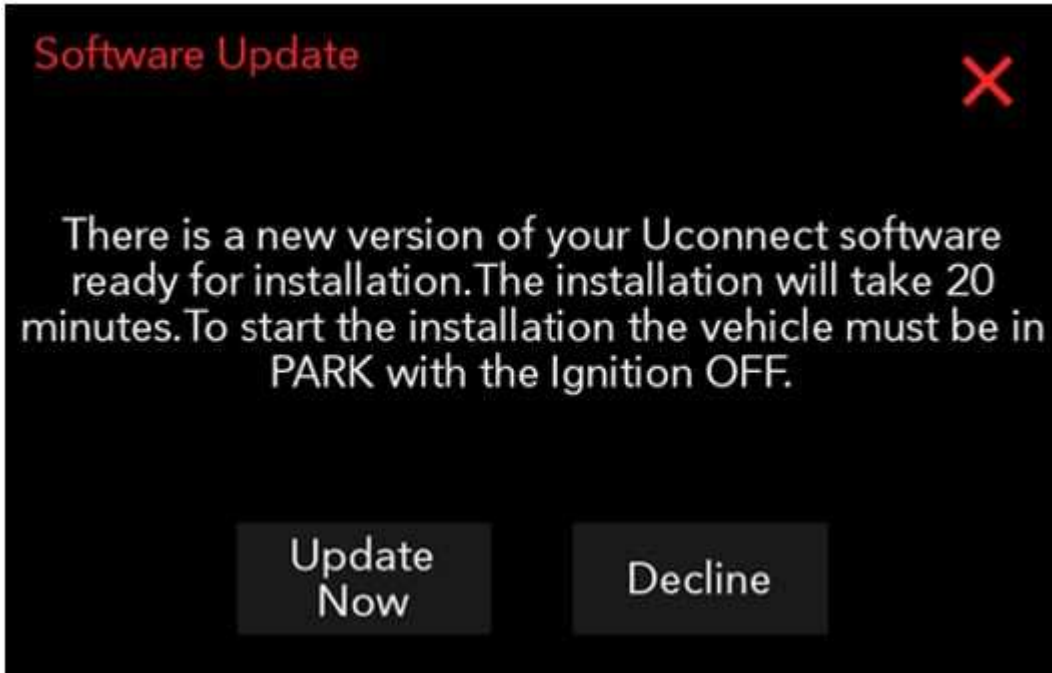
Fig. 7  
Software Update Is Available

12. Once the system has verified there is an available update, press the “Update Now” button. Make sure the vehicle is in park. **Do NOT turn off the ignition at this point**, (Fig. 7) .

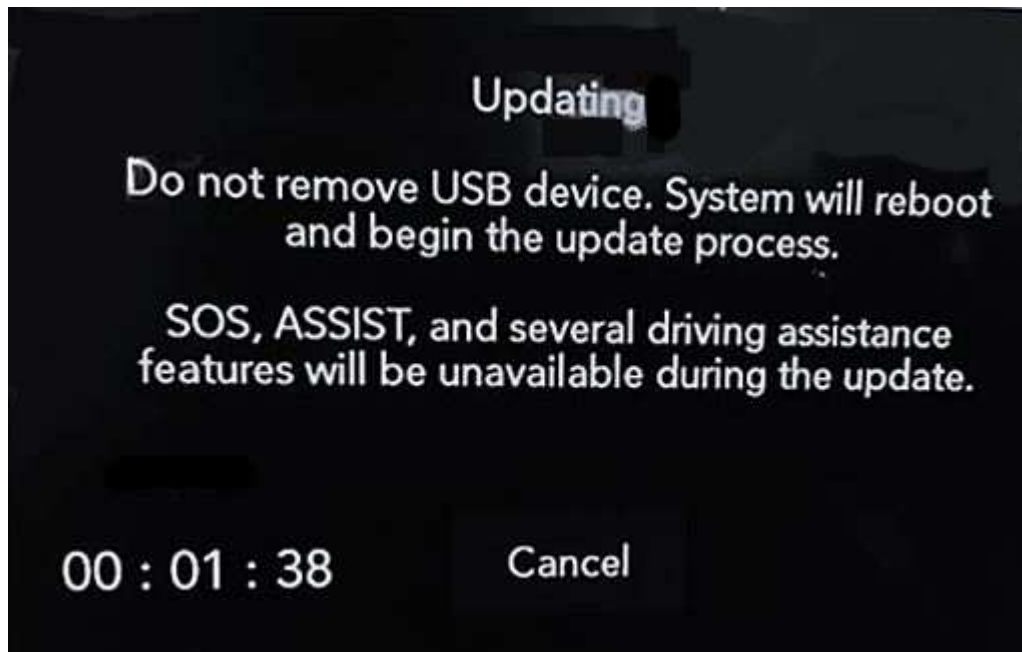
Fig. 8  
Radio Update Process Begins

13. When the radio starts updating, the screen in (Fig. 8) will be displayed.

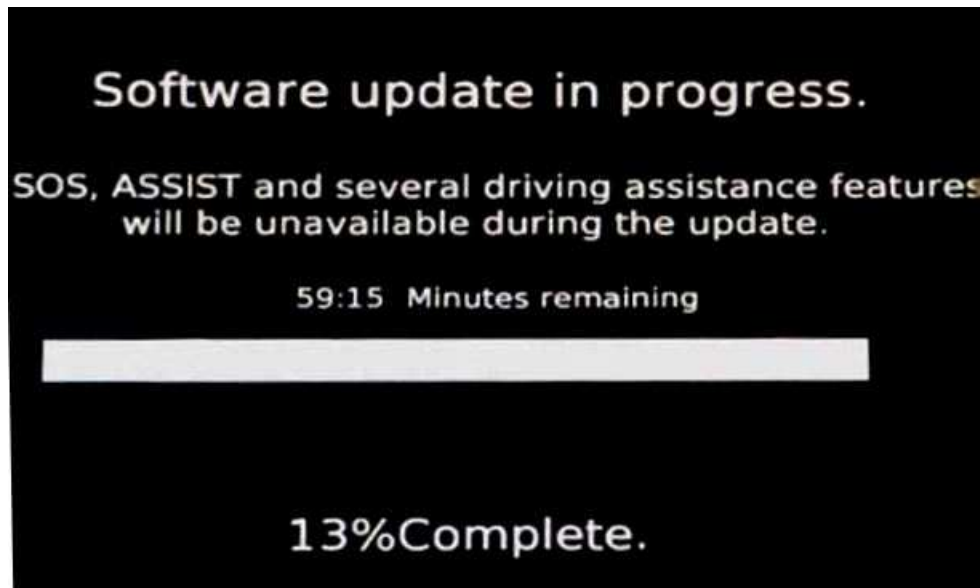
Fig. 9  
Software Update In Progress

**NOTE:** The completion indicator may not reach 100%, even though the software update has been completed. Once the software update has finished, the radio and display screen will turn off (Fig. 9) .

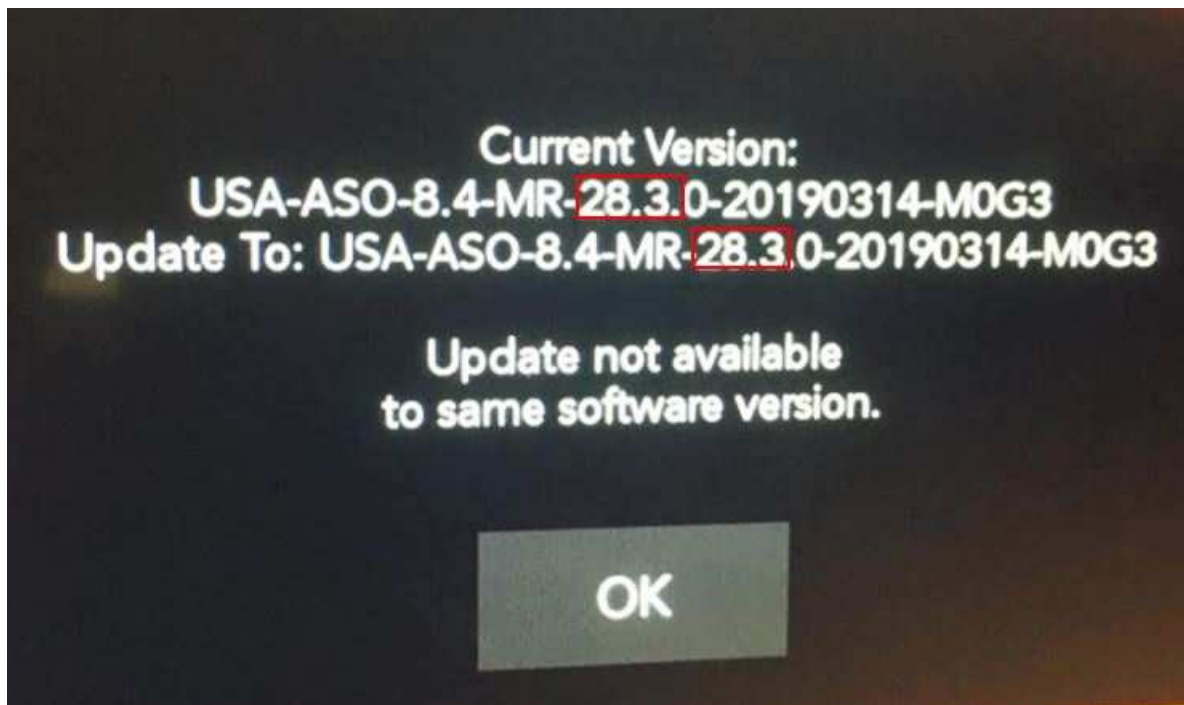
Fig. 10  
Software Levels After Update

15. After the update has completed, the radio will shut down. With the USB flash drive still inserted in the USB port, turn the ignition back to the run position. If the radio has been updated correctly, the screen in (Fig. 10) will be displayed. Press "OK" and remove the USB flash drive.
