# Corrosion on Cab at Lower Corner(s) of Center Stop Lamp Assembly

YEAR(S)	MODEL(S)	ADDITIONAL INFORMATION
2007 - 2020	Tundra

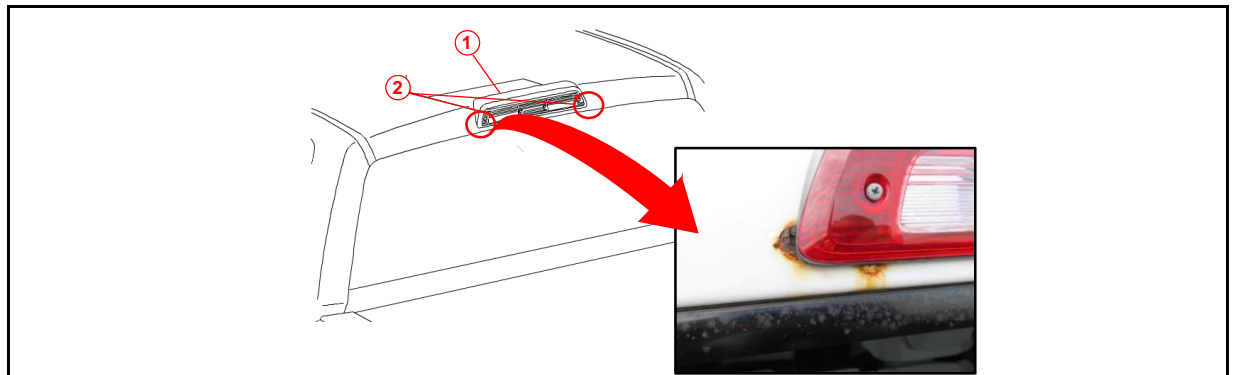
**Figure 1.**

Does surface corrosion and/or perforation corrosion exist at the lower corner(s) of the center stop lamp assembly?

<b>1</b>	Center Stop Lamp Assembly
<b>2</b>	Surface Corrosion and/or Perforation Corrosion

2. Order the center stop lamp assembly service part and sublet to a body shop for repair of the surface corrosion and/or perforation corrosion.
