TECHNICAL INSTRUCTIONS
FOR
LIMITED SERVICE CAMPAIGN KLG
CUSTOMER SUPPORT PROGRAM 19LE05

SAFETY CONNECT SYSTEM – VEHICLE LOCATION INACCURATE
CERTAIN

Updated 10/17/2019

The Data Communication Module (DCM) in the subject vehicles are equipped with software to identify the location of the vehicle using the Global Positioning System (GPS) to support features of the Safety Connect system. Due to incorrect programming in the DCM software, after November 2nd, 2019, the GPS coordinates for this system will be calculated incorrectly. This will cause the system to use incorrect vehicle coordinates if one of the system's features is activated.

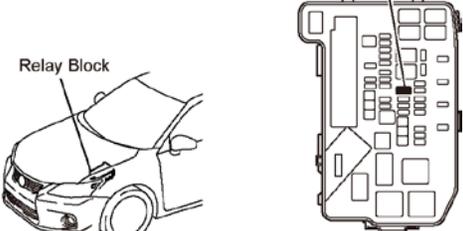
<p>Relay Block</p>
<p>GS350 (GRL1#) Remove D/C CUT Fuse (30 A)</p>

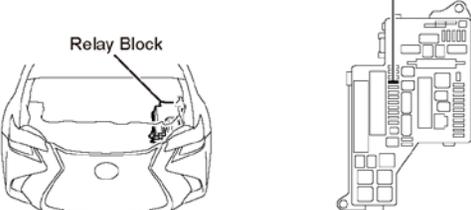
<p>Relay Block</p>
<p>IS250,IS350,IS250C,IS350C,IS F (GSE2#,USE20) Fuse Block Remove this D/C CUT Fuse(20A)</p>

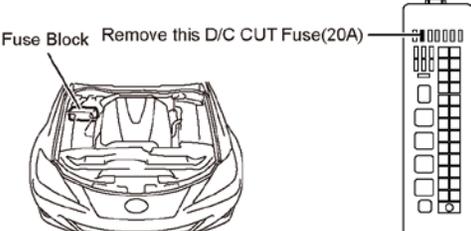
<p>Fuse Block</p>	<p>IS250,IS350,IS300 (GSE3#,ASE3#) Remove D/C CUT Fuse (30 A)</p>

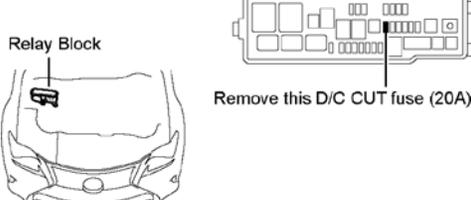
<p>Relay Block</p>	<p>RX350/450h (GGL1#,GYL1#) Relay Block Remove this Short Pin</p>

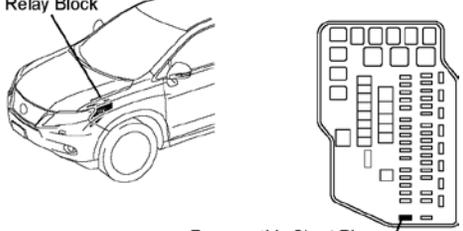
<p>Relay Block</p>
<p>NX200t,NX300,NX300h (AGZ1#,AYZ1#) Relay Block Remove this D/C CUT FUSE (20A)</p> <p>for Hybrid : for Gasoline :</p>

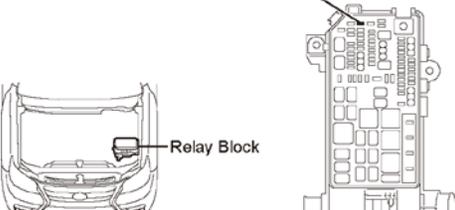
<p>Relay Block</p>	<p>ES350,ES300h (GSV6#,AVV6#) Relay Block Remove this Short Pin</p>
