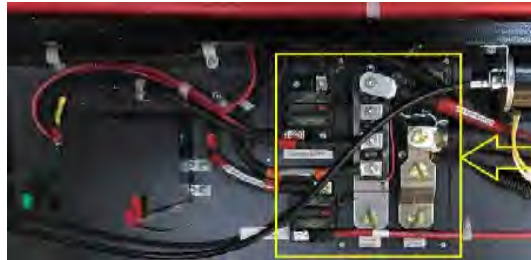
Dealer: I just spoke with my tech and he said that the charger is spiking to 80 amps and then drops to zero or -6. When this happens anything on starts to flicker. Is this part of your setting reconfiguration?

Pleasure-Way: According to our electrical supervisor also please check if there are any loose wiring connections by the battery stint area.

Dealer: THEY DID HAVE LOOSE WIRES BUT THAT DID NOT SOLVE THE ISSUE, I SPOKE TO XANTREX AND THEY GAVE ME A WAY TO GO BUT WE NEED TO KNOW THE ABSORTION RATE FROM PLEASURE WAY TO PROCEED WITH REPAIRS.
