**SERVICE BULLETIN**

**APPLICABILITY:** 2019-20MY Impreza  
 2019-20MY Crosstrek (Including Hybrid Model)  
 2019-20MY Forester  
 2019MY Legacy/ Outback  
 2019-20MY WRX  
 2019-20MY BRZ- Navigation -equipped ONLY  
 2019-20MY Ascent

**NUMBER:** 15-236-18R  
**DATE:** 12/04/18  
**REVISED:** 11/08/19

**SUBJECT:** Reprogramming File Availability for Optimization of Harman Gen 3.1 Audio and Navigation Head Units

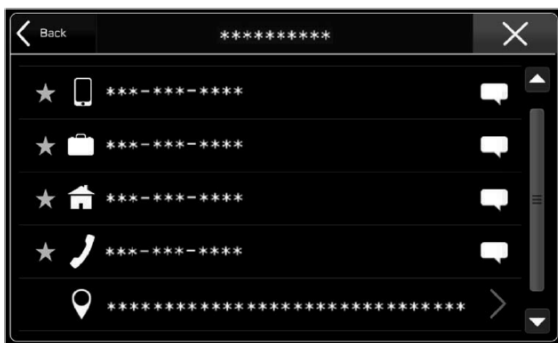
- 1) AM/FM radio station presets are lost.
- 2) Favorite Phone Contacts list is lost.

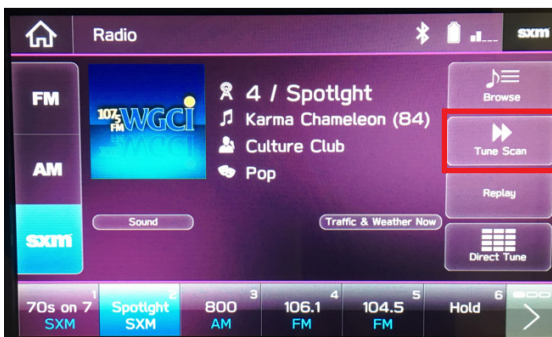
- 3) <Scan> previously displayed on SXM screen was changed to <Tune Scan> (a.k.a. SEEK).

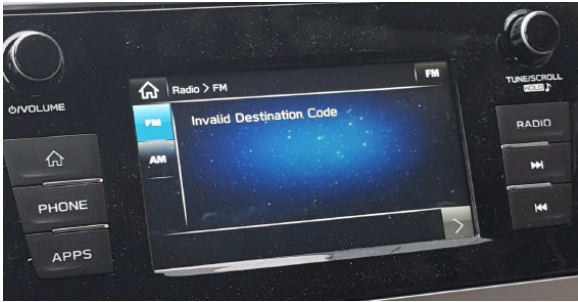
- 10) The voice guidance volume no longer changes After Ignition Off/On. Once the Voice Guidance has been muted, the system retains that setting even after switching the ignition Off/On.
- 11) Invalid Destination Code message appears on the display while listening to the radio.

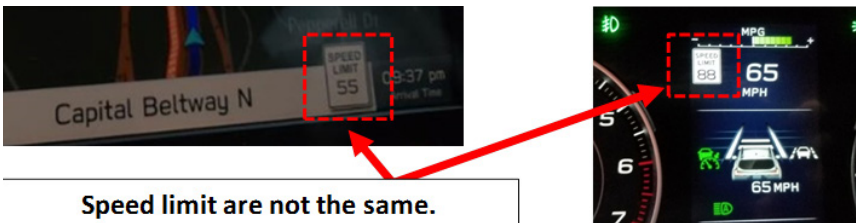
- 12) Spanish version FOTA (Firmware Over The Air) translation corrected.
- 13) Mismatch of Speed Limit between Navigation display and the Speed Limit displayed in the Combination Meter Multi-Function Display (MFD).

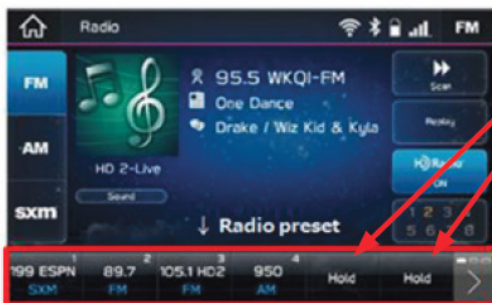
- 1) Station presets are lost. Touch buttons read “Hold”. (Applicable for software versions Rel\_4.18.25.50 (or before)). Included in software version Rel\_U1.18.38.50.
