## SERVICE INFORMATION BULLETIN

**APPLICABILITY:** 2018MY Legacy and Outback w/ 8-inch Navi System **NUMBER:** 15-254-19  
 2017-18MY Impreza with 8-inch Navi System **DATE:** 11/08/19  
 2018MY Crosstrek with 8-inch Navi System  
 2018MY BRZ with 7-inch Navi System

**SUBJECT:** Map Data Update Procedure for Harman Gen 3.0 Navigation Equipped Head Units (H/U)

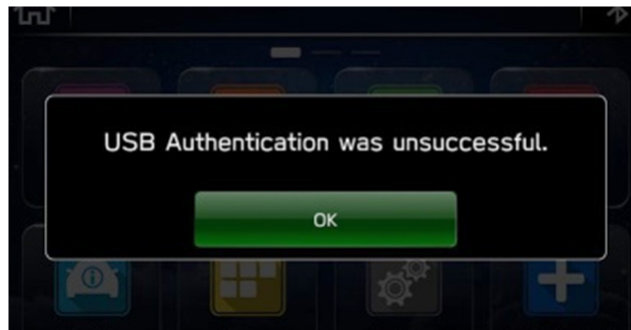
**CAUTION: NEVER** attempt to install this software update on any 2019 or 2020 MY vehicles as they are equipped with Gen 3.1 Navigation systems. This update is **ONLY** for models equipped with **Gen 3.0** Navigation systems. Should an attempt be made to install any of these files into a Gen 3.1 H/U, the USB Authentication error screen below will be displayed.

- The USB Authentication error screen will also be displayed when attempting to install the map data bundled with a software version older than the version already installed in the H/U.
- Move the vehicle to an outside location where the engine can be safely started and kept idling during the update process.
- Never idle the vehicle in a closed space such as a garage, even if the garage door is open.
- Once the vehicle is in a safe location, be sure the vehicle is in Park if CVT or Neutral if MT and the parking brake is fully engaged.
- Unplug any cables or devices from the USB ports.
