Technical Service Bulletin

34 Transmission oil leak from the case seam

34 19 42 2052421/2 November 21, 2019. Supersedes Technical Service Bulletin Group 34 number 18-37 dated September 18, 2018 for reasons listed below.

Model(s)	Year	VIN Range	Vehicle-Specific Equipment
R8	2013 - 2018	All	With S-tronic transmission

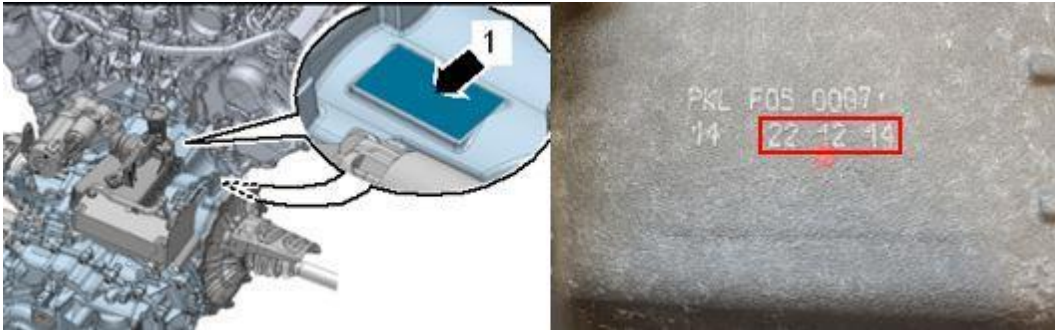
Check and record the transmission build date for your records or possible Audi Technical Assistance Center contact. The build date is located on the top of the transmission bellhousing on the passenger side (Figure 1). The date is stamped into the bellhousing in Day-Month-Year format.

Figure 1. Example of a gearbox production date.

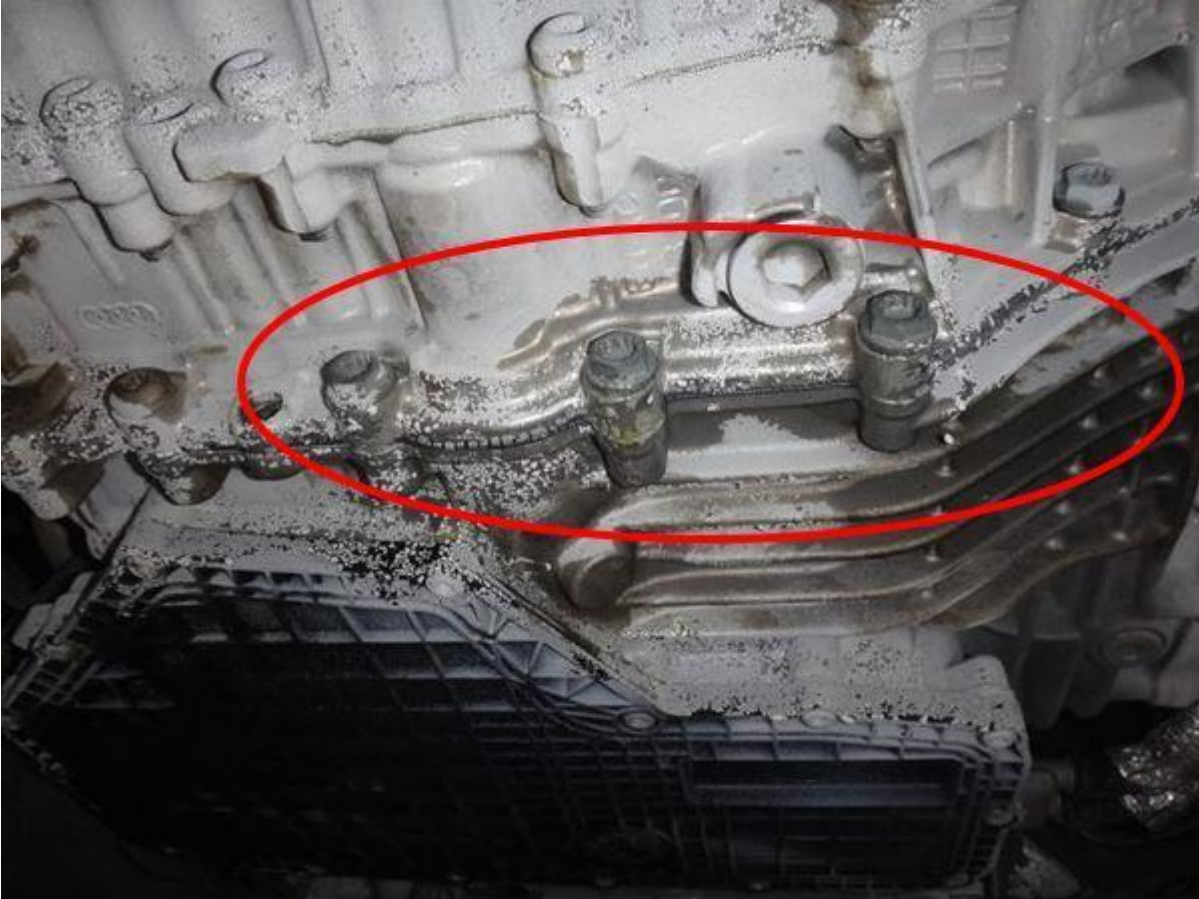
- Transmission oil leaking from case seam at the front of the intermediate housing.

Deviation of tightening torque of case seam bolts.

Figure 2. Oil leak example.

5. If the oil leak is from the seam at the front of the intermediate housing shown in Figure 2 proceed to step 7 in this TSB.
6. If the oil leak is not from the location shown in Figure 2 this TSB does not apply and you should complete your diagnosis outside of this bulletin. Take clear pictures of the leak location and open an Audi Technical Assistance Center contact. Attach the pictures of the oil leak to technical inquiry and contact the Audi Technical Assistance Center.
7. Check the seven steel bolts (Figure 3) for a torque of 25 Nm. The seven bolts have a hex head with an internal polygon socket (triple square). If one or several bolts do not have the specified torque (25 Nm), document which bolts (1 through 7) were not tightened correctly.

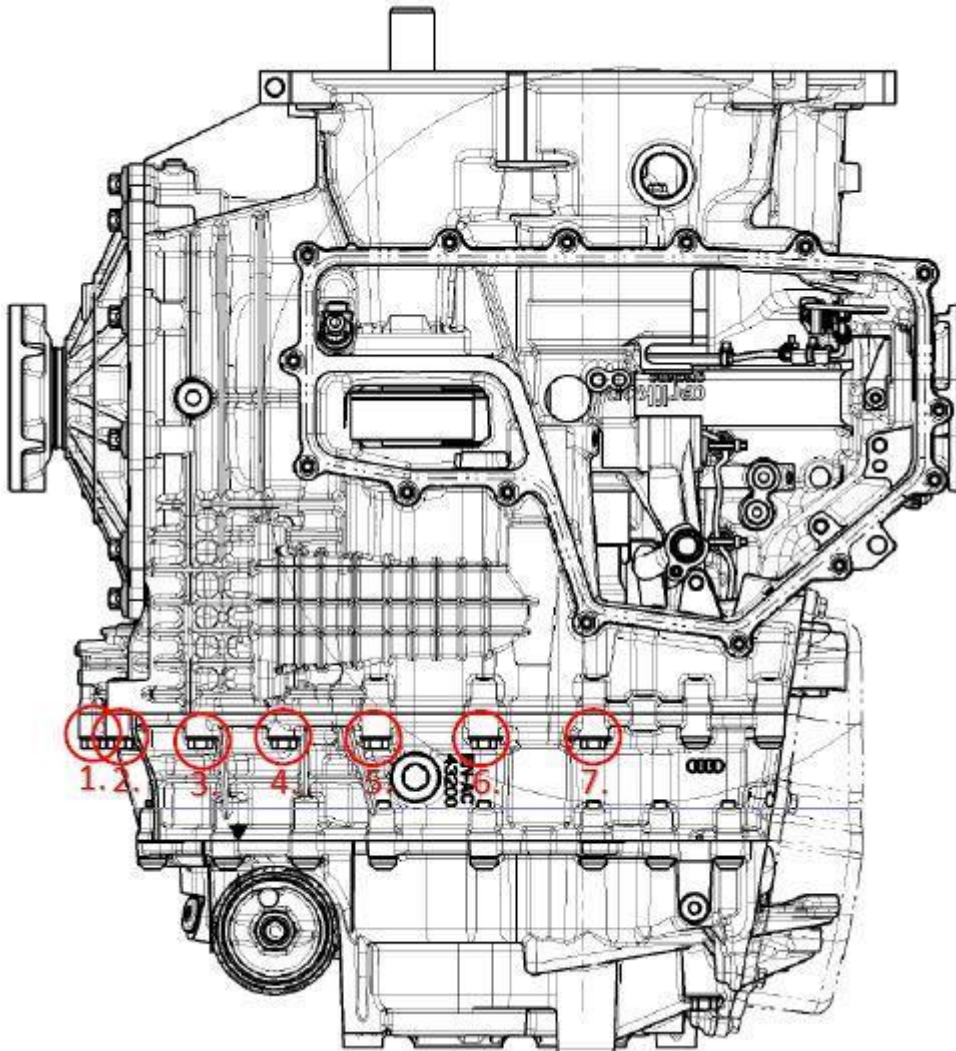
- One or several steel bolts of the seam at the front of the intermediate housing are loose.

Figure 3. Bolt locations.

8. Replace the incorrectly tightened bolts individually with a torque of $20\text{Nm} + 90^\circ$. Do not replace any bolts that were not loose.

Never remove two or more bolts at the same time.
