Technical Service Bulletin

37 Transmission malfunction, DTC P17F600, P17F500, P17F400, U008000, and/or U010100 stored in the TCM or ECM

37 19 90 2053878/6 November 8, 2019. Supersedes Technical Service Bulletin Group 37 number 19-89 dated October 22, 2019 for reasons listed below.

Model(s)	Year	VIN Range	Vehicle-Specific Equipment
A6, A7	2019	000001 - 121296	3.0TFSI

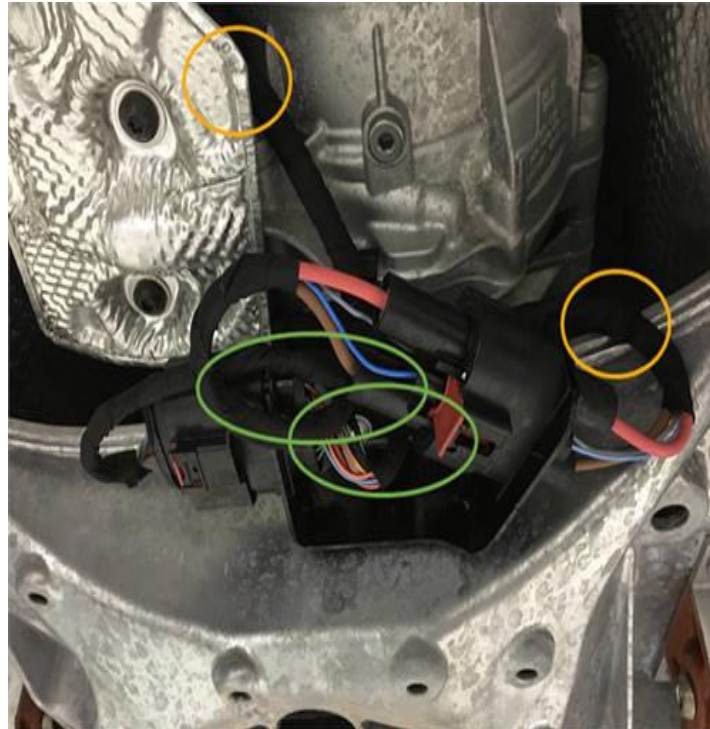
The transmission harness can come in contact with the transmission crossmember and could be damaged.

Figure 1. Common areas for harness damage. Also depicted is the original routing concept.

1. Inspect for damage to the transmission harness (Figures 1 - 4).
 - Thoroughly inspect the transmission wiring harness and routing to determine if the routing is the new or the original concept (Figures 1, 7, and 8).
 - Inspect the body harness and transmission harness for damage near the areas indicated in Figure 1.
 - Harness damage can be very subtle. Even a light chafing of the harness wrap can cause the DTCs.

If **transmission harness damage** is found and/or the original routing concept is in place, proceed to step 3.

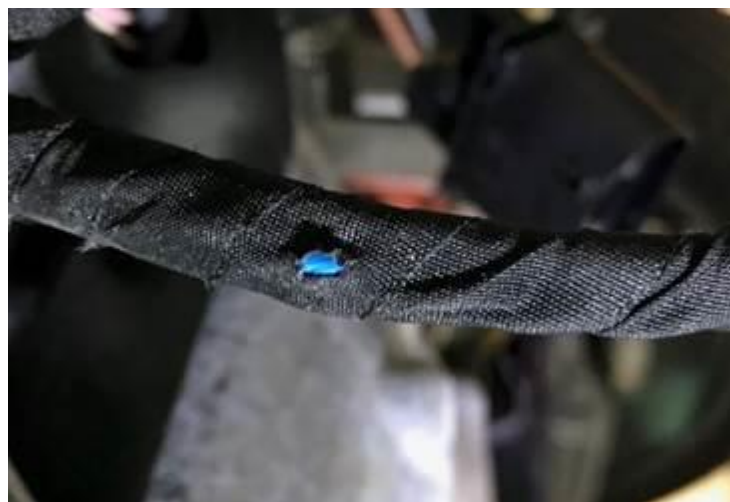
Figure 2. Example of a small rip in the protective tape.

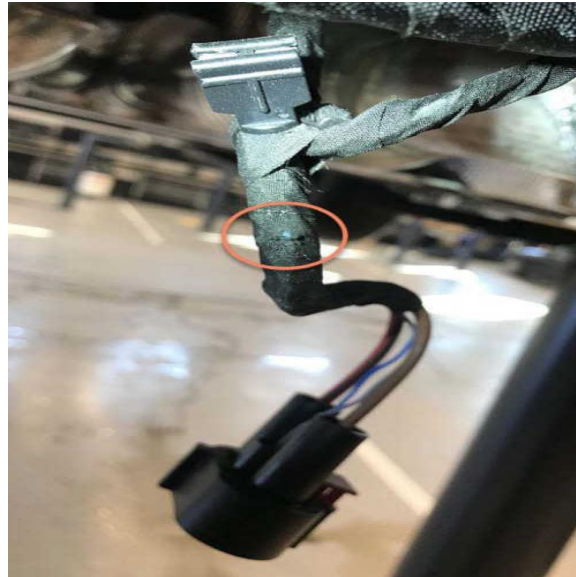
Figure 3. The damage on the original harness might be difficult to spot.

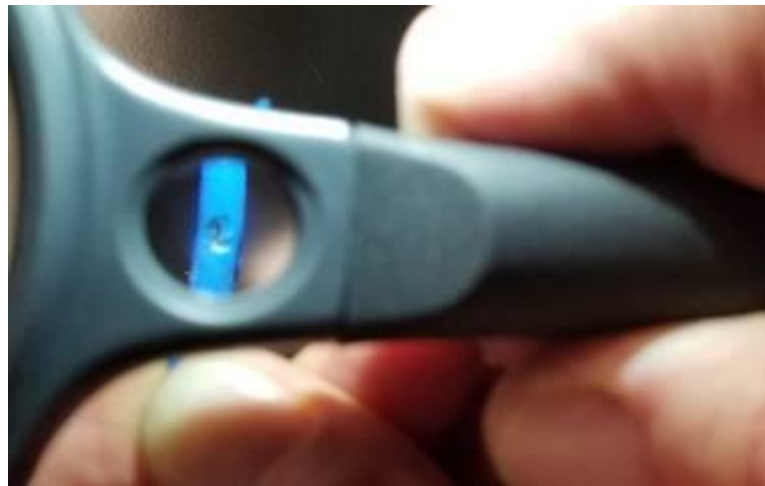
Figure 4. The cause of the DTC may be as small as a pinhole.

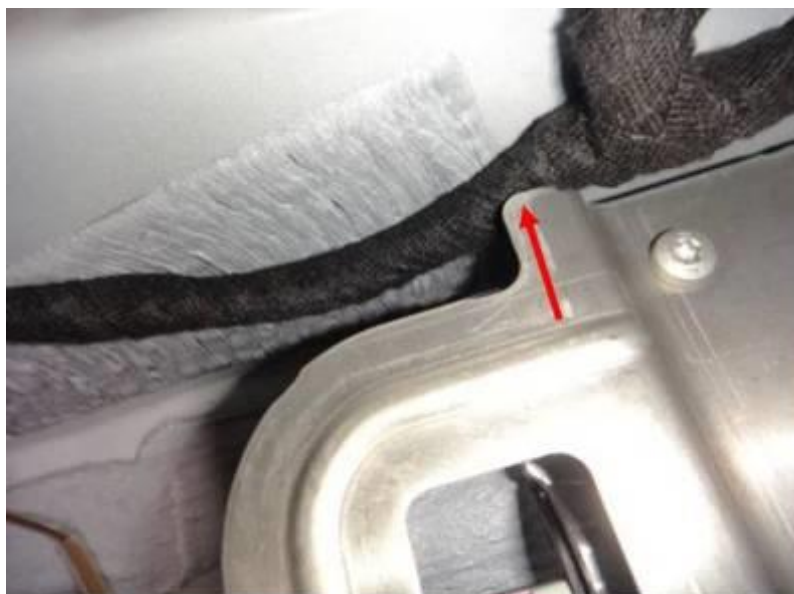
The body harness containing the FlexRay circuit to the transmission may rub against the mounting bracket of the driver assist systems control module, J1121 (address word 00A5).

Figure 5. The area where the body harness may rub.

If there is no damage found and DTC U11B000 (FlexRay data bus branch 2 faulty) is stored, inspect the area shown in Figure 5 and 6.

If damage is found in this area then create a TAC case, include photos, and a clear description of your findings.

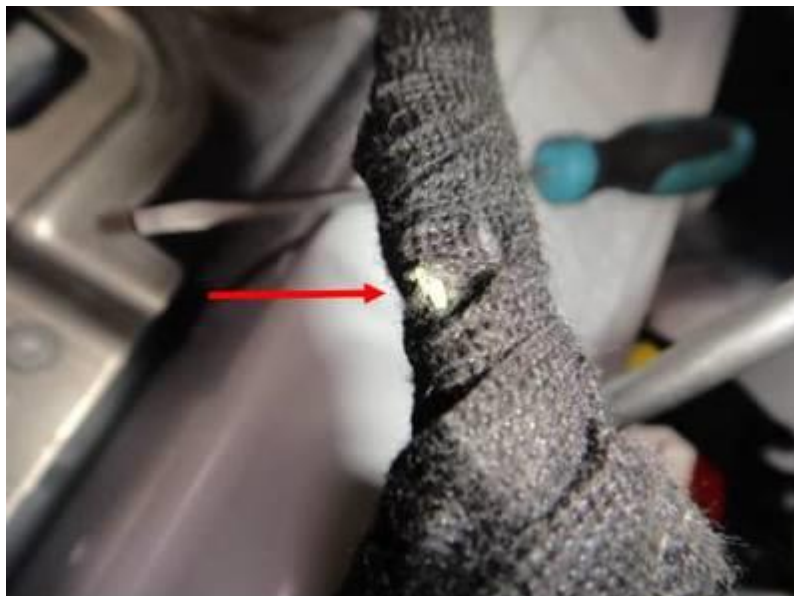
Figure 6. Shows the rub mark on the wiring harness.

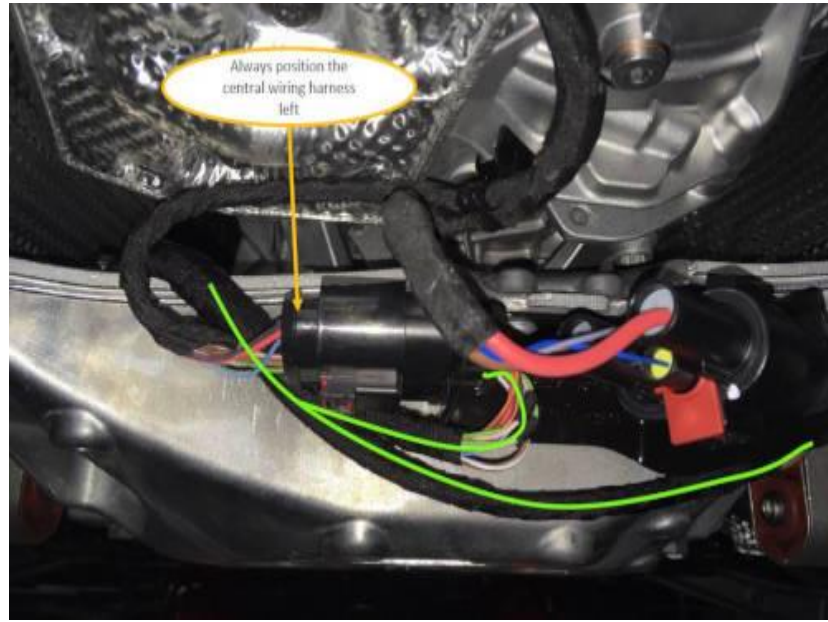
Figure 7. New routing and wrapping of the aft part of the transmission harness.

3. Replace the original transmission harness with a new part and reroute the transmission harness. The transmission harness should not be repaired.
 - Remove the original transmission harness in the vehicle.
 - Wrap the exposed wires on the new transmission harness as shown in Figure 7.
 - Mount and route the new transmission harness as shown in Figure 8.

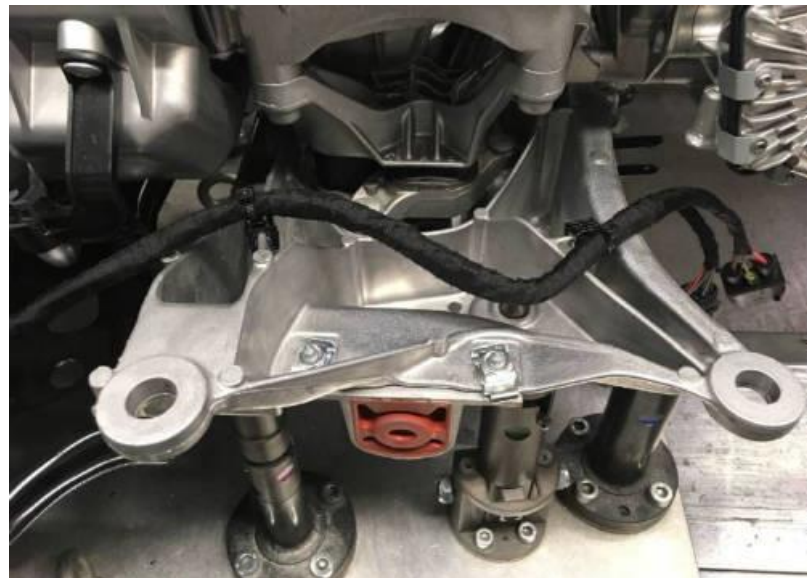
8. Routing and mounting of the transmission harness behind the crossmember.

4. The crossmember is shown dismounted in Figure 8 to show the new mounting points more clearly.
