Technical Service Bulletin

37 Transmission malfunction, DTC P17F600, P17F500, P17F400, U008000, and/or U010100 stored in the TCM or ECM

37 19 91 2053878/7 November 21, 2019. Supersedes Technical Service Bulletin Group 37 number 19-90 dated November 8, 2019 for reasons listed below.

Model(s)	Year	VIN Range	Vehicle-Specific Equipment
A6, A7	2019	All	3.0TFSI

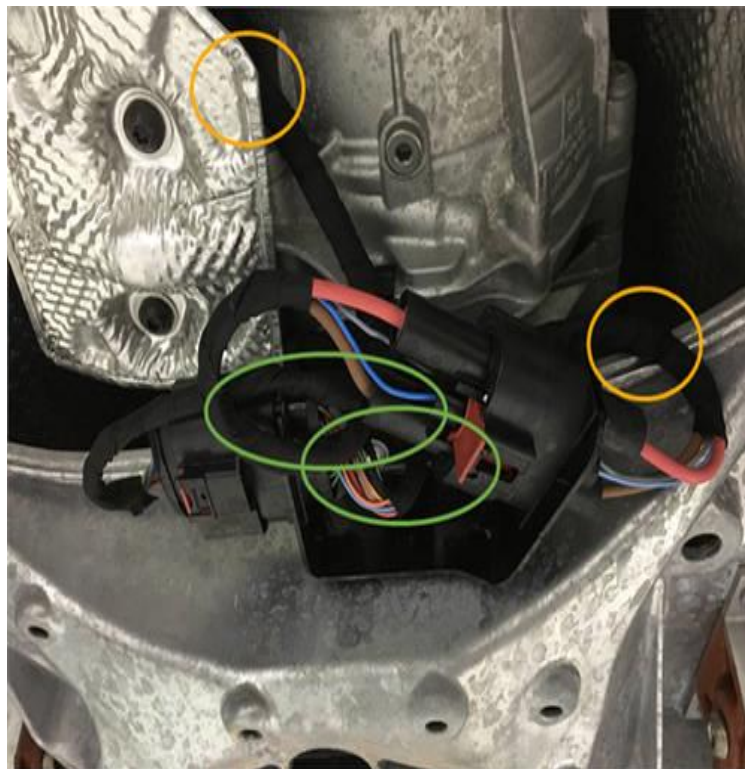
The transmission harness can come in contact with the transmission crossmember and could be damaged.

1. Inspect for damage to the transmission harness (Figures 1 - 4).
 - Thoroughly inspect the transmission wiring harness and routing to determine if the routing is the new or the original concept (Figures 1, 7, and 8).
 - Inspect the body harness and transmission harness for damage near the areas indicated in Figure 1.
 - Harness damage can be very subtle. Even a light chafing of the harness wrap can cause the DTCs.

Figure 1. Common areas for harness damage. Also depicted is the original routing concept.

If **transmission harness damage** is found and/or the original routing concept is in place, proceed to step 3.

3. Replace the original transmission harness with a new part and reroute the transmission harness. The transmission harness should not be repaired.

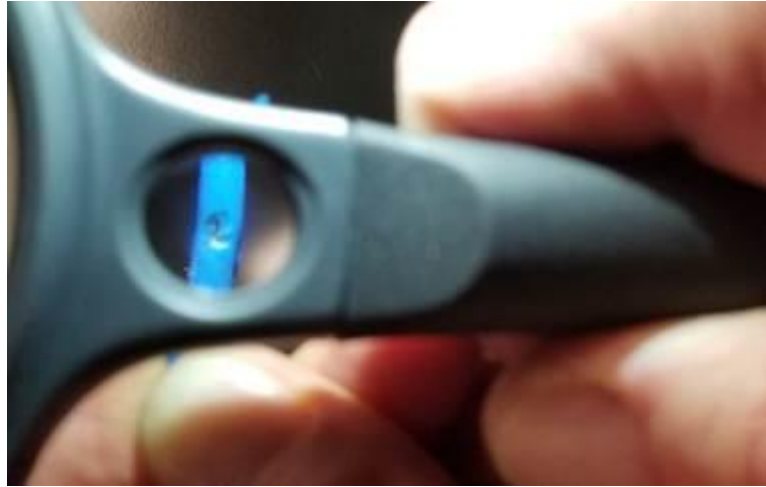
Figure 4. The cause of the DTC may be as small as a pinhole.

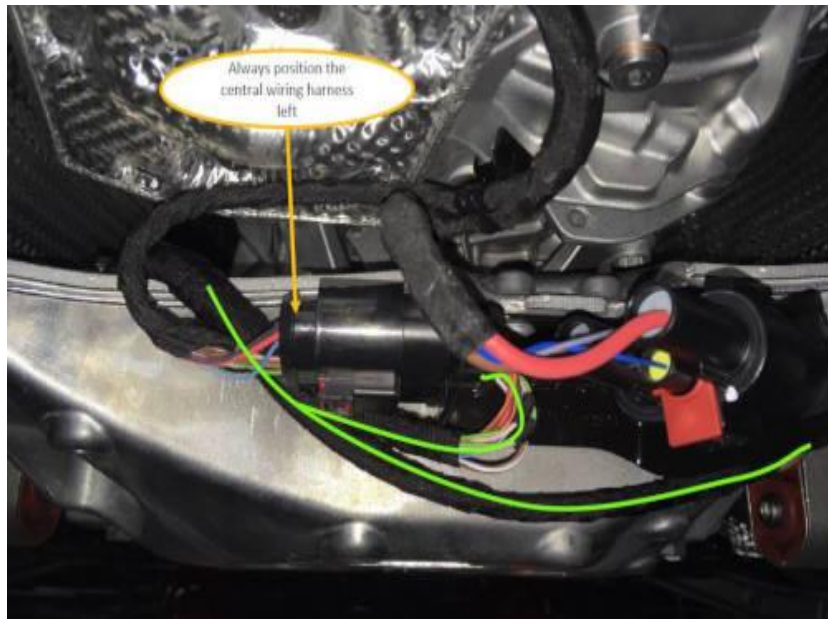
Figure 7. New routing and wrapping of the aft part of the transmission harness.

- Remove the original transmission harness in the vehicle.
- Wrap the exposed wires on the new transmission harness as shown in Figure 7.
- Mount and route the new transmission harness as shown in Figure 8.

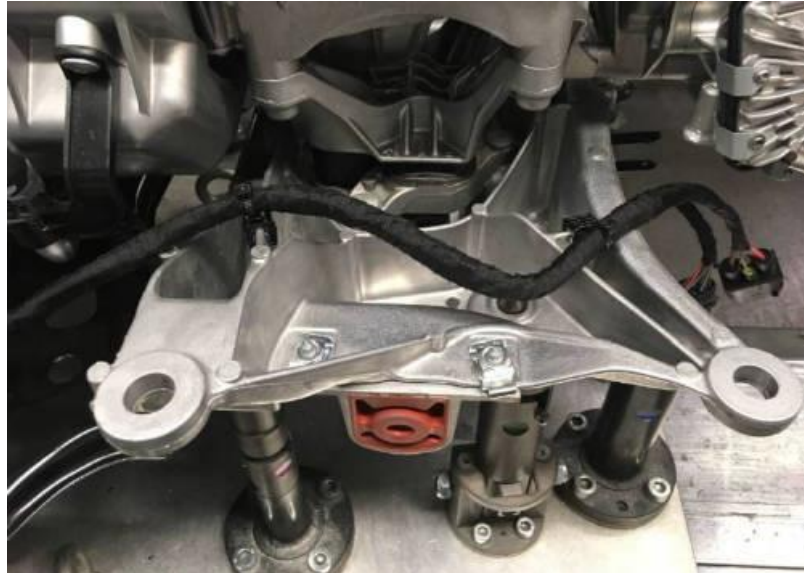
Figure 8. Routing and mounting of the transmission harness behind the crossmember.

4. The crossmember is shown removed in Figure 8 to show the new mounting points more clearly. For mounting and installation of the new transmission harness, the crossmember does not have to be removed.
