## SERVICE BULLETIN

**APPLICABILITY:** 2019MY Impreza  
 2019MY Crosstrek (Including Hybrid Model)  
 2019MY Forester  
 2019MY Legacy & Outback  
 2019MY WRX  
 2019MY BRZ- Navigation -equipped Models ONLY  
 2019MY Ascent

**NUMBER:** 15-256-19

**SUBJECT:** FOTA (Firmware Over-The-Air) Reprogramming  
 Procedure to Optimize Harman Gen 3.1 Audio / Navigation Units

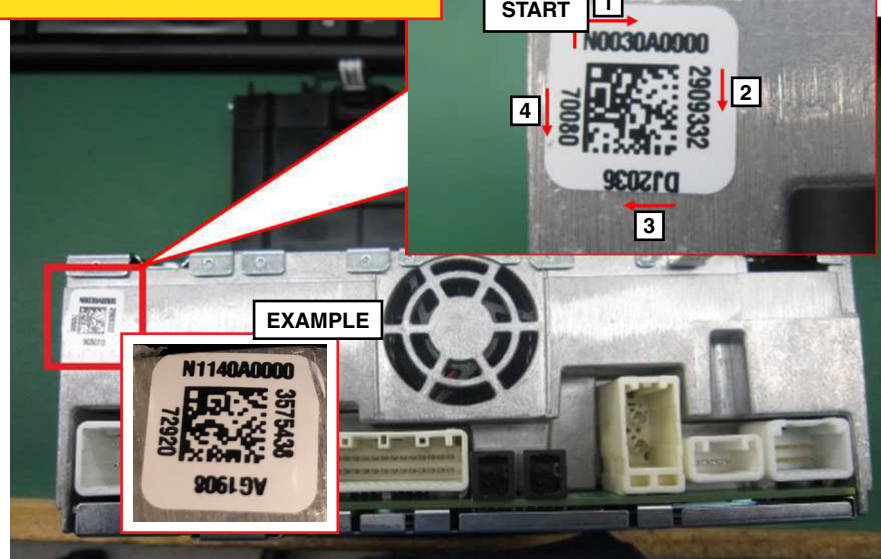
**IMPORTANT:** If the H/U software cannot be updated using FOTA, update the H/U following the USB flash drive procedure outlined in TSB **15-236-18R**. In such a case, a VIN/ H/U Serial Number mismatch may exist. If this occurs, the H/U must be removed and the serial number recorded as shown below. In these cases, the COMPLETE 28-digit serial number is required to be entered in the Miscellaneous Detail field during claim submission (no spaces or special characters). Also, capture a photo of the serial number label for reference in case any question arises about the serial number submitted. Examples of the serial number label are shown below.

**VERY IMPORTANT:** Always record all 4 “segments” of the 28-digit H/U Serial Number. Take and retain a photo of this small label in case it is needed in the future for confirmation.

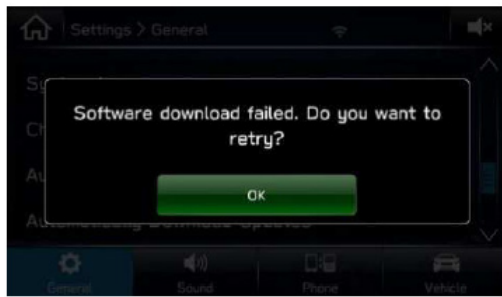
1.5.6) If the H/U display shows “Software download failed. Do you want to retry?”, there is possibility the H/U is not receiving the clock information correctly.

1.5.7) Move the vehicle to a location where the Navi can receive GPS signal or connect to a smartphone via Bluetooth. Ensure that transferring of phonebook data has been approved on the phone. (To review clock setting procedures, refer to Step 1 above.)
