SAFETY RECALL ACTION

Reference number:	RA-01-1327	Issued: 21 November, 2019
Subject:	Incorrect Installation of the Passenger Airbag	
Model(s):	DB11, Vantage (19MY), DBS Superleggera	
VIN Range:	Refer to the separately published list of Vehicle Identification Numbers (VINs)	
Applicable to:	All Dealers	
Distribute to:	After Sales Manager Executive Manager Service Manager Sales Manager	Warranty Staff Technician(s) Parts Staff

Reason for this Safety Recall Action (NHTSA Reference 19V-806)

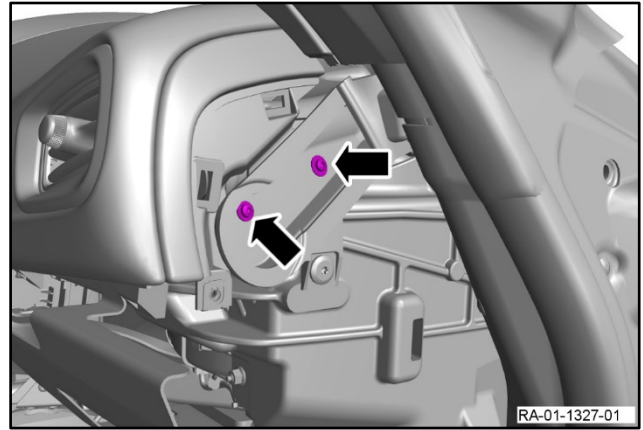
Figure 3

1. Remove the passenger side bottom panel for the IP (refer to Workshop Manual procedure 01.12.DV).
2. Remove the two screws that attach the duct for the door (refer to Figure 3).

7. Install the duct for the door (refer to Figure 4).
8. Install the two screws that attach the duct for the door (refer to Figure 3).
9. Install the passenger side bottom panel for the IP (refer to Workshop Manual procedure 01.12.DV).

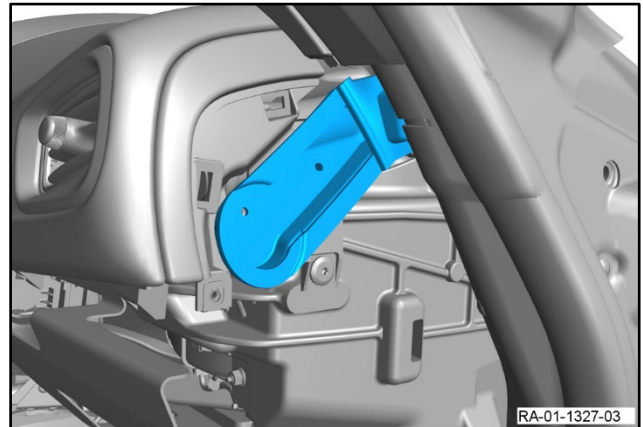
Figure 4

3. Remove the duct for the door (refer to Figure 4).

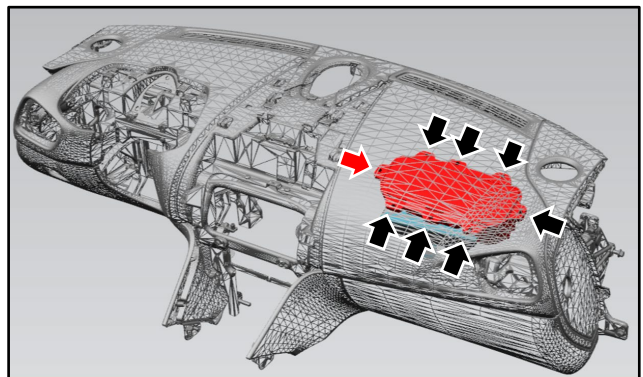
Figure 5

4. Use a fibre-optic camera to inspect the seven locking nuts that are accessible in the locations shown (refer to Figure 5).

Note: There are eight locking nuts in total, but one locking nut is not visible (refer to the red arrow).

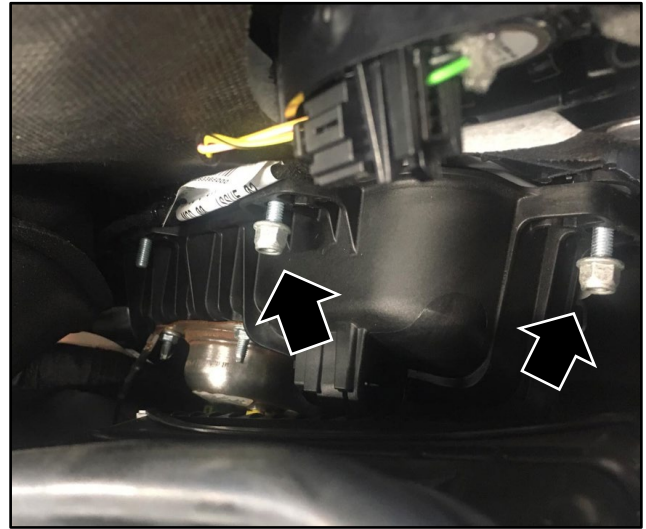
Figure 6

On the affected vehicles, it is possible the locking nuts that attach the passenger airbag to the instrument panel (IP) are not torqued to the correct specification.

5. If any of the locking nuts are not installed correctly (refer to Figure 6) go to Part B: Torque the Locking Nuts to the Correct Specification.

WARNING: IF A LOCKING NUT IS MISSING, INSTALL A NEW LOCKING NUT WITH THE PART NUMBER GIVEN IN THE PART DATA. IF YOU DO NOT USE THE CORRECT PART, IT IS POSSIBLE THAT THE AIRBAG WILL NOT BE ATTACHED CORRECTLY IN THE EVENT OF AN ACCIDENT AND NOT DEPLOY CORRECTLY.

2. Torque the eight locking nuts that attach the passenger airbag to the IP to 6.5 Nm.
3. Install the front evaporator and heater assembly (refer to Workshop Manual procedure 12.03.AH).

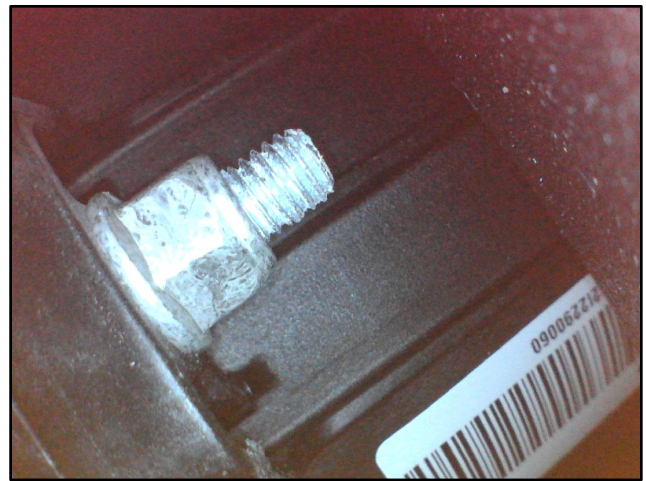
Figure 7

6. If all the locking nuts have been installed correctly (refer to Figure 7) go to step 7.
