## 91-19-04 - Universal Serial Bus (USB) Damage

Release date: 11/4/2019

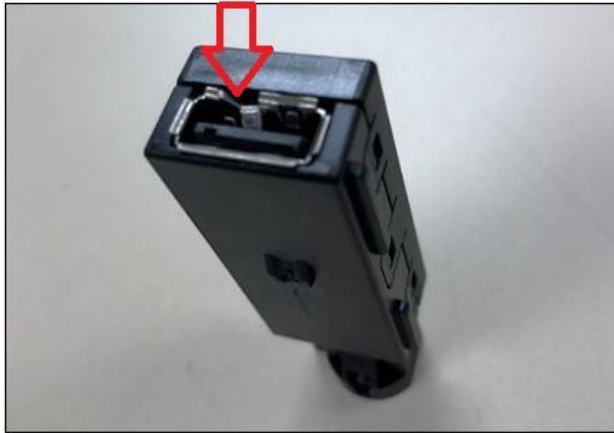
Malfunction(s) of the MIB1, MIB2 or MIB3 infotainment systems involving device connectivity via the **-U41-** Universal Serial Bus (USB) may be the result of damage to the vehicles Universal Serial Bus (USB) connector(s) by outside influence.

Figure 1: Damage Example

If diagnosis leads to a malfunction of the vehicle's Universal Serial Bus (USB) connector(s), perform a visual inspection of the connector to check for evidence of damage due to outside influence (see Figure 1). As per Volkswagen Warranty Policies and Procedures Manual, damages resulting from negligence or outside influence are not eligible for warranty reimbursement.
