## Condition

**THIS IS A TECH TIP, NOT A TECHNICAL BULLETIN.  
TECH TIPS ARE NOT ASSOCIATED WITH WARRANTY CLAIMING.**

Model(s)	Year	Eng. Code	Trans. Code	VIN Range From	VIN Range To
Golf, EOS, Beetle, Passat, CC	2008-2017	2.0L (CBFA)	All	All	All

Ticking or chirping noise heard only on a cold start from the high pressure fuel pump area.

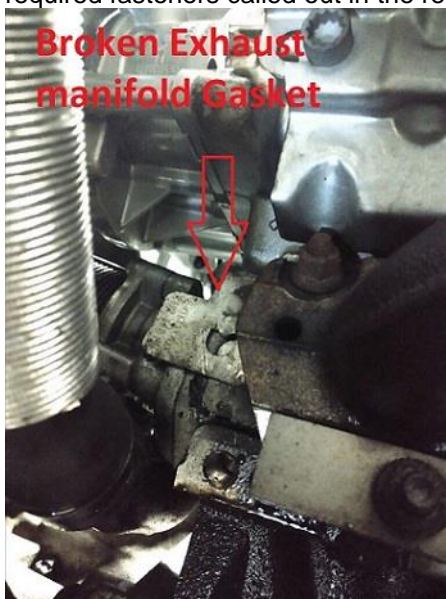
Figure 1

A noise described as a ticking or chirping noise that happens only on a cold start and goes away after a short time may be mistaken for a defective high pressure fuel pump. The noise is heard in the area of the high pressure fuel pump or the vacuum pump. This can be caused by a broken or cracked exhaust manifold gasket at the port for number 4 cylinder. Inspect for black staining or a piece of gasket sticking out in this area. Also soapy water sprayed in this area before starting the engine is helpful in diagnosis. The repair is to replace the defective gasket and any required fasteners called out in the repair procedure. See Repair Group 26 in Elsa.
