**Document ID:** IK1600207

**Title:** Wind noise at upper side of cab door due to door out of alignment

**Applies To:** LT, MV, HV, RH, LoneStar, ProStar, TranStar, WorkStar, DuraStar, TerraStar. (Does not apply to CV, PayStar, or HX)

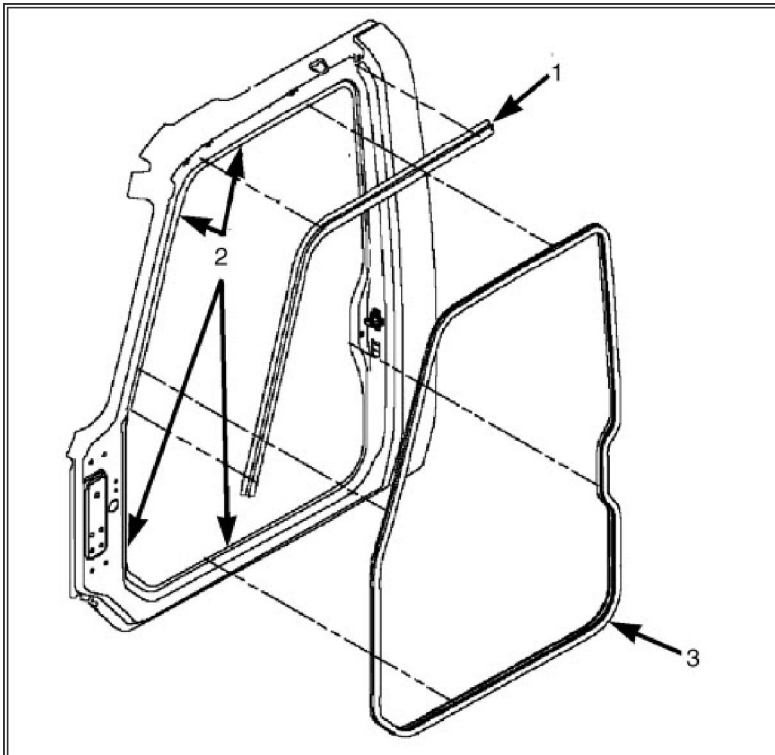
**Figure 1: Door Seals**

There are instances when the cab side entry door does not have proper contact with the door seals along the top of the door causing wind noise and/or flutter sounds. In extreme cases and in inclement weather, there could be water intrusion as well. Many design improvements were made between 2004 and 2009 that drastically improved quality in this area, however there are still isolated occurrences when this issue still persists.

Item 1: Secondary Door Seal  
 Item 2: Weather Seal Flange  
 Item 3: Primary Door Seal

1. Inspect the primary (Figure 1, Item 3) and secondary (Figure 1, Item 1) door seals. Ensure they are seated down completely. If there is any visible damage or waves, adjust or replace as necessary.

3. After replacing or adjusting any of the parts in steps 1 or 2, remove the primary door seal (Figure 1, Item 3).
4. While closing the door, place a dollar bill or similar size/shape piece of paper between the secondary door seal (Figure 1, Item 1) and the door (Not Shown) at the base of the A-pillar where the secondary door seal starts/terminates just above the upper door hinge (Figure 2, Item 1).

5. Slide the dollar bill up and along the door all the way back to the upper rear corner of the door.
6. If the dollar bill does not slide freely, there is proper contact between the door and seal and no shimming is required. Reinstall the primary door seal (Figure 1, Item 3), ensuring that it is completely seated all the way around the door perimeter. The job is complete.

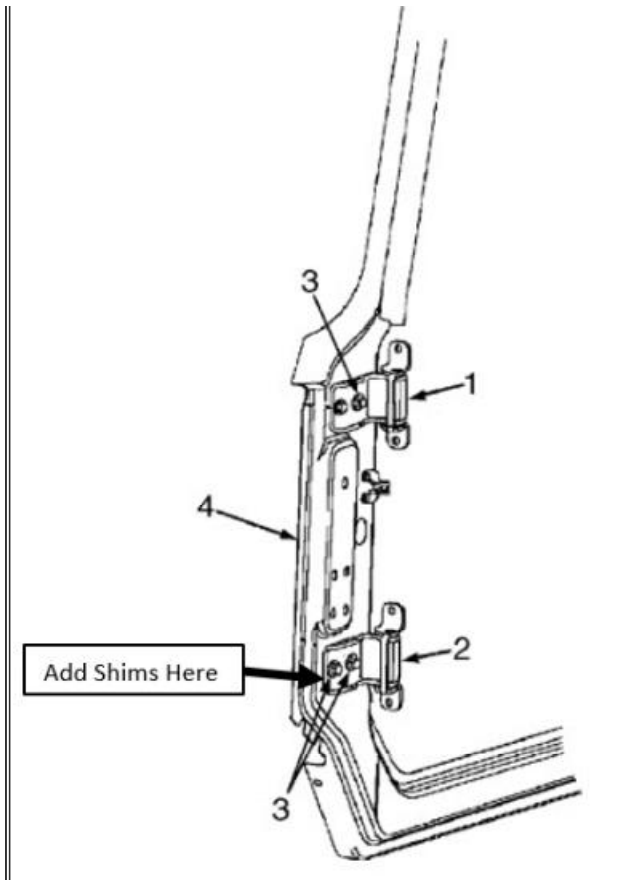
**Figure 2: Door Hinges**

- Item 1: Upper Door Hinge
- Item 2: Lower Door Hinge
- Item 3: Hinge Mounting Bolts
- Item 4: Cab Hinge Pillar

7. If the dollar bill slides freely, there is not a proper amount of contact between the door and the door seal. Continue below.
8. Loosen the lower A-pillar door hinge bolts (Figure 2, Item 3).

9. Insert the thickest shim (1.5mm) between the cab hinge pillar (Figure 2, Item 4) and the lower door hinge (Figure 2, Item 2). Position the shim with the long "ear" forward so the shim is completely covered by the hinge.

10. Re-tighten the lower hinge bolts (Figure 2, Item 3) to 19.6 - 24.0 N-m (14.5 - 17.7 Lbf-ft).
11. Repeat steps 4-10 using the 0.5mm shim until the issue is resolved. Do not use more than one shim kit on each door (total shift of 3.0mm).
