Countries: CANADA, UNITED STATES, MEXICO, PUERTO RICO
Availability: ISIS, FleetSIS, IsSIR
Major System: CAB / SLEEPER / HOOD
Current Language: English
Other Languages: NONE
Viewed: 442
Document ID: IK1600251
Revision: 1
Created: 3/15/2019
Last Modified: 11/12/2019
Author: Steven Bautz

Title: Water Leaks Past Plastic Vapor Barrier Sheet in the Inner Cavity of the Cab Entry Door

Applies To: Any Cab Entry Door on LT, RH, HV, MV, LoneStar

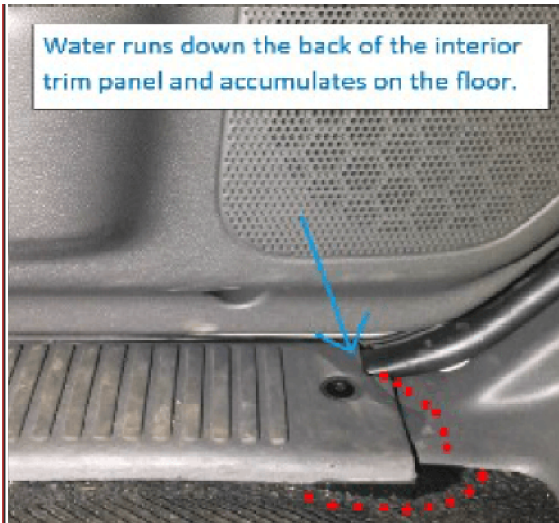
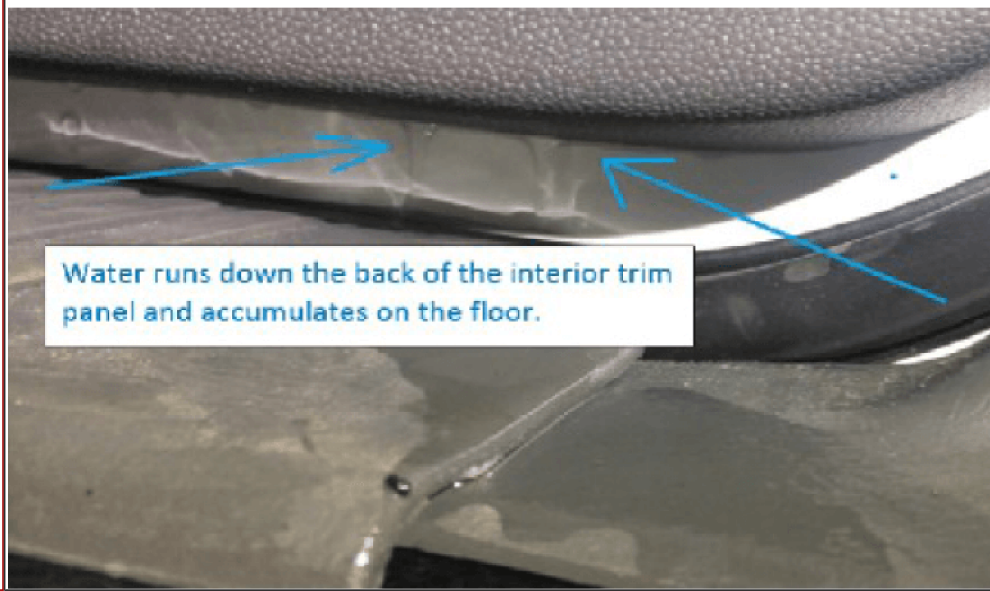
Step	Action	Decision
1	<p>DIAGNOSTIC:</p> <ul style="list-style-type: none"> Is water dripping or present at or near cab threshold? Is the Cab floor wet near the door? 	<p>Yes. Remove interior trim door panel and inspect the seal bead holding the plastic vapor barrier to the door panel at each opening for proper adhesion to metal door panel. Water can be poured at base of the outer door window to observe if water leaks past seal bead at any given location. (See photos)</p> <p>Note: The seal bead not adhered to the metal panel may be hard to see so using water at time of evaluation is preferred to confirm seal integrity.</p> <p>No. The vapor barrier is properly sealed. No further action is required.</p>

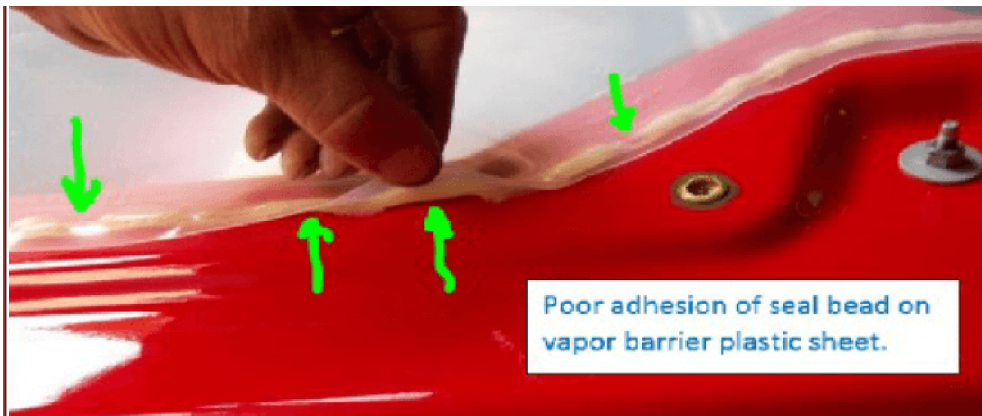
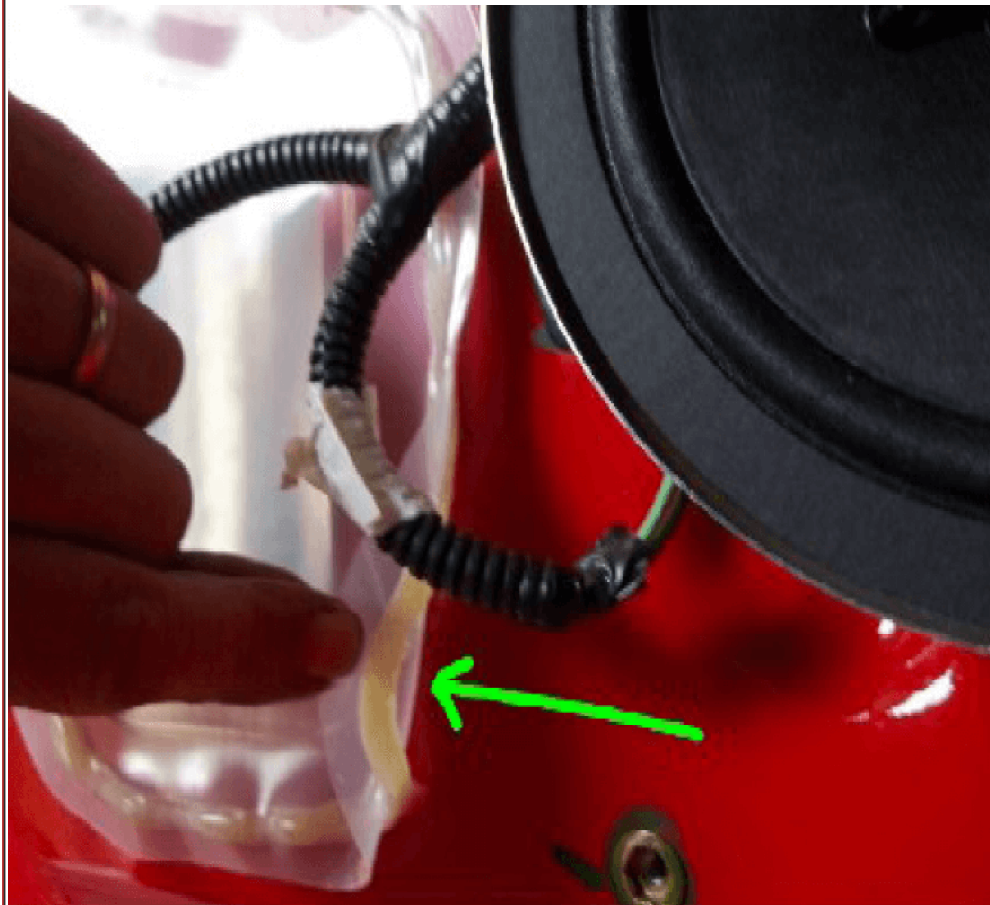
Step	Inspection for seal bead adhesion to metal door panel	Procedure
2		<p>1. Check for adhesion by water leaking or dripping</p> <p>2. Slightly lift plastic vapor barrier all around each sealed location to check for adhesion to metal door panel.</p> <p>Note: If the areas of the bead that are not adhering are minor the seal bead can be cleaned and resealed or an additional bead of Butyl seal tape can be added.</p>

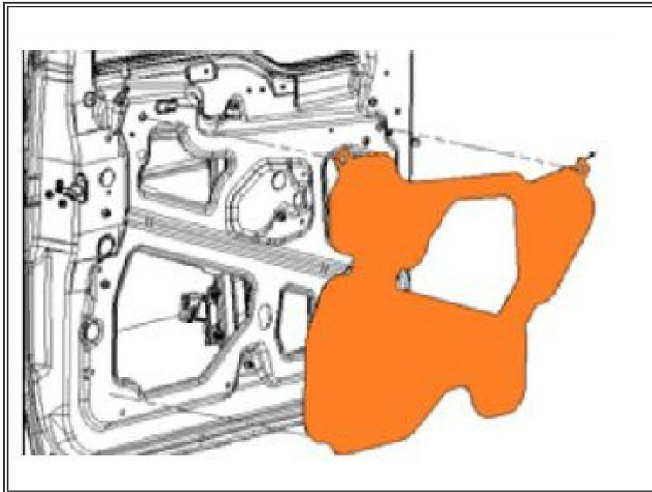
Figure 1: Placement of New Vapor Barrier

The new barrier will come from the PDC with the sealant bead already adhered to the plastic sheet. Reference Fig 1.

3. Replace the entire plastic vapor barrier with a new plastic vapor barrier from service parts. (If this option is used; follow the procedure below)
