Service Bulletin

E246

EPA2013 and EPA2017 PACCAR MX-13 and MX-11 Engine Mounted Fuel Filter Installation

11/1/2019

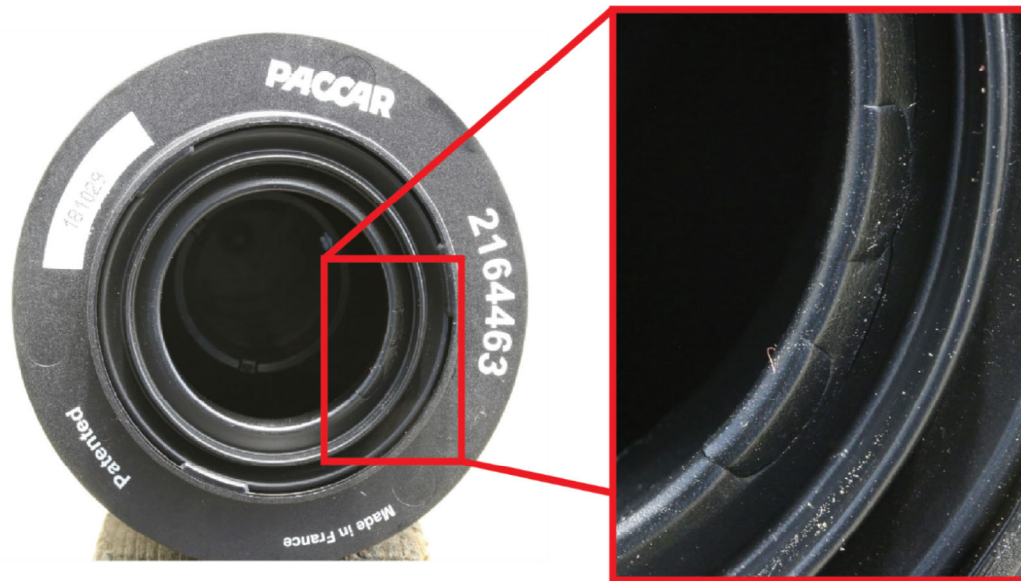
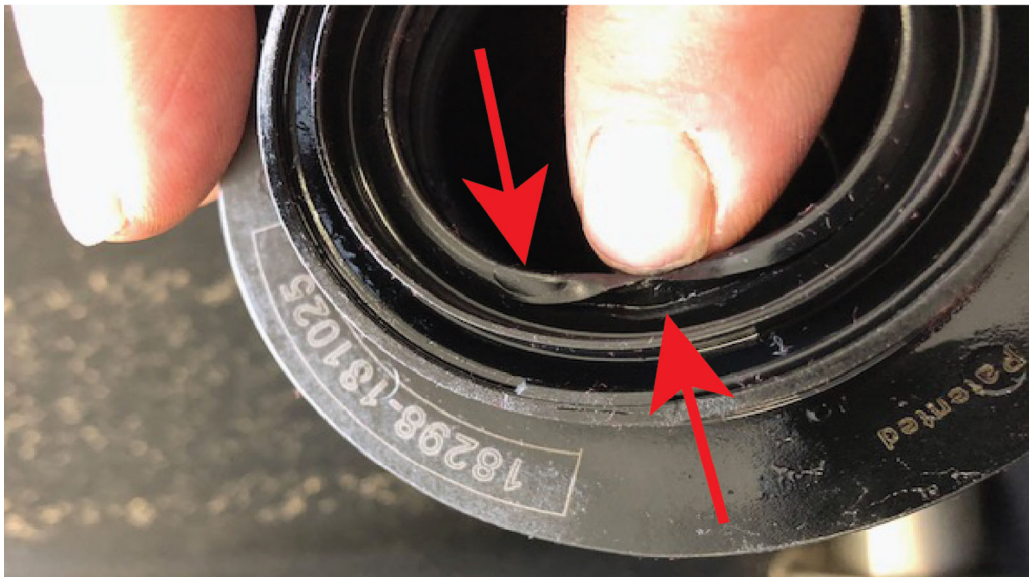
Failure to follow the updated procedure can lead to the following symptoms:

- Low fuel pressure fault codes
 - P1087: Fuel Pressure – Data valid but too low, moderately severe
 - P0087: Fuel Pressure – Data valid but too low, most severe
- Low Power
- Crank no start

The following images show fuel filter damage typically caused by not lubricating the fuel filter seal and rotating it during installation. Notice the depressions and tears in the [seal](#).

Refer to the updated fuel filter installation procedures in Repair & Maintenance RMI.
