**19PBE**

Safety Recall - Back of Sleeper Reflective Conspicuity Tape Location

11/4/2019

Subject: Safety Recall 19PBE – Back of Sleeper Reflective Conspicuity Tape Location  
NHTSA 19V733  
EXPIRATION DATE: NONE

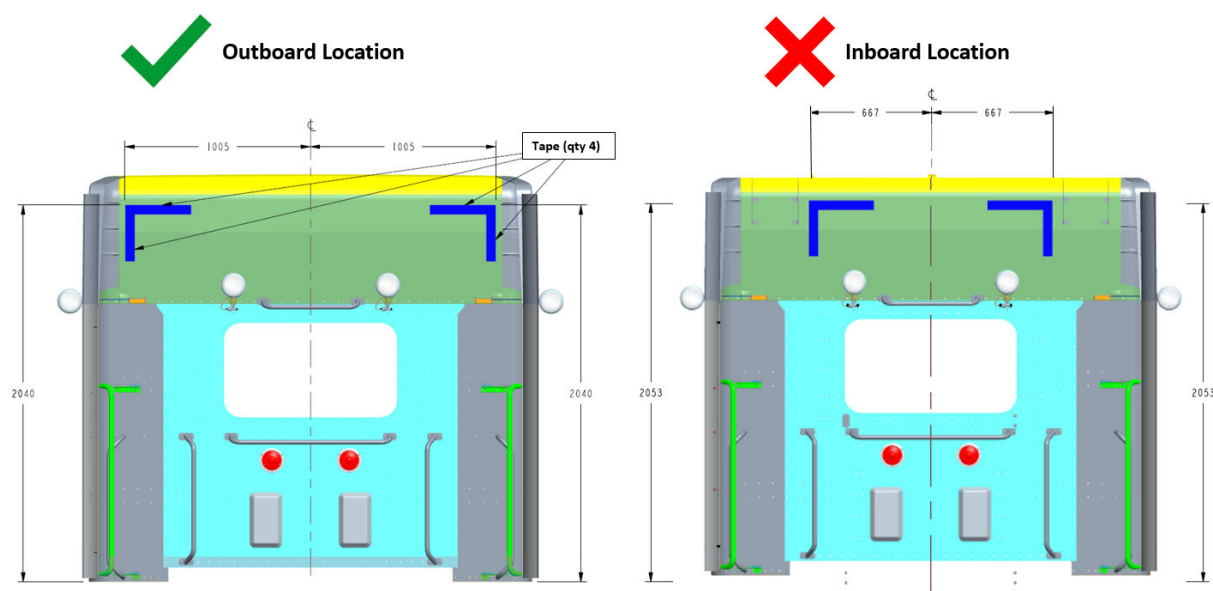
Peterbilt Motors Company has determined that a regulatory non-compliance, may exist in certain model 579 vehicles manufactured between 8/26/2019 and 9/12/2019. On certain trucks, the reflective conspicuity tape on the back wall of the sleeper box was installed in incorrect locations. FMVSS 108 Section S8 2.4.2 regulations require the conspicuity tape to be placed in specific areas. A truck that does not have properly placed conspicuity tape may be less visible to others and could create an increased risk of a crash. Vehicles operating without a trailer may be cited for incorrect tape location and fail an annual truck inspection.

1. Refer to Figure 1 and inspect the location of the Reflective Conspicuity Tape.
2. If the tape is located in the inboard location, continue to the next step. Removal of the tape in the inboard location is not required. If the tape is removed, use an adhesive cleaner that is appropriate for use on painted surfaces to remove the tape residue.
3. Clean the new installation surface and install the new tape in the outboard location as shown in Figure 1.
