Technical Service Bulletin

91 Rear parking aid does not work, various DTC(s) stored in the driver assist or vehicle electrical system modules

91 19 10 2057357/1 November 8, 2019.

Model(s)	Year	VIN Range	Vehicle-Specific Equipment
A6, A7	2019	All	Not Applicable

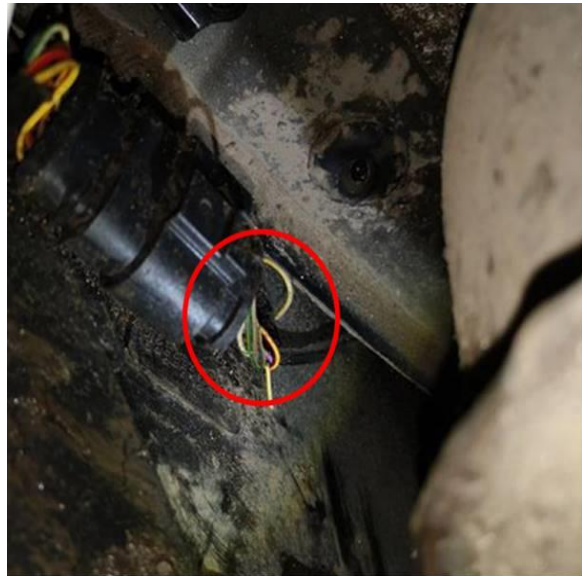
The connector housing or wires leading to connector T14m may become damaged due to road debris.

Figure 1. Location to inspect T14m for damage.

1. Inspect connector T14m and its circuitry at the left rear bumper connector station TSFHL (Figure 1 and 2).

2. If damage is found, repair the affected wires and/or connector housing using VAS1978B.
3. Slide the new grommet, part number 443 906 102 G onto the harness and then reassemble the connector. Ensure the grommet is fully seated on the connector before refitting the bumper.
4. Once the repair is complete, clear out all DTC's and check system for functionality.

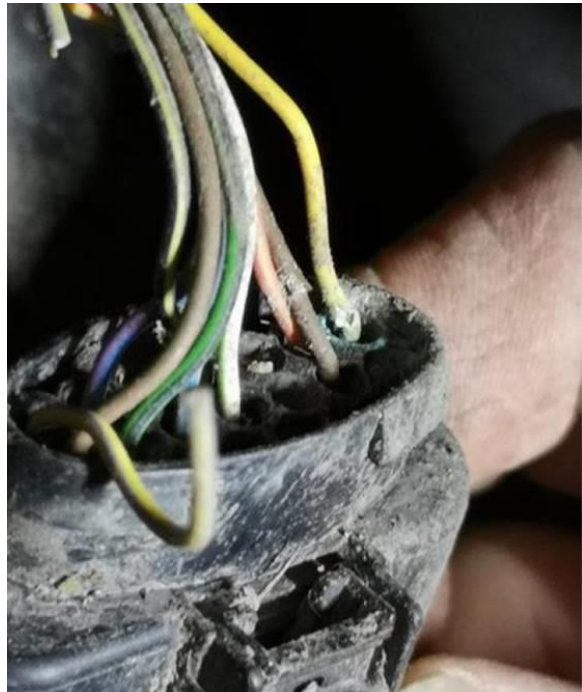
Figure 2. Close up of T14m connector showing harness damage.
