Technical Service Bulletin

91 SOS Warning displayed in the instrument cluster, no communication to the telematics control module

91 19 11 2056076/4 November 8, 2019. Supersedes Technical Service Bulletin Group 91 number 19-95 dated September 30, 2019 for reasons listed below.

Model(s)	Year	VIN Range	Vehicle-Specific Equipment
A4, A5, A6, A7, A8, Q5, Q7, Q8, and Audi e-tron quattro	2019 - 2020	All	With ConBox

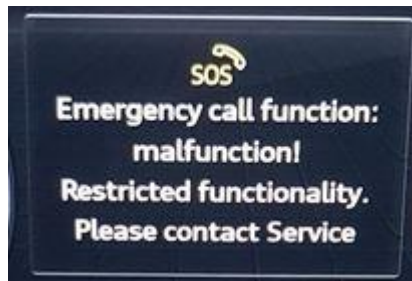
- An SOS Warning is displayed in the instrument cluster (Figure 1).

Figure 1. Emergency call malfunction warning.

- No diagnostics communication can be established with the control module for emergency call module and communication unit (telematics control module or ConBox), J949 (address word 0075).

A software bug can cause the control module to freeze during cold start.

1. Remove the telematics control module, J949 (address word 0075) according to the repair manual in Elsa.
2. Open the battery compartment of the telematics control module, J949 (address word 0075) and disconnect the backup battery.

3. Leave the battery disconnected for approximately 60 seconds.
4. Reinstall the backup battery back into the telematics control module, J949 (address word 0075).
5. Reinstall the telematics control module, J949 (address word 0075) back into the vehicle.
6. **If ODIS still cannot connect** to the telematics control module, J949 (address word 0075), follow the ODIS test plan.

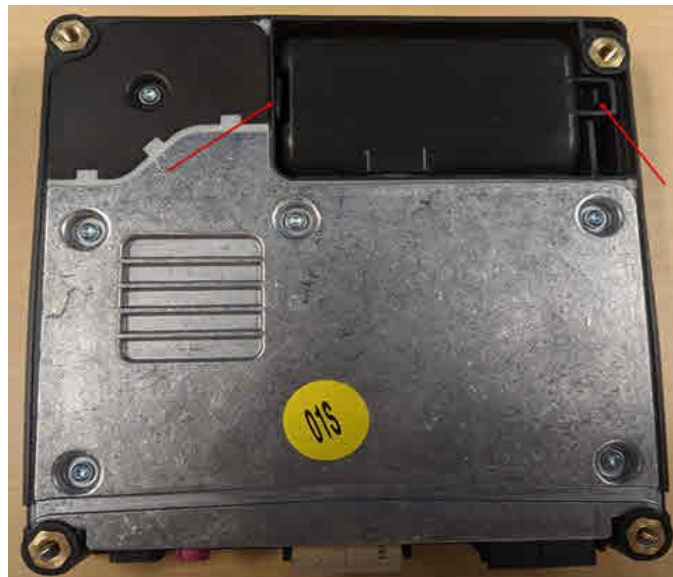
Figure 1. Backup battery compartment location.

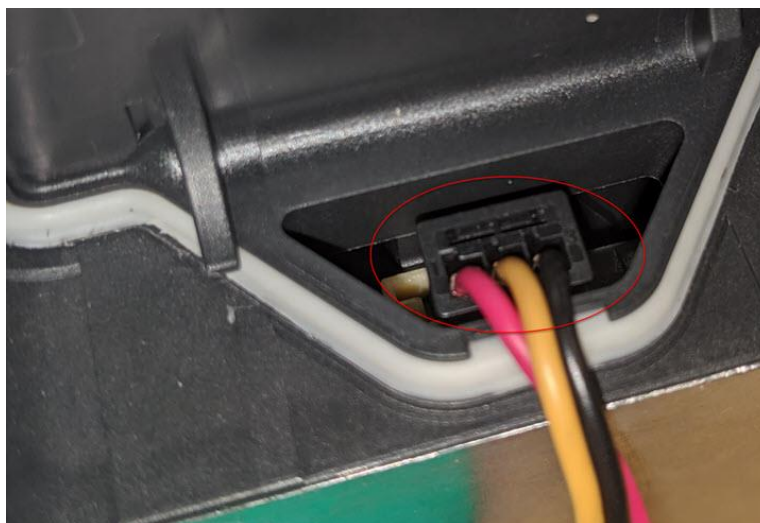
Figure 2. Backup Battery connector (no release mechanism).
