Technical Service Bulletin

91 Night vision system inoperative, DTC B201000 stored in night vision control module

91 19 12 2045020/4 November 13, 2019. Supersedes Technical Service Bulletin Group 91 number 18-04 dated July 17, 2018 for reasons listed below.

Model(s)	Year	VIN Range	Vehicle-Specific Equipment
Q7	2017 - 2019	All	With night vision system
A6, A7	2015 - 2018	All	With night vision system

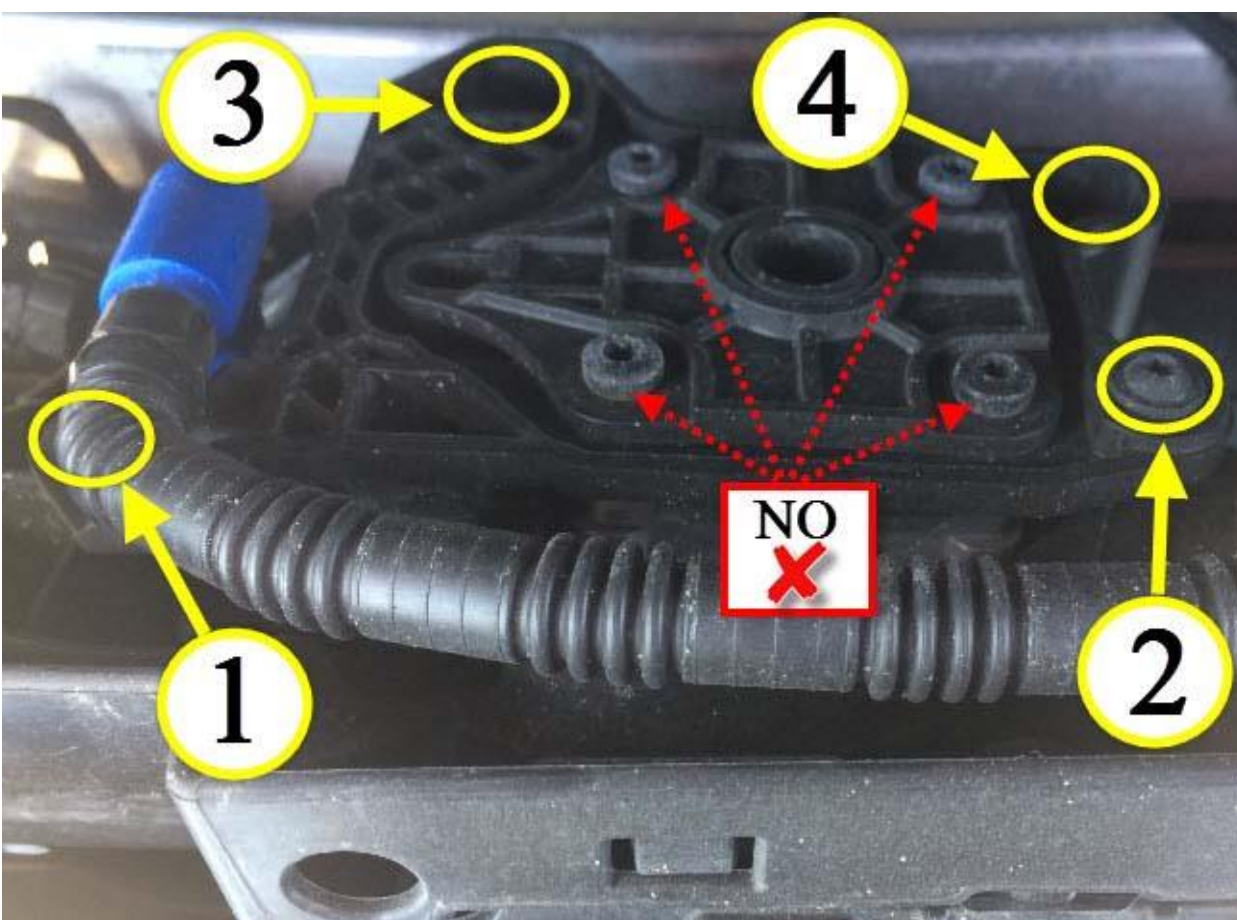
Do not remove or loosen the four screws that hold the camera onto the camera mounting bracket, these are shown in the image with red dotted arrows.

Figure 1. Night vision camera mounting bracket screw retainer locations 1, 2, 3, and 4. Loosen screws 1, 2, 3, and 4. Do not remove or loosen the four screws holding the camera to the bracket.

6. Loosen the night vision camera mounting bracket by loosening the four mounting screws that hold the mounting bracket to the radiator grille. Mounting screws are shown in the image below (Figure 1) by numbered arrows 1, 2, 3, and 4.

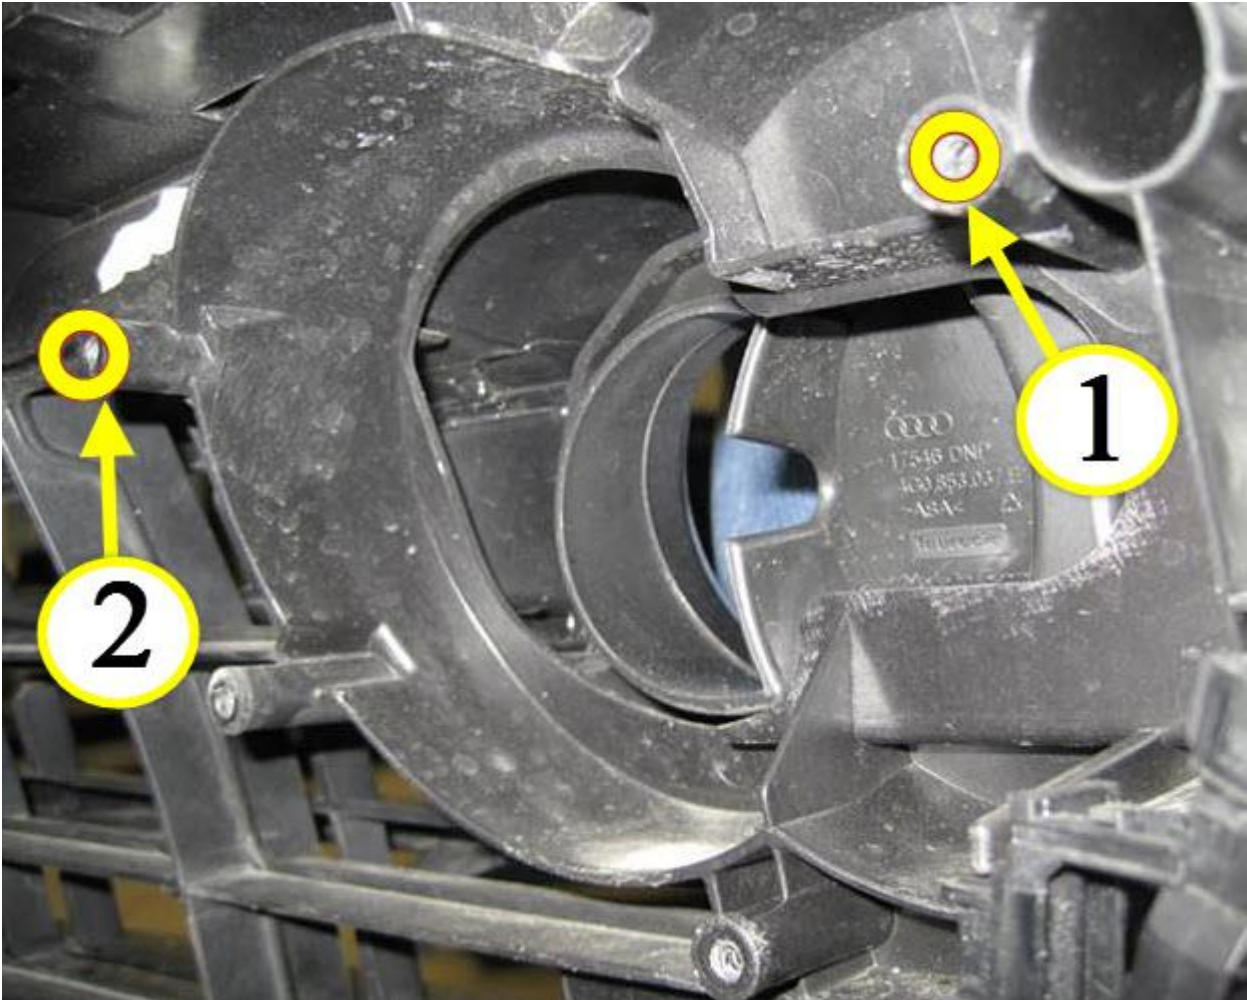
Figure 2. Radiator grille screw retainer locations with camera removed for reference. Spacers (N01152322) will be placed at locations 1 and 2.

7. Place a single spacer, part number N01152322, between each of the two upper mounting points that secure the night vision camera bracket to the radiator grille. These screws are shown in the above image as points 1 and 2 (Figure 1). The image below (Figure 2) references these points on the radiator grill as 1 and 2. The next image (Figure 3) shows the placement of the spacer on the camera as points 1 and 2, the camera has been removed for clarity.

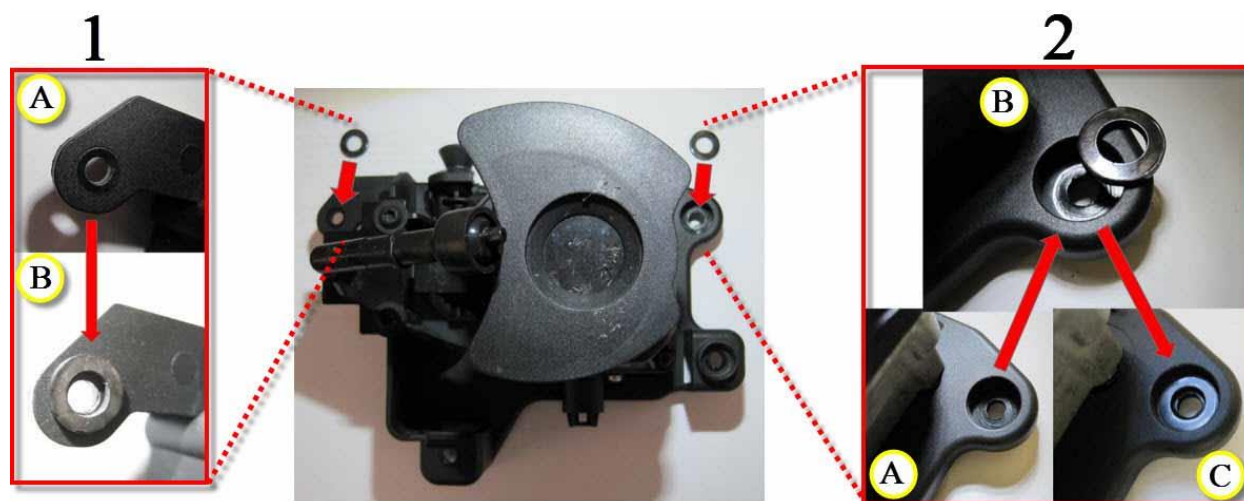
Figure 3. Additional photo showing the spacer placement with the camera removed for reference. Place a spacer on the grille facing side of the camera's upper mounting surface in positions 1 and 2.

8. After positioning the two spacers between the night vision cameras upper mount points and the radiator grille, torque all four screws to 2.5Nm.
9. Perform the calibration of the night vision system once again. Following the calibration, the new final pitch angles displayed by the tester should be between 0.3° and 1° less than the original values recorded. A final pitch value between +0.5° and +1.1° is acceptable.
10. If this is an RS 7 model, additional systems must also be calibrated due to the removal of the front bumper. Consult the Elsa repair manual for these procedures.
