Technical product information

Topic	New Continental GT and GTC - Rattle / Buzzing Noise - Head-Up display
Market area	Bentley: worldwide (2WBE),Hongkong-Macau (5HK)
Brand	Bentley
Transaction No.	2052431/3
Level	EH
Status	Approval
Release date

Rattle / buzzing noise from Control Unit for Head-Up display - dashboard upper trim panel.

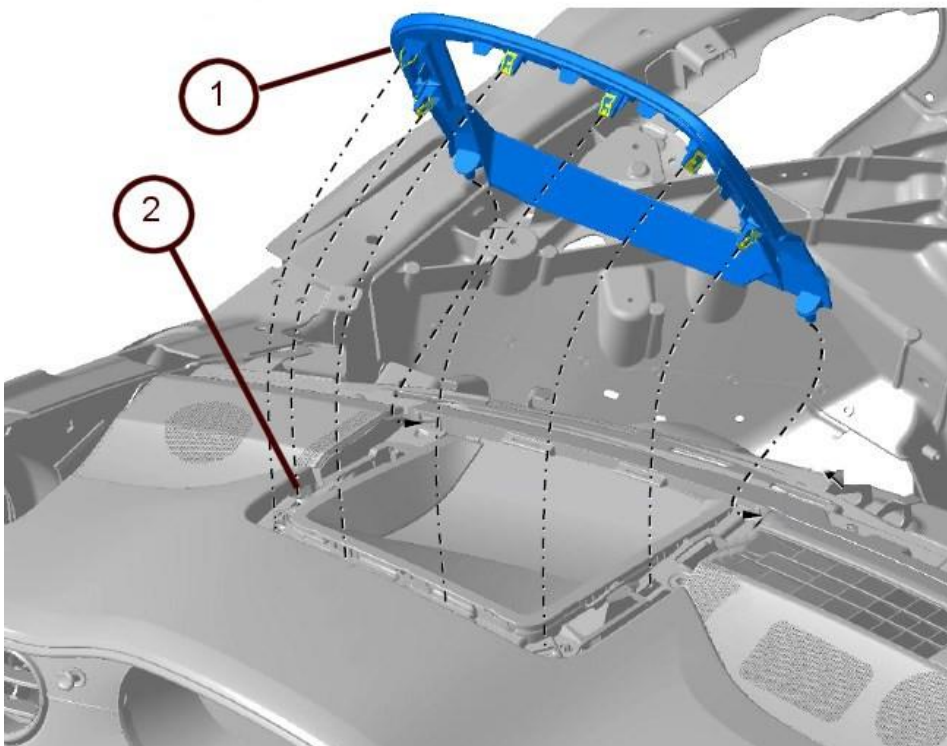
Figure 1

- Relative movement between Control Unit for Head-Up Display and associated Trim Ring – figure 1.
- Contact between the dashboard and dashboard upper trim panel.
- Head-up Display internal fault

1 – Trim Ring

2 – Control Unit for Head-Up Display

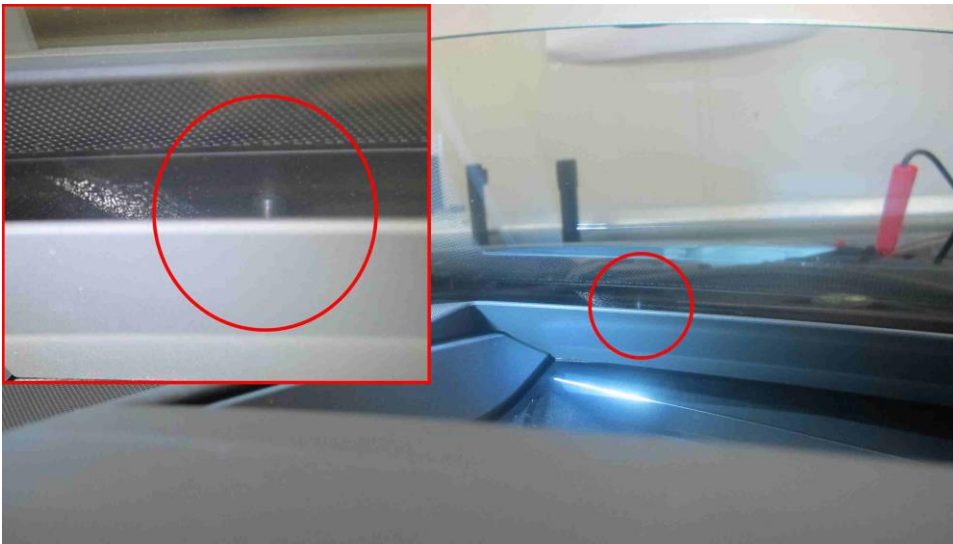
Figure 2

Bump stop introduced to the dashboard at the forward area of the HUD – figure 2.
