WKG7 - Reworking Filler Flap/Charge Port Door Module (Workshop Campaign)

Vehicle Type: **Panamera Sport Turismo (971)**

Model Year: **As of 2018 up to 2019**

Subject: **Filler flap/charge port door module**

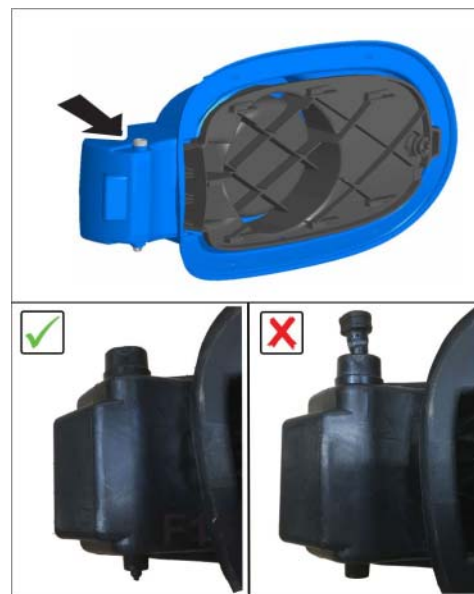
Checking filler flap/charge port door module

Information: **Due to unfavorable tolerances, there is a possibility that the hinge pin on the filler flap/charge port door hinge will loosen at one side.**

- 2.1 Check whether the hinge pin is secure in the hinge arm ⇒ *Checking filler flap/charge port door module -arrow-*.
If the hinge pin has moved out of the hinge, first push the hinge pin fully into the hinge arm again.
