TECHNICAL SERVICE BULLETIN

2.7L/3.0L EcoBoost - Oil Pan Leaking

19-2332
04 November 2019

Ford
2015-2017 Edge
2017 Fusion
Lincoln
2017 Continental
2016-2017 MKX
2017 MKZ

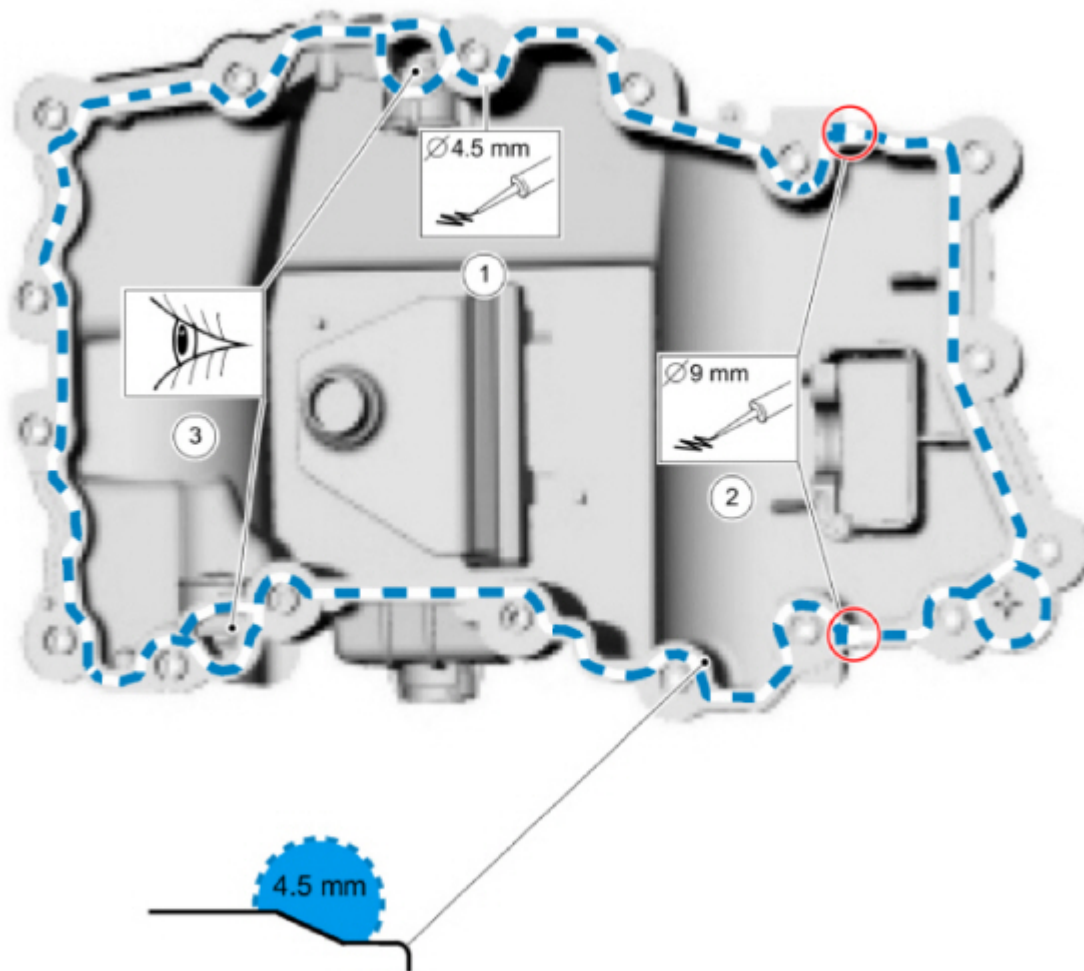
(1). Using too little sealant may result in oil leaks and using too much sealant may result in oil contamination and engine damage.

8. Apply a 4.5 mm (0.18 in) bead of Motorcraft® High Performance Engine RTV Silicone to the new oil pan. The RTV bead must be applied to straddle the step chamfer and sealing face. (Figures 5-6)

9. Apply a 9 mm (0.35 in) bead of Motorcraft® High Performance Engine RTV Silicone to the engine front cover-to-cylinder block joint areas on the new oil pan as shown in Figure 5.
10. Install the new oil pan. Refer to the WSM, Section 303-01.
