Technical Service Bulletin

55K6 UPDATE – Servicing Rear Lid Drive (NVLW)

November 08, 2019

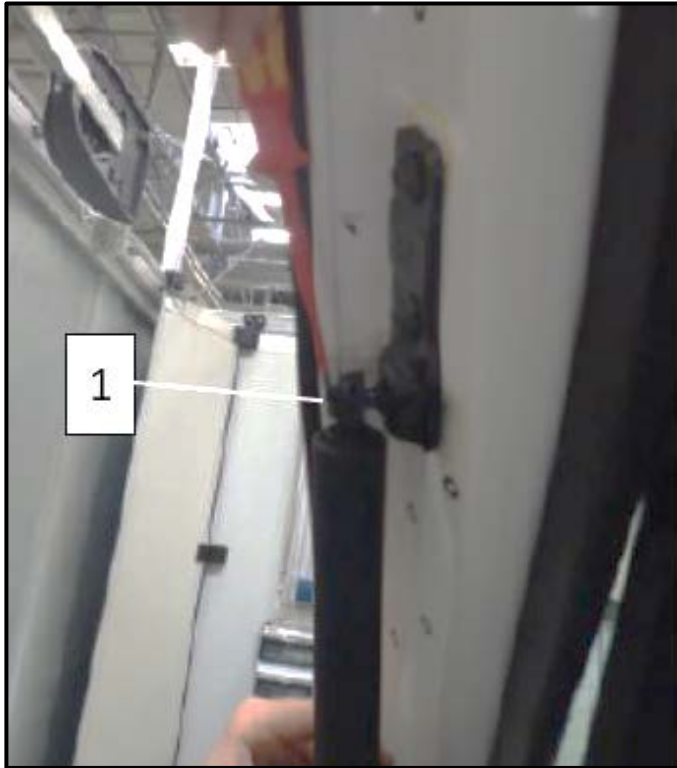
- Open the rear lid.
- Support the rear lid to prevent it from dropping down.
- Use a small screwdriver to lift securing clip <1> slightly and detach spindle motor from ball stud on body and rear lid.

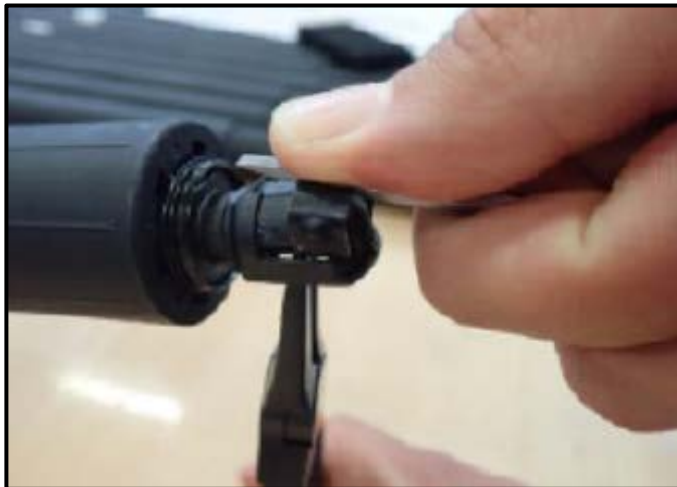
After removing securing clip, check plastic ball socket visually for damage.

- Press securing clip open using circlip pliers and lever off towards front using a screwdriver.
