Technical Service Bulletin

97 Fuel gauge does not work

97 19 67 2056234/2 November 19, 2019. Supersedes Technical Service Bulletin Group 97 number 19-65 dated September 23, 2019 for reasons listed below.

Model(s)	Year	VIN Range	Vehicle-Specific Equipment
A8	2018 - 2020	All	Not Applicable

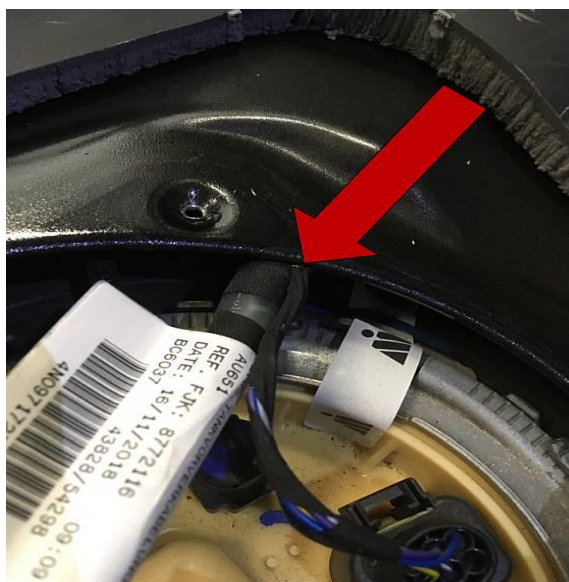
The wiring of the fuel tank senders can rub through on the service opening for the fuel tank.

Figure 1. Location to inspect for rub through.

Improved harness routing and addition of abrasion resistant tape in production.

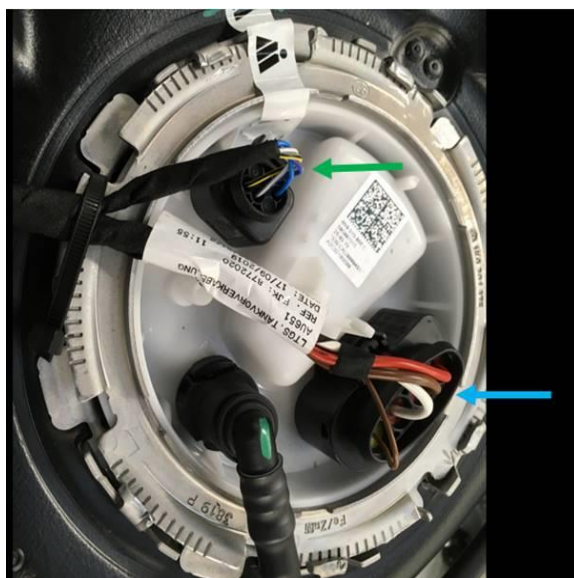
Figure 2. Fuel tank harness connectors to be removed.

- Tools required for the unplugging:
 - Small plug (tank unit) green arrow (Figure 2).
 - Use VAS1978/16 to release the primary lock
 - Use VAS1978/17 to release the secondary lock.
 - Large plug (fuel pump) blue arrow (Figure 2).
 - Use VAS1978/18 to release the primary lock.

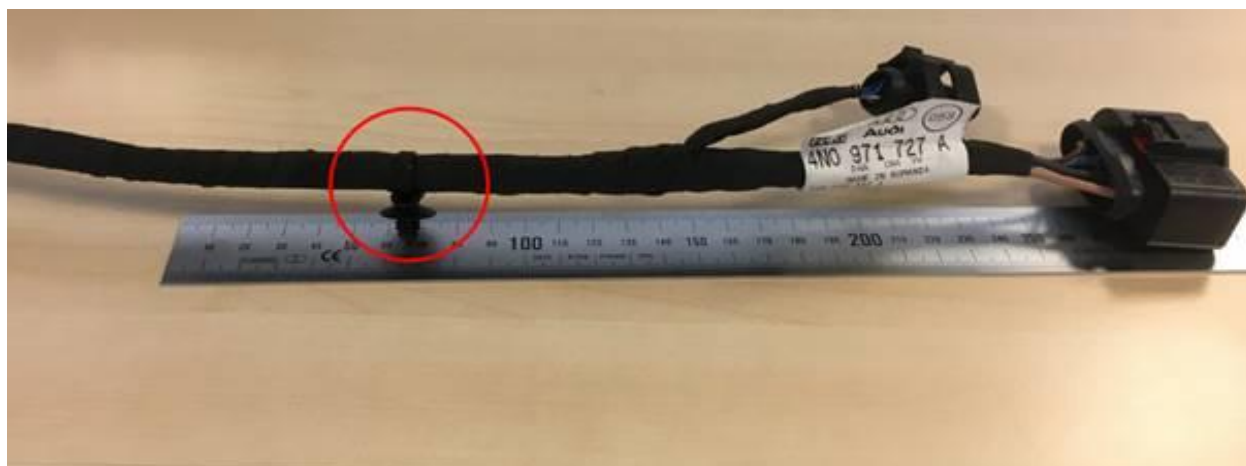
Figure 3. Clip to be removed from the old or new harness.

3. Lever out the round clip between the vehicle body and fuel tank highlighted by the red circle in Figure 3.

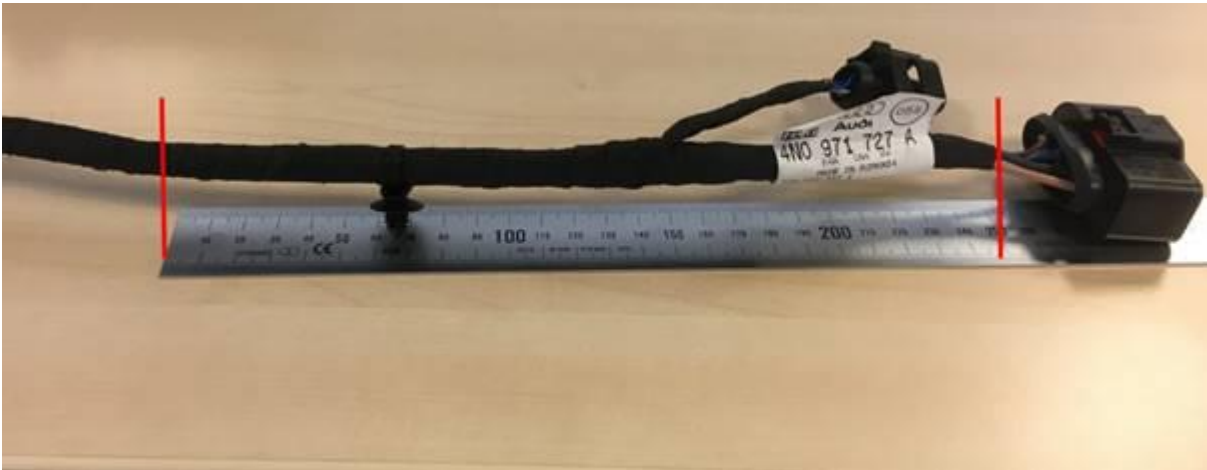
Figure 4. Add additional wrapping between the two red lines, approximately 250mm.

4. Remove the trim for the fuel pump control module from the right underbody of the vehicle.
5. Carefully pull the wiring harness downwards so that the attached fish tape/mechanics wire does not come loose.
6. Carefully inspect the wiring harness for damage.
7. If any damage is found on the harness, replace the wiring harness and continue with the remaining steps to re-route the new harness.
8. If there is no damage found, perform the remaining steps using the existing harness and continue with standard diagnosis.
9. Remove the round clip from the wiring harness (red circle in Figure 3.)
10. Add an additional wrap to the harness using textile tape **N 105 920 02** between the indicated lines in Figure 4 (approximately 250 mm).

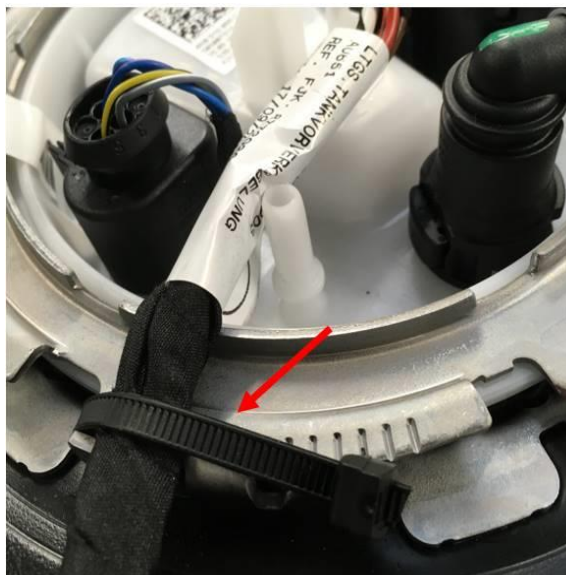
Figure 5. Harness shown secured to tank.

12. Secure the wiring harness with a cable tie to the retaining ring for the tank unit (Figure 5).
