Technical Service Bulletin

97 MMI display black and/or a parking brake malfunction, DTCs C100C01, U105400, U10B800, U10E200, and/or U10CA00

97 19 68 2057768/1 November 22, 2019.

Model(s)	Year	VIN Range	Vehicle-Specific Equipment
A6, A7	2019	All	Not Applicable

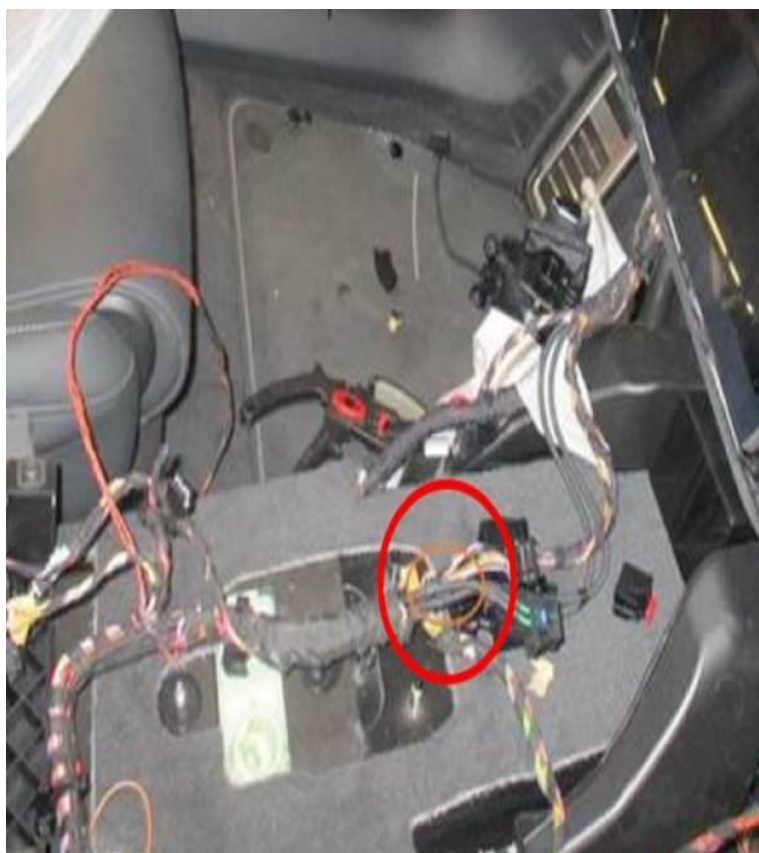
Figure 1. Location to inspect underneath center console.

2. Inspect the harness under the center console for damage as shown in Figures 1 and 2.

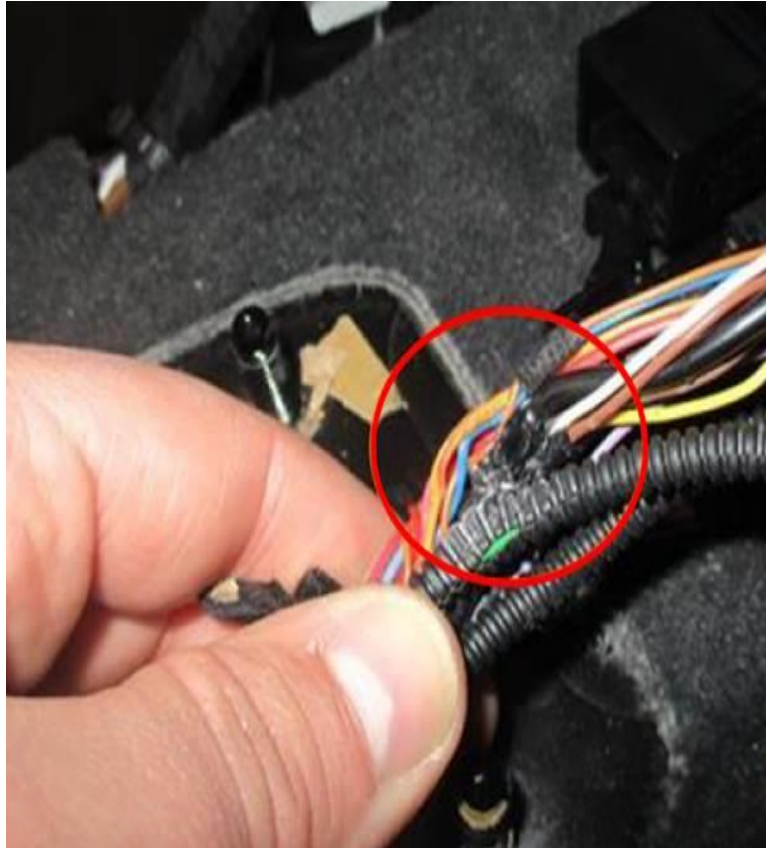
The wire harness underneath the center console may be pinched during assembly.

Figure 2. The harness is damaged during assembly.

3. If damage is found as shown in Figure 2, repair the damaged wires using VAS 1978B. Additionally, add the harness protection using the steps below.

4. Once the damaged wires have been repaired with VAS 1978B, wrap the repaired section with the textile tape N 107 209 02.
5. Install the corrugated tube part number N 107 328 01 over the wrapped cables between the red lines indicated in Figure 3.

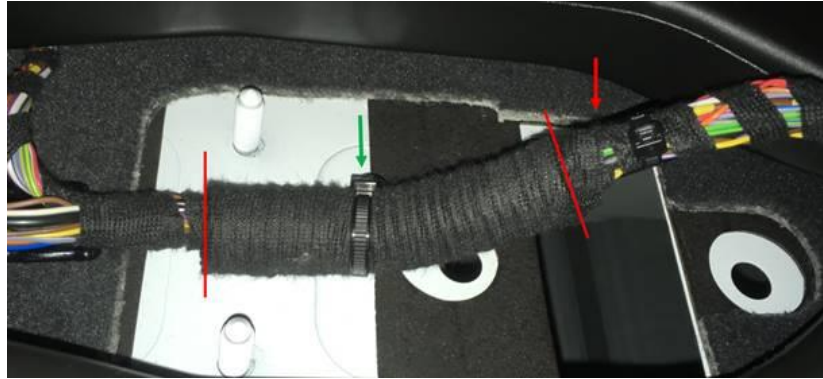
Figure 3. Completed harness protection.

6. Using textile tape N 107 209 02, completely wrap the corrugated tube over the harness so that it cannot slip out of place (red arrow on Figure 3).

7. Use a new cable tie, part number **3D0 971 838 A** and secure the harness to the body (green arrow on Figure 3).
8. Once complete, refit the center console according to the repair manual.
