Subject: BODY VIBRATION DURING EXTREMELY COLD WEATHER	Bulletin No.: 01-020/19
	Last Issued: 11/26/2019

2019 Mazda3 (Japan built) vehicles with VINs lower than JM1BP*****143775 (produced before May 31, 2019)
2019-2020 Mazda3 (Mexico built) vehicles with VINs lower than 3MZBP*****120674 (produced before Aug. 28, 2019)

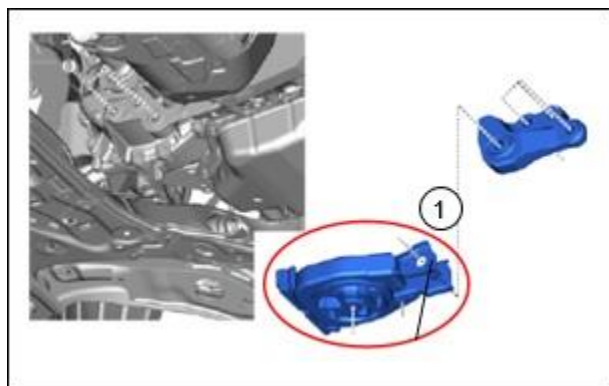
Some vehicles may exhibit an excessive body vibration when idling or driving after being left in extremely cold weather (-20°C/-4°F or below) for a long time. This is caused by the No.1 engine mount (1) rubber hardening due to material characteristics.

To correct this concern, the cold environment performance of the No.1 engine mount rubber has been increased by changing the rubber material.

- If yes, replace the No.1 engine mount rubber with a modified one according to the instructions on MGSS.
 - ENGINE MOUNT DISASSEMBLY/ASSEMBLY [SKYACTIV-G (WITH CYLINDER DEACTIVATION (US))]
 - ENGINE MOUNT DISASSEMBLY/ASSEMBLY [SKYACTIV-G (WITHOUT CYLINDER DEACTIVATION (US))]
