GROUP	MODEL
BOD	2020MY Sorento (UMa)
NUMBER	DATE
198	November 2019

TECHNICAL SERVICE BULLETIN

SUBJECT: SERVICE ACTION: DRIVER DOOR CHECKER ROD

INSPECTION AND REPLACEMENT (SA407)

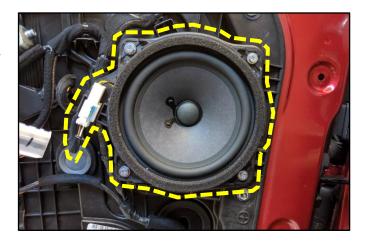
Remove the left front door speaker by referring to the "Body Electrical System → AVN System → Speaker → Repair procedures" chapter in the applicable Shop Manual on KGIS.
