GROUP TRA	MODEL 2011-2020MY Sportage (SL, QL) 2013-2020MY Sorento (XMa, UMa)
	NUMBER 086	DATE November 2019
SUBJECT: TECHNICAL SERVICE BULLETIN		
PARTIAL REPAIR OF 4WD COUPLING

SUBJECT: **FOUR WHEEL DRIVE (4WD) COUPLING REPAIR**

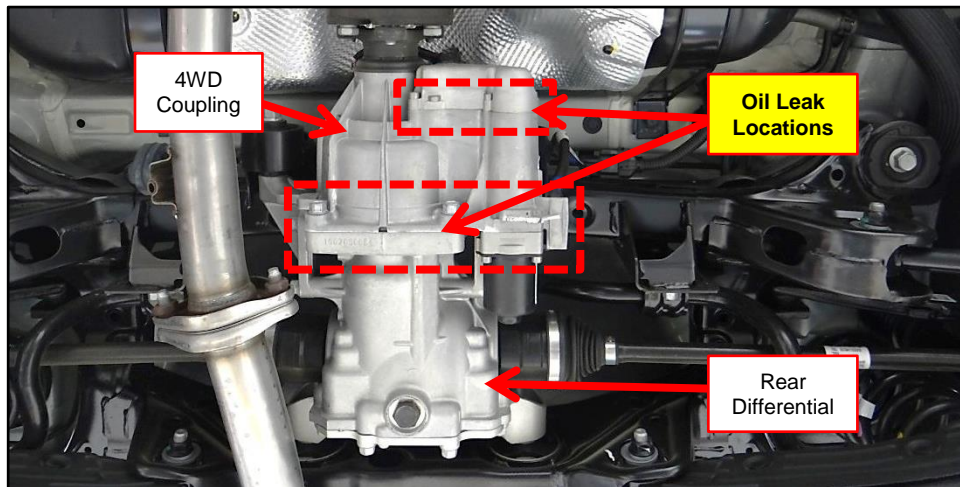
1. Oil is leaking from the 4WD coupling assembly (between the coupling housing or where it connects to the rear differential. (Refer to both red outlined areas in the image).
2. MIL is ON (Refer to the DTCs listed in the table below).
3. Noise and/or vibration is present when vehicle is driven (Refer to audio clip).

No.	Concern Type	Confirmation		Remedy
1.	Oil Leaking	4WD Coupling Visual <u>Leak</u> Noticed		Replace the <u>4WD Coupling</u>
2.	MIL ON with <u>DTCs</u>	P1820, P1821	Motor overcurrent	Replace the 4WD Coupling <u>*Actuator Motor</u>
		P1822	Motor open circuit	
		P1823	Motor low voltage	
		P1824	Motor overload	
		P1829, P1830	Low actual torque	
		P1833, P1834	Motor overheating	Replace the 4WD Coupling <u>Pressure Sensor</u>
		P1825, P1826	Sensor over/low voltage	
		P1827	Sensor battery short circuit	
				P1828
		P1831, P1832	4WD coupling overload	
3.	Noise and/or Vibration	Noise and/or vibration is present while driving. <u>Click for:</u> <a href="#">Noise/Vibration Audio</a>		Replace the <u>4WD Coupling</u>

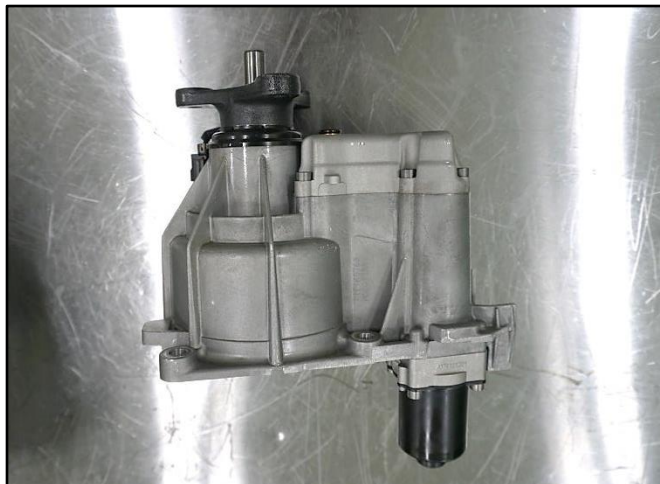
Use caution not to tip the 4WD coupling assembly with the actuator motor facing down as oil may escape.

1. Remove the 4WD Coupling Assembly by referring to the "4 Wheel Drive (4WD) System → Coupling Assembly → Direct Electro Hydraulic Actuator Coupling → Repair procedures" chapter in the applicable Shop Manual on KGIS.

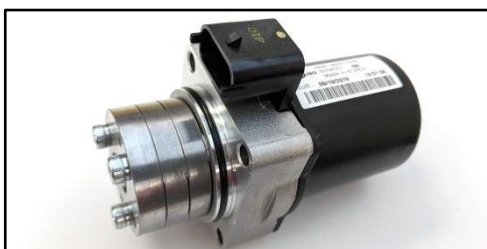
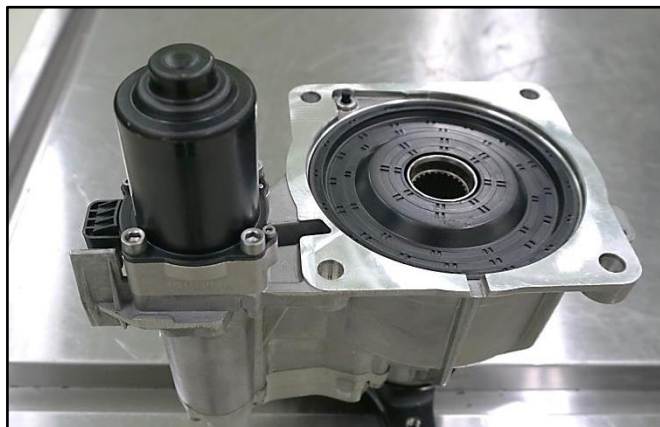
**Note:** Use caution not to tip the 4WD coupling assembly with the actuator motor facing down as the existing oil may escape.

1. Refer to **4WD Coupling Replacement Procedure** outlined above.
2. Remove the 4WD Actuator Motor Assembly by referring to the "4 Wheel Drive (4WD) System → Coupling Assembly → Oil hydraulic Motor (Actuator) → Repair procedures" chapter in the applicable Shop Manual on KGIS.
