Bulletin No.: PIP5652A
Published date: 11/1/2019

PIP5652A Rattle Noise From Front of Engine With or Without DTCs P0011, P0014, P0016, P0017

Brand:	Model:	Model Years:	VIN:		Engine:	Transmissions:
			from	to		
Cadillac	XT4	2019	All	All	2.0 LSY	All

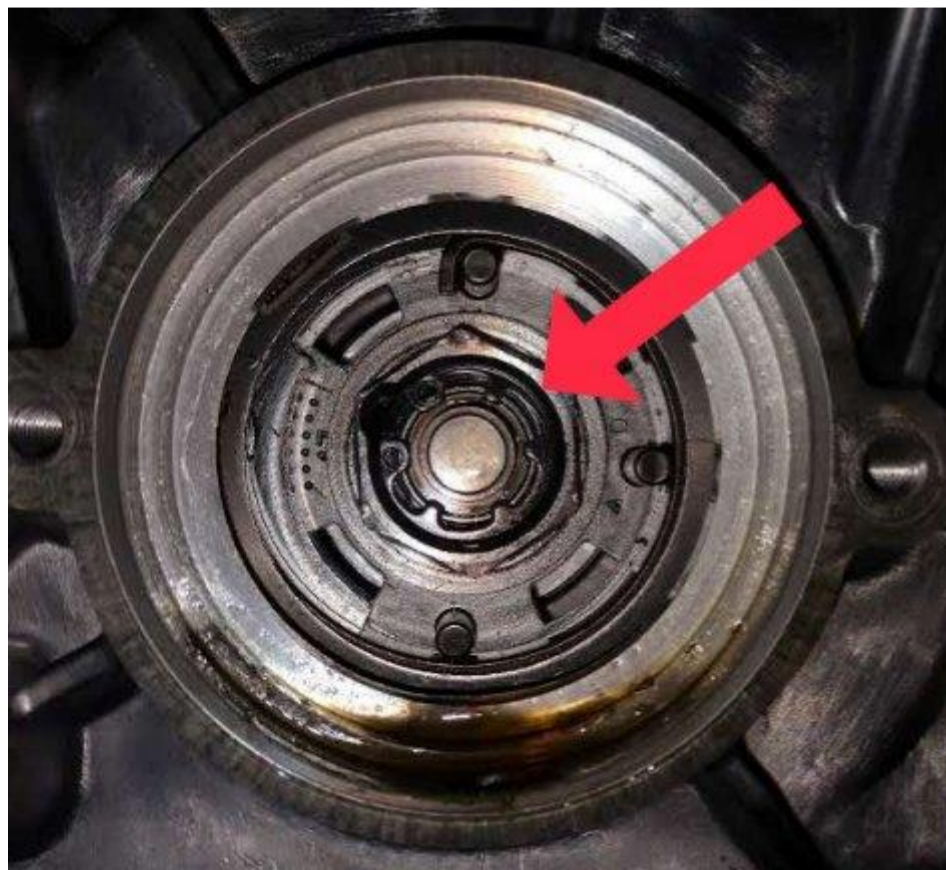
A stuck or collapsed timing chain tensioner may cause damage to the oil control valve assemblies in either Camshaft Sprocket Bolt.

Check for a missing, out of position or damaged Camshaft Position Actuator Valve snap ring. (see picture below)

If the Snap Ring for either Camshaft Sprocket bolt is missing, out of position or damaged, replace both Camshaft Sprocket Bolts following the latest SI documents and perform the timing chain tensioner / guide inspections listed below.

If both Snap Rings are in the correct position, perform the timing chain tensioner and guide inspections listed below.

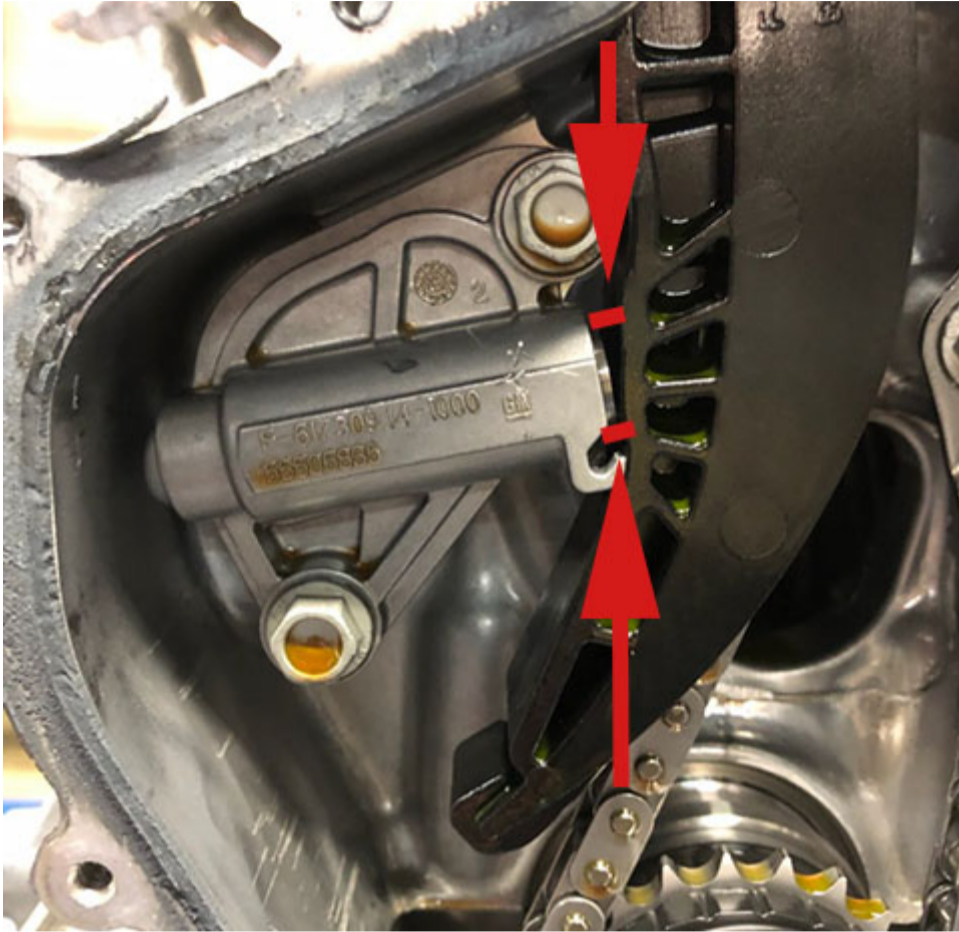
Remove the lower engine front cover assembly and inspect the timing chain tensioner for an air gap between the tensioner plunger and timing chain guide. (see picture below)

If the timing chain tensioner is found to be stuck or collapsed, replace the Timing Chain Tensioner, inspect the three timing chain guides for excessive wear or damage and replace as necessary.

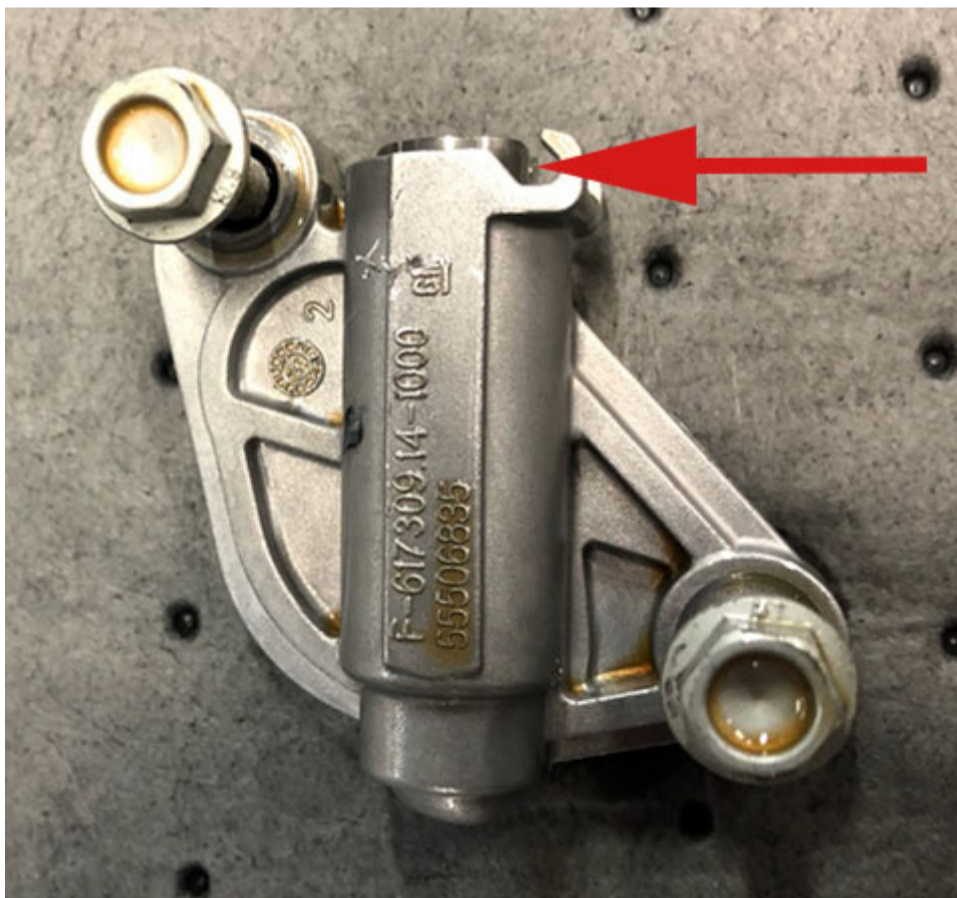
Photo below shows the timing tensioner removed from engine. Note the plunger is stuck in body of tensioner.
