Bulletin No.: PIT5700A Published date: 11/4/2019

PIT5700A Service Front Camera Message

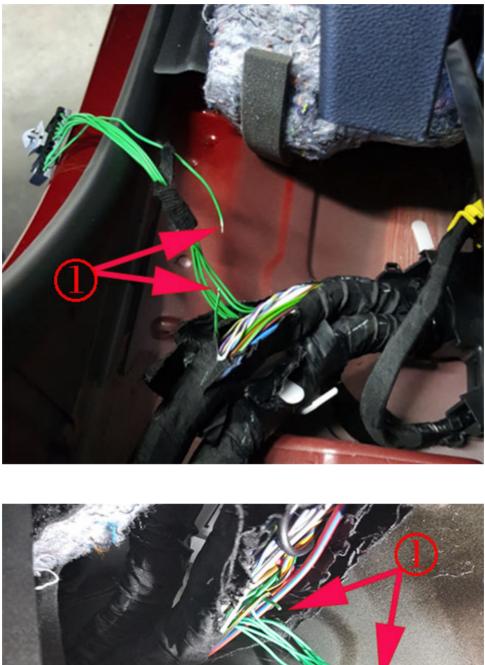
If it is found that the K124 ASCM is not communicating on low speed (with UGN) inspect circuit 5060 for an open in the harness near JX300.

On Blazer JX300 is located at the base of the B pillar. On Acadia JX300 is located on the floor near the driver seat. See # 1 below:

If an open is found repair the circuit following SI Serial Data Circuit Wiring Repairs.
