SERVICE BULLETIN

Classification: BT19-016	Reference: NTB19-100	Date: November 7, 2019
-----------------------------	-------------------------	---------------------------

2019-2020 ALTIMA; FOAM OUT OF POSITION AND VISIBLE AT LEADING EDGE OF INSTRUMENT PANEL

APPLIED VEHICLES: 2019-2020 Altima (L34)

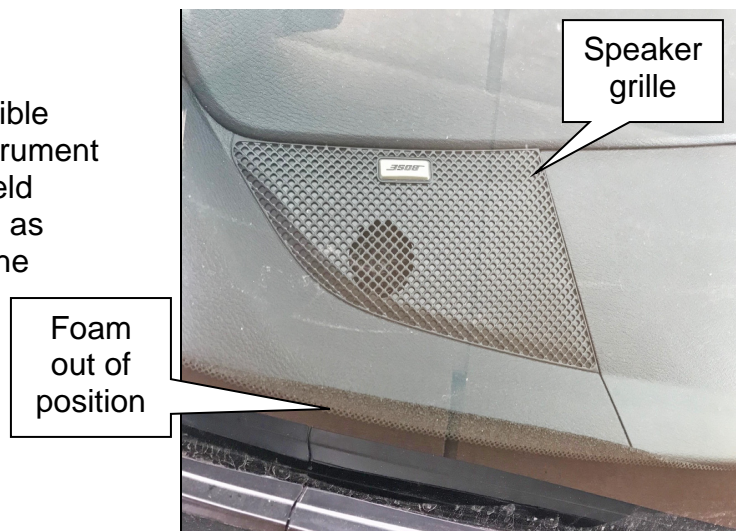
Figure 1

There is foam out of position and visible between the leading edge of the instrument panel and the bottom of the windshield (Figure 1 shows foam out of position as viewed from outside the vehicle on the passenger side).

Remove the foam following the **SERVICE PROCEDURE** on the next page.

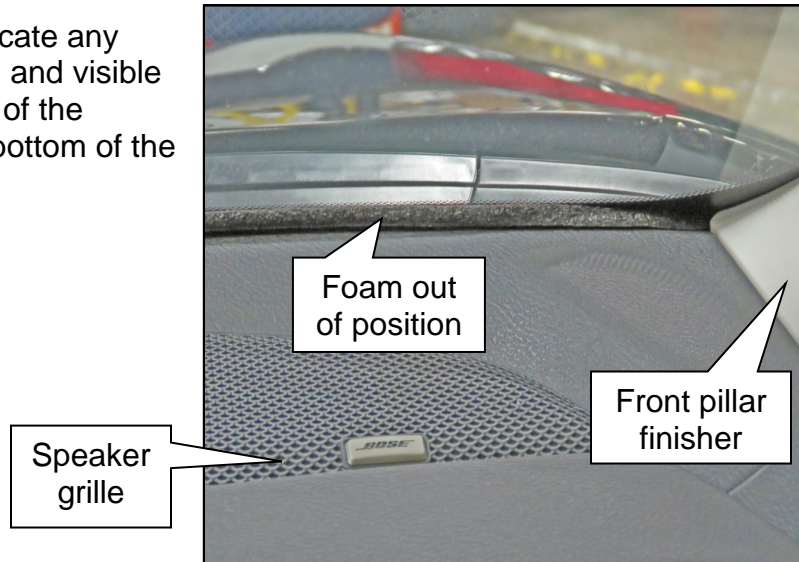
1. Reference Figure 2 and locate any foam that is out of position and visible between the leading edge of the instrument panel and the bottom of the windshield.
