SERVICE BULLETIN

Classification: FA19-002	Reference: NTB19-105	Date: November 22, 2019
-----------------------------	-------------------------	----------------------------

CLICKING/POPPING NOISE FROM FRONT AXLE AREA DURING TAKE OFF/ACCELERATION AND/OR DECELERATION

APPLIED VEHICLES: 2019-2020 LEAF (ZE1)

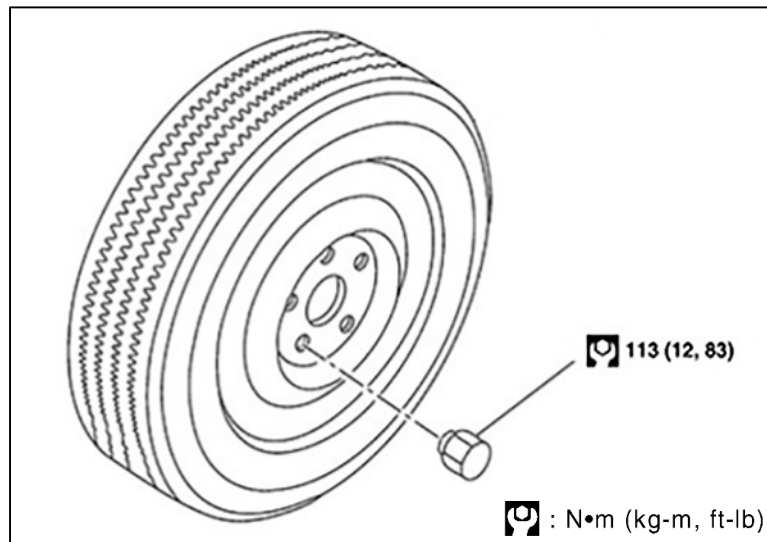
Figure 1

A clicking or popping noise is coming from the front axle area during take off/acceleration and/or deceleration.

Before performing diagnostic procedures, torque the lug nuts for all four (4) wheels to 113N•m (12kg-m, **83 ft-lbs**), in a diagonal pattern.

- If the clicking/popping noise is still present after torquing the lug nuts, refer to the ESM for further diagnostic information.
