JTBO0685NAS3

**TECHNICAL BULLETIN**

Vibration Felt In Passenger Compartment When Starting and/or Idling Engine

MODEL:	MODEL YEAR:	VIN:	ASSEMBLY PLANT:	APPLICABILITY:
F-PACE (X761)	2018 Onwards	093634 Onwards	Solihull	INGENIUM I4 2.0L Petrol/INGENIUM I4 2.0L Diesel

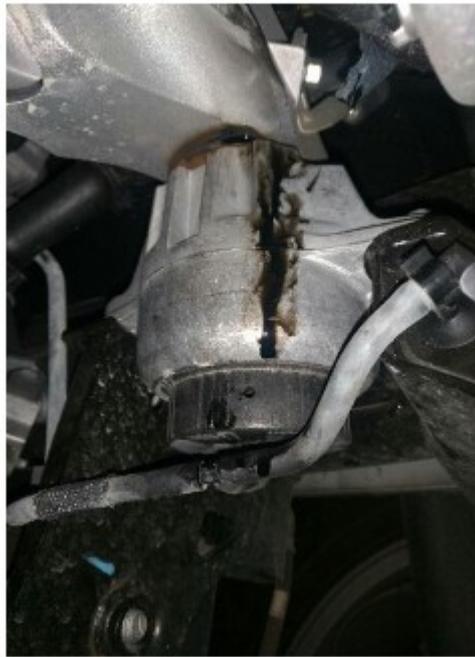
E246391

For the release of the new active engine mounts, the parts team will require a photograph of the damaged/leaking active engine mount(s). Make sure a clear photograph is taken, with the active engine mount still installed to the vehicle, as shown in the illustration.

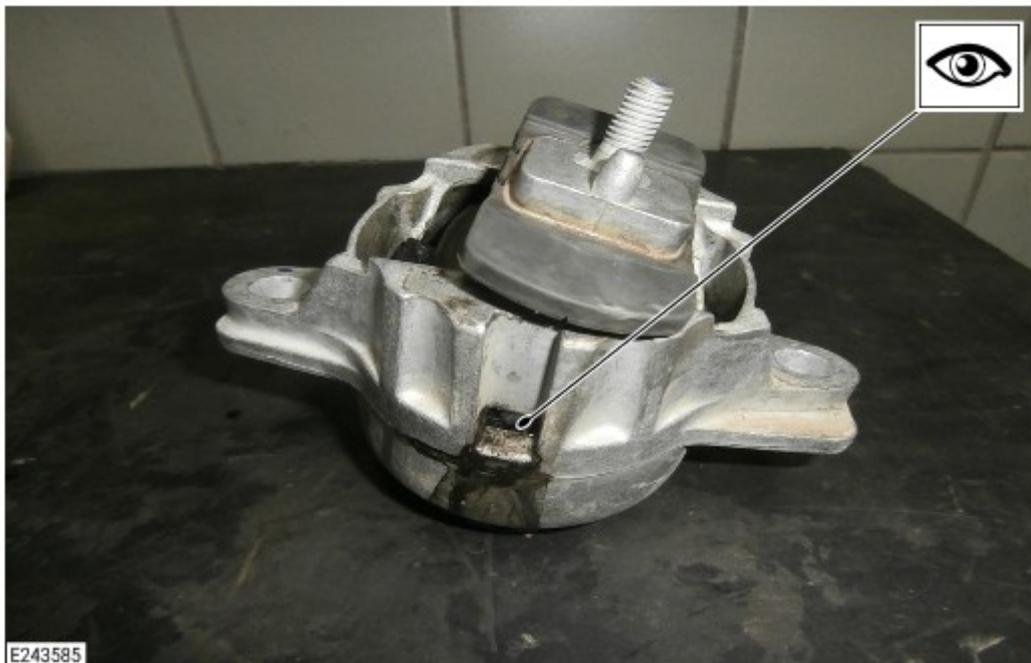
2.

Example of an excessively worn and/or leaking active engine mount.

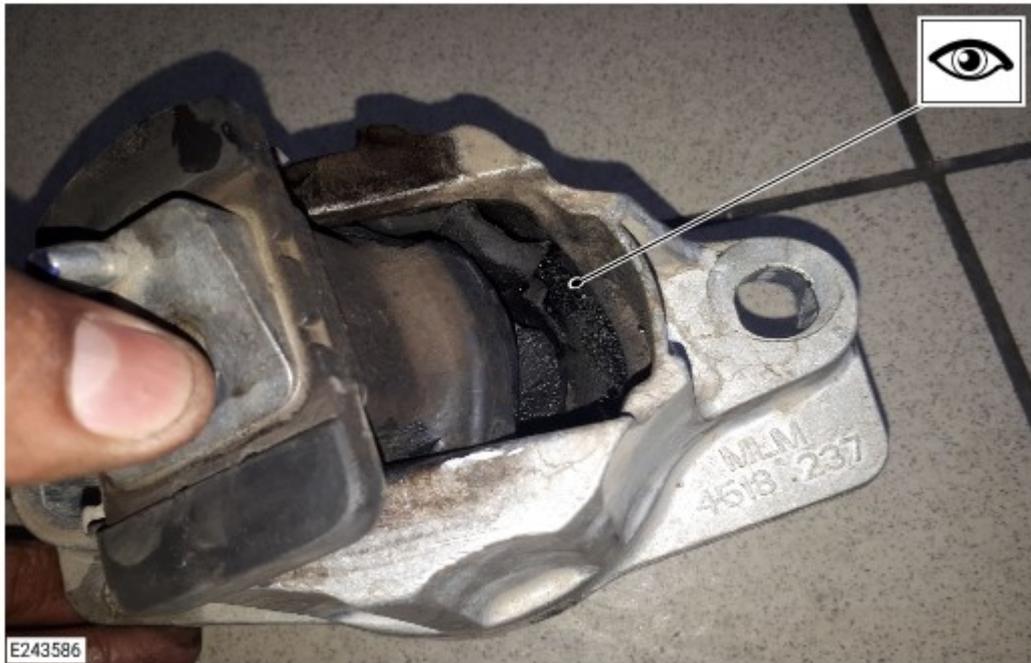
3.

Example of an excessively worn and/or leaking active engine mount.

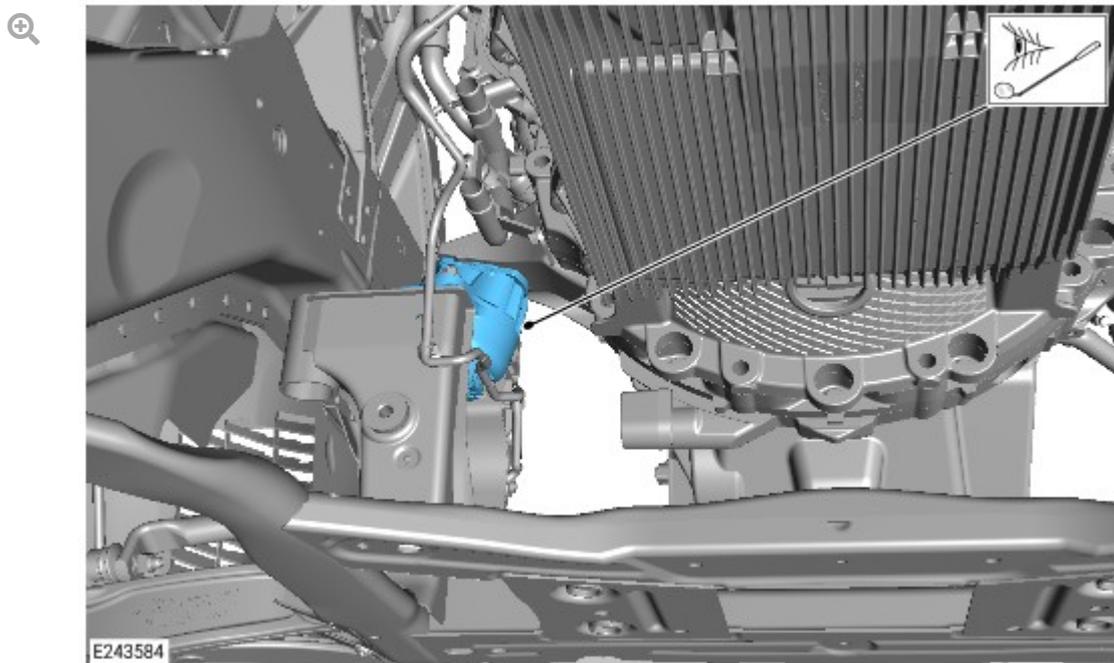
2.

Inspect the active engine mounts for signs of excessive wear and/or leaking fluid.

- ■ If **both** active engine mounts show **no** signs of excessive wear and/or leaking fluid, **do not continue with this technical bulletin**, as the content of this technical bulletin does not directly relate to the customer's concern. Continue to diagnose the vehicle using the TOPlx workshop manual, (see TOPlx workshop manual section 303-00: Diagnosis and Testing - Engine).
- ■ If **any** of the active engine mounts show **any** signs of excessive wear and/or leaking fluid, **continue to step 3**.

3. Renew **both** active engine mounts, (see TOPlx workshop manual section 303-01: Removal and Installation - Left/Right Engine mount).
